Custom Kit No. CK-AG- 29

December 23, 1997

WING FATIGUE LIFE EXTENSION

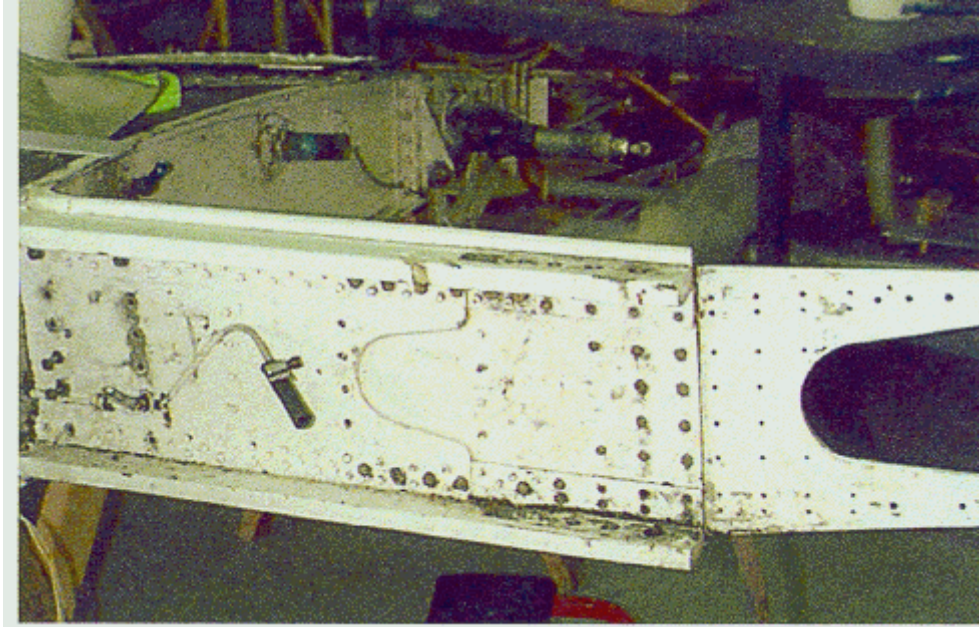
Figure 1. Front view of the main spar Custom Kit #29 work area.

2. Once the wings have been removed from the aircraft, remove the butterfly center splice plate (P/N 20211-3). Care must be taken not to damage the original butterfly plate, it will be used as a drill template for the replacement (P/N 20211-9 & -11) butterfly plates.

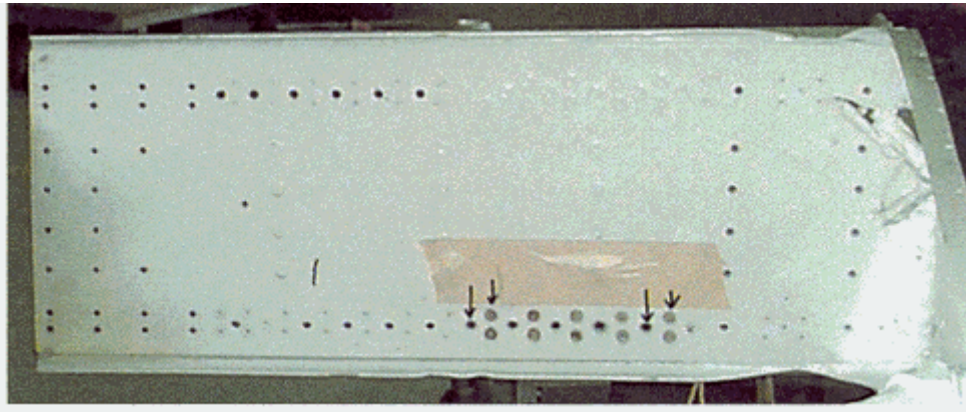
Figure 2. Rear view of the main spar, wing station 00 to 28. A piece of tape has been placed above the operation (4) work area. The two shorter arrows point to the first and last holes in the set of 10 newly countersunk MS24694 screw holes.

4. The new replacement butterfly plates have longer lower extension. Additional fasteners must be removed and the holes prepared to accommodate the additional butterfly length.
The steel Huck fastener collars will be difficult to remove without the aid of a Huck cutter and/or chisel. Care must be taken not to damage and elongate the holes during fastener removal.
The outboard edge of the lower arm of the new butterfly plate (P/N 20211-9) is located at wing station 19.43. Because the butterfly plate edge is so close to the two adjacent MS24694 screws, the screws must be countersunk to assure clearance. In addition, the eight each MS24694 screws inboard of wing station 19.43 must be countersunk to allow the butterfly plate (P/N 20211-9) to set flush against the aft face of the main spar web.

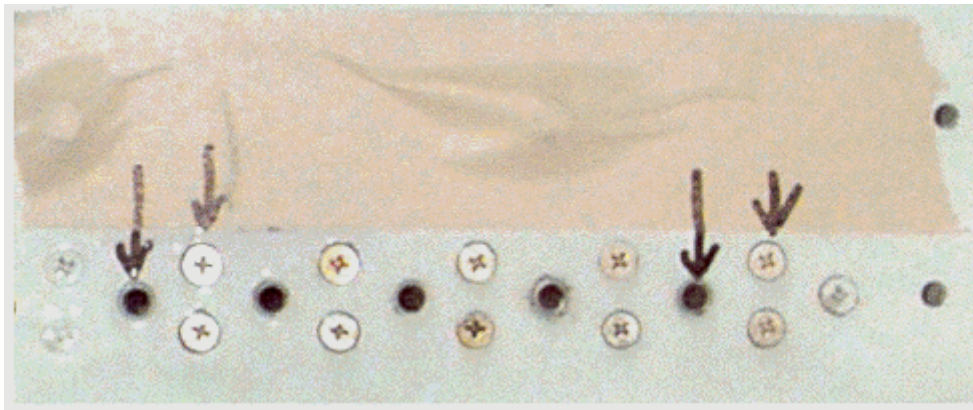
Figure 3. Close-up view of the figure (2) work area, rear view of the main spar. The 10 each MS24694 countersunk screws have been installed. In contrast are the 5 each NAS1104 bolt locations (situated between the two larger arrows).

6. Place the new butterfly splice plates into position onto the aft surface of the main spar. With a number #13 drill bit, drill up the holes. Line ream to 3/16". All but five (5) of the required hole locations transferred from the original butterfly plate (P/N 20211-3) to the new butterfly plate (P/N 20211-9). Transfer the five (5) each NAS1104 bolt locations from the spar web to the lower arm of the butterfly plate (P/N 20211-9).

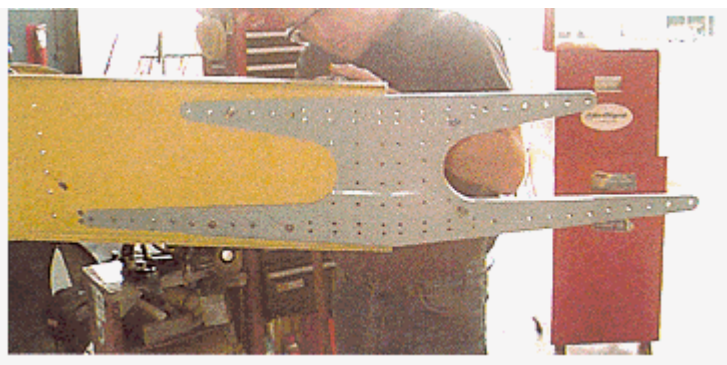
Figure 4. Rear view of the main spar, center butterfly splice plates (P/N 20211-9 & -11) temporarily installed. Transfer drilling operations on the butterfly plates is complete. The mechanic is line reaming the holes to size.

7. Remove the butterfly plates from the spar web. On a drill press, drill out the five (5) hole locations on the new butterfly plate (P/N 20211-9). Use a 15/64" or an #A drill bit.
8. Temporarily reinstall the butterfly plates (P/N 20211-9 & -11) onto the aft face of the main spar web. Ream the five (5) lower arm butterfly plate holes to 1/4".
9. The other half of the new butterfly plates (P/N 20211-9 & -11) must be fit to the opposite wing spar. Repeat instructions (4) through (8) on the other wing.
10. Nicks and/or scratches through the paint down to the metal surface shall be touched up.
