Rockwell service letter No. SL-AG-63

Service Letter No. SL-AG-63
July 13, 1970

WIND GUST DAMAGE TO AILERONS

EFFECTIVITY: Serial No. 1190C & Subs., All S-2D & S-2R

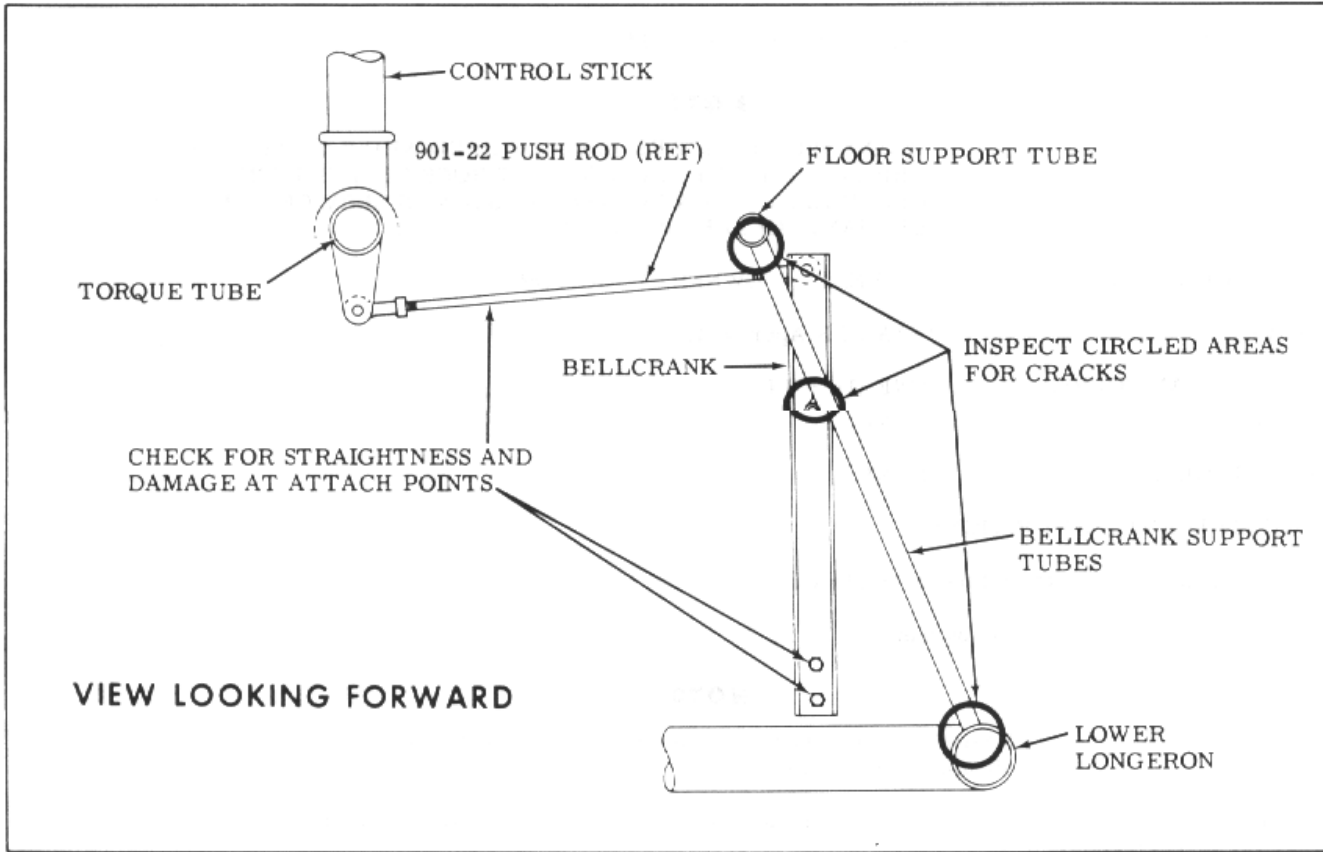
We have had several reports of bent pushrods in the aileron control system due to strong winds with the plane tied down in a tail into the wind position.

With the control stick lock in place and a strong wind blowing into the tail, there is a movement set up due to the extra large surfaces of the ailerons and the flexure of the system.

If any aircraft has been subjected to this situation, a close inspection should be made of all pushrods, bellcranks and bellcrank support structures to check for cracks and bent components. (See attached drawing.)

Wind gust locks should be installed between the aileron and the wing tips to prevent any movement if the plane will be subject to strong gusty winds as stated above.

Do not install locks between flaps and ailerons. If the flap switch were activated with the locks on, serious damage to both ailerons and flaps could result.

An economical lock may be made by using two 6" x6" x 3/4" plywood blocks with a 1/4" hole drilled through the center of each block and covered with discarded inner tube rubber or other protective material. Use a 1/4" bolt and wing nut to secure the two plates together. Place one plate on the upper surface and the other on the lower surface with the bolt in the slot between wing tip and aileron. A red flag should be secured to the lock. Pilots should be instructed to remove locks as part of pre-flight inspection and to check aileron movement before flights as a secondary precaution to assure lock removal.
