Service Bulletin No. SB-AG-21

09-21-88

METAL FIN SPAR REINFORCEMENT

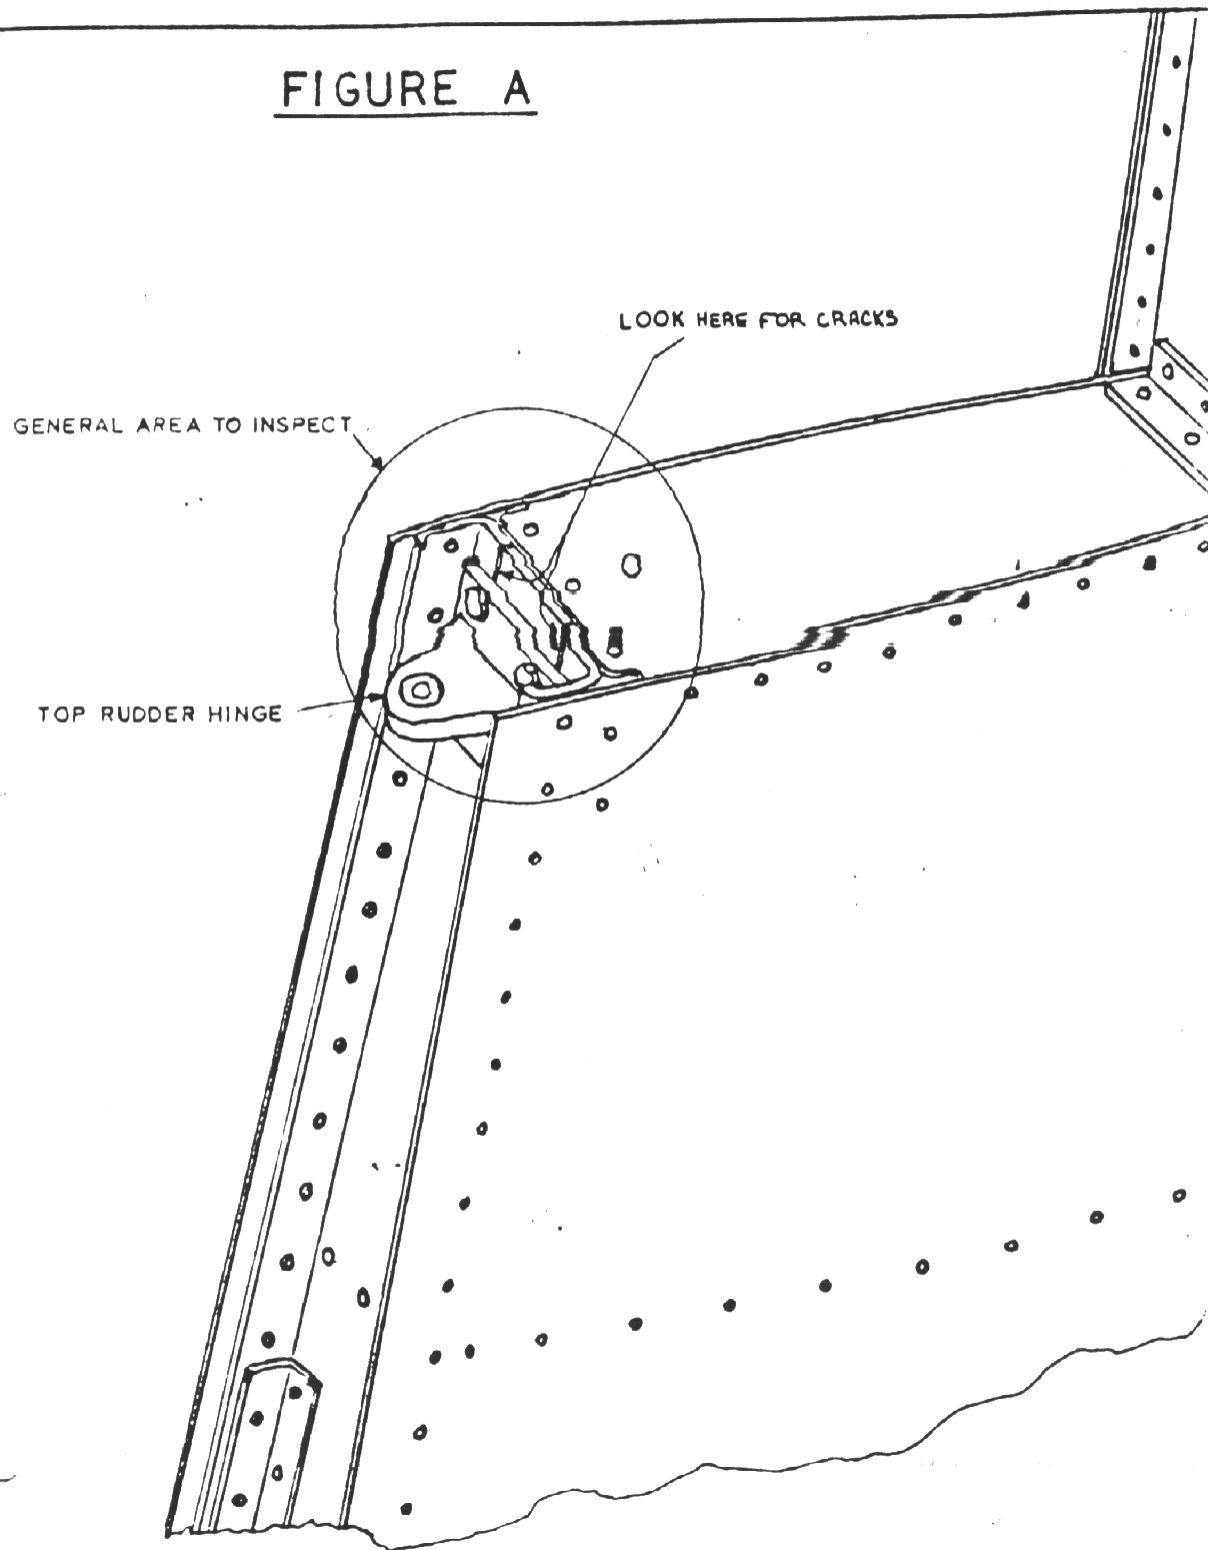
FIGURE A

REASON FOR PUBLICATION: TO PREVENT THE POSSIBILITY OF FATIGUE CRACKS FORMING IN THE TOP OF THE FIN REAR SPAR IN THE AREA JUST ABOVE THE UPPER RUDDER HINGE BRACKET.

COMPLIANCE: WITHIN THE NEXT 50 HOURS OF FLIGHT PROVIDED THE AREA IN QUESTION IS INSPECTED PRIOR TO EACH FLIGHT. THIS PREFLIGHT INSPECTION MUST BE CONTINUED UNTIL SB-AG-21 IS ACCOMPLISHED. SEE FIGURE "A" FOR AN ILLUSTRATION OF THE AREA TO BE INSPECTED. IF ANY CRACKS ARE FOUND, ACCOMPLISH THIS SERVICE BULLETIN PRIOR TO NEXT FLIGHT.

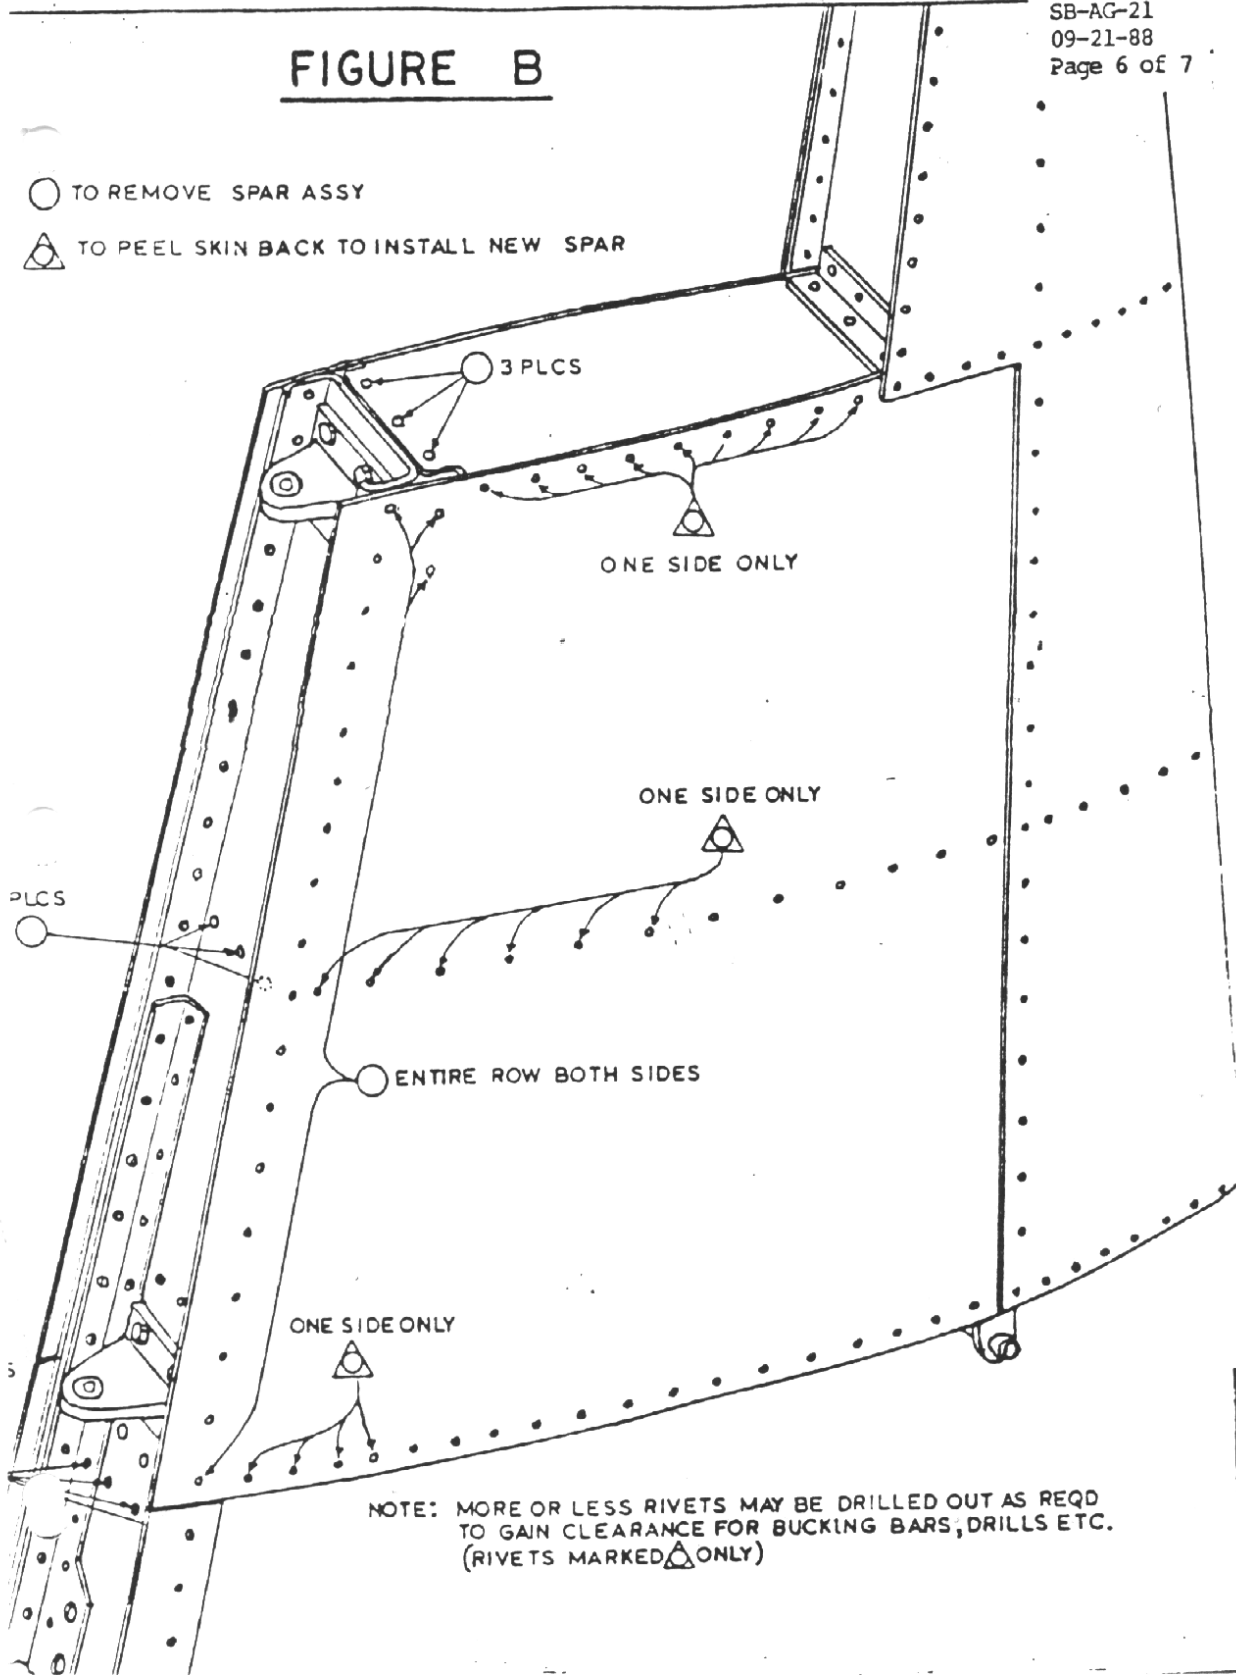
FIGURE B

- TO REMOVE SPAR ASSY
- △ TO PEEL SKIN BACK TO INSTALL NEW SPAR

- Remove the rudder from the aircraft.
- Remove the vertical fin from the aircraft.
- Drill out all of the rivets that attach the rear spar of the vertical fin to the remaining structure. (These rivets are marked 0 in Figure "B".) (All rivets are 1/8 inch diameter.)

- Remove the rear spar from the fin.
- In addition, on one side of the fin only, drill out the rivets marked in Figure B. This will allow the skin on one side only to be peeled back. (All rivets are 1/8 inch diameter.)
