# Rockwell service letter

No. SL-AG-84

Service Letter No. SL-AG-84  
5 February, 1976

### TAIL WHEEL SHOCK STRUT MODIFICATION

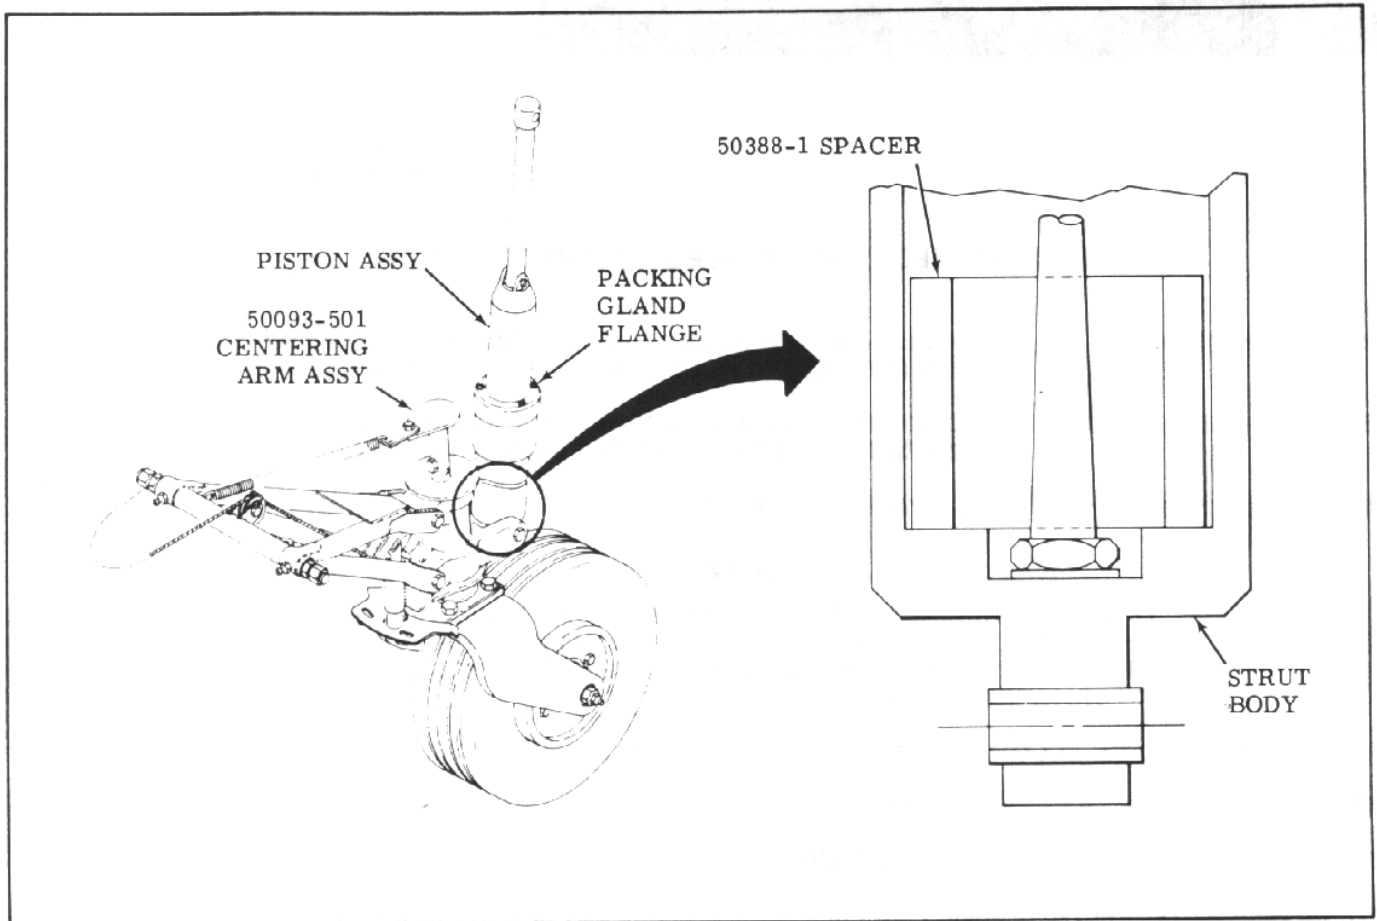
Figure 1.

**REASON FOR PUBLICATION:** Eliminate possible damage to fuselage skin and tail wheel centering arm when shock strut is deflated.

- 1 Remove aft fuselage skins as necessary to gain access to tail wheel shock strut assembly upper attach bolts.
- 2 Jack airplane tail section as necessary to facilitate removal of tail wheel shock strut assembly.

- 3 Remove bolts attaching tail wheel shock strut assembly and remove shock strut assembly.
- 4 Remove the air from the shock strut by depressing the air valve core pin until all air pressure has been relieved.
- 5 After shock strut assembly has been deflated, remove filler plug and drain all fluid.
- 6 Remove lockwire and four (4) nuts on the studs that hold the packing gland flange in place (see Figure 1).
- 7 Remove the piston assembly from the strut body.
- 8 Insert 50388-1 spacer in strut body (see Figure 1).
- 9 Reinstall piston assembly in strut body, tighten four (4) nuts just enough to prevent leakage past packing rings, and safety nuts with 0.040-inch diameter stainless steel safety wire.

- 10 With strut assembly in a vertical position and fully compressed, fill with MIL-H-5606 oil, up to filler hole, and install filler plug.
- 11 Inflate shock strut assembly to 450 psi air pressure and check for leaks.
- 12 Remove and discard existing centering arm assembly from tail wheel assembly.
- 13 Install new 50093-501 centering arm assembly using hardware (see Figure 1).
- 14 Reinstall shock strut assembly on airplane using existing hardware.
- 15 Reinstall aft fuselage skins.
- 16 Remove jack from airplane.
