Rockwell service bulletin

Service Bulletin No. SB-AG-12
13 July 1977

RIGHT WING RIB RIVET INSPECTION AND/OR RIB REPLACEMENT

MODELS AFFECTED: MODEL S-2R, SERIAL NO'S 5000 THRU 5084

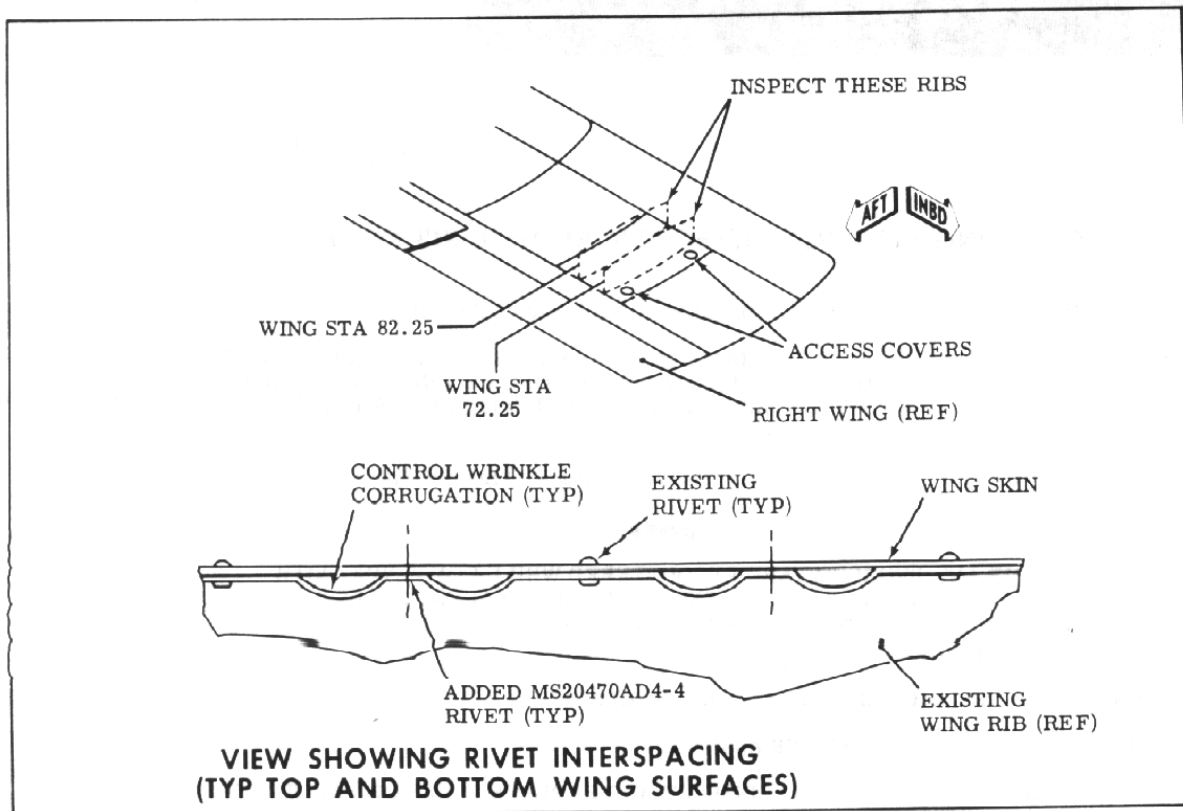
Figure 1.

1. Remove two (2) lower wing access covers from right wing just outboard of wing fuel tank.
2. Inspect wing ribs at WS 72.25 and WS 82.25 for loose rivets and possible cracks in ribs.
3. If any cracks are found in either rib at WS 72.25 or WS 82.25, proceed to Part II.

4. If no cracks are found in ribs, proceed as follows:
 - a. Remove and loose rivets found during inspection and replace with MS20470AD4-4 rivet.

- b. Add interspaced MS20470AD4-4 rivets between existing rivets on upper and lower flanges of wing ribs (See Figure 1).

Added rivets to upper flange of wing ribs will have to be individually located to center on flat area between control wrinkle corrugations.
