Rockwell service letter

Service Letter No. SL-AG-82
5 February, 1976

TAIL WHEEL TRUNNION ASSEMBLY MODIFICATION

MODELS AFFECTED: S-2R, SERIAL NO'S 1351R, 1416R THRU 2173R AND 5000 THRU 5075.

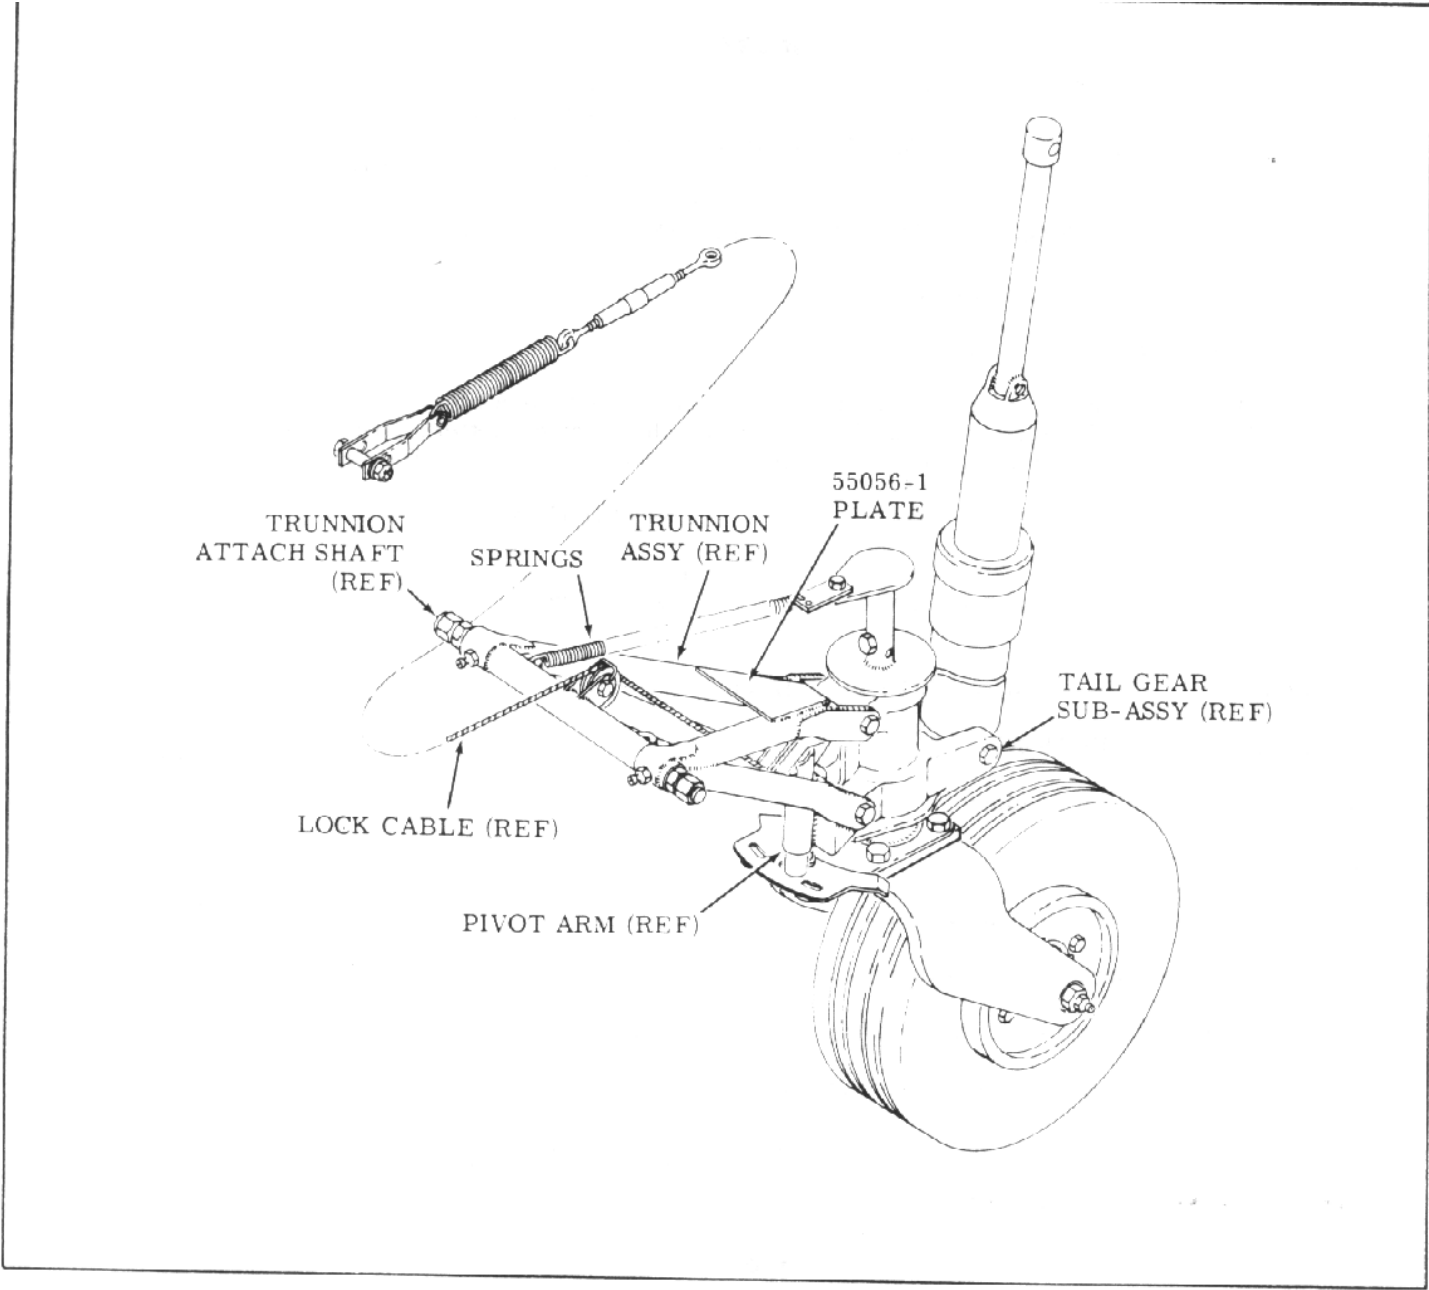
Figure 1.

REASON FOR PUBLICATION: STRENGTHEN TRUNNION ASSEMBLY AND PREVENT POSSIBLE BREAKING OF WELDS IN FORK AREA FOR AIRCRAFT OPERATIONS FROM UNIMPROVED FIELDS,

1. Jack and secure tail of airplane.
2. Remove tail wheel trunnion assembly as follows:
 - a. Disconnect lock cable at pivot arm.
 - b. Disconnect springs from trunnion assembly.
 - c. Remove bolts, nuts and washers that attach tail gear sub-assembly to trunnion assembly.
 - d. Remove nuts and washers from trunnion attach shaft.
 - e. Remove trunnion assembly by withdrawing trunnion attach shaft.
3. Weld 55056-1 plate on trunnion assembly (see Figure 1.).

Material is 4130 steel condition "N", S-0345.
