Rockwell service letter

Service Letter No. SL-AG-78

Revision No. 1

COLLECTOR RING REPLACEMENT

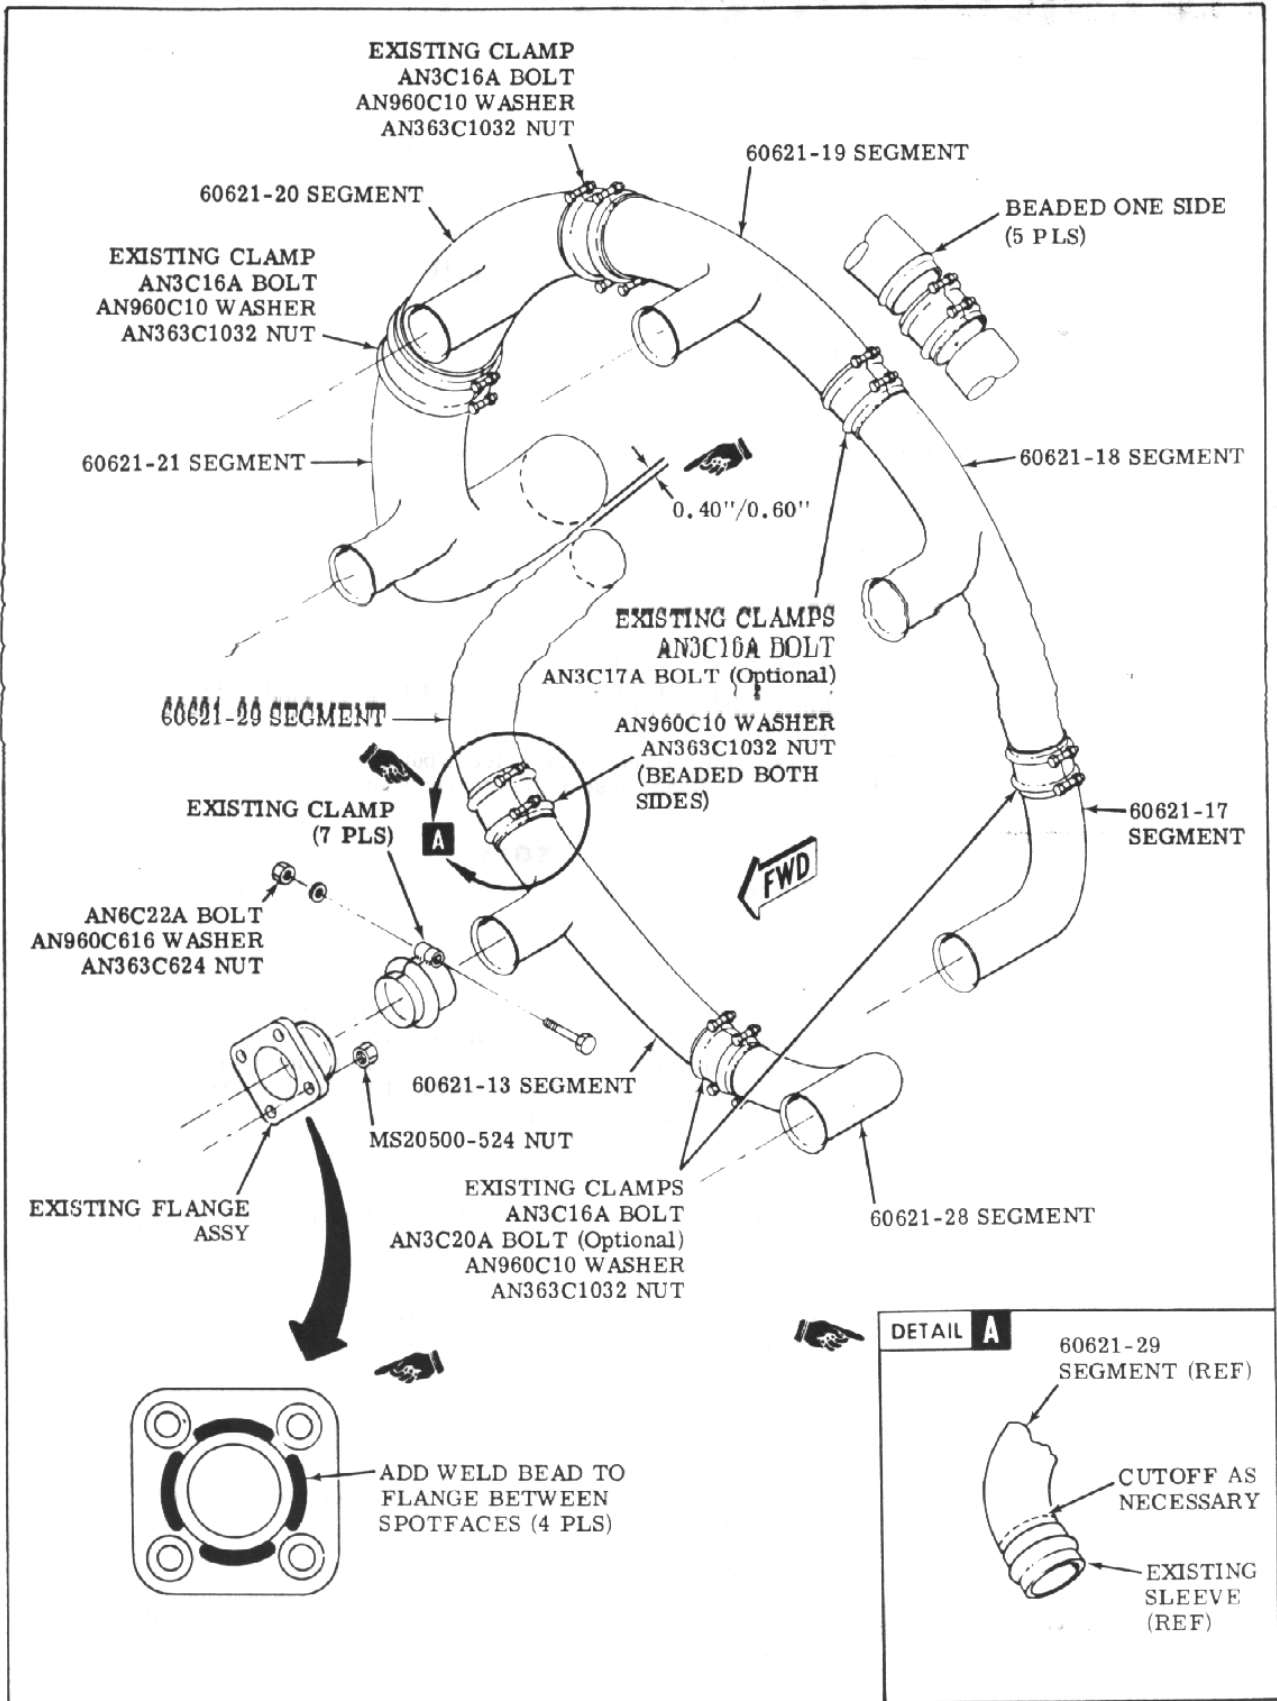
Figure 1.

Add: View of flange assembly to figure 1 showing area to be welded. See sheet 3 of this revision.

- b. Work progressively around engine until all segments of collector ring assembly are in place. After all segments are in place and properly aligned (each segment must align with next segment within 0.040-inch), assure that clearance between 60621-21 segment and 60621-29 segment is 0.50 (± 0.10) inch (see Figure 1).

Clearance of more than 0.60-inch is acceptable.

- 4 Assure that hole in existing flange assemblies are spot faced 0.80 inch diameter on center of bolt hole. Flange to be a minimum thickness of 0.25 inch after spot facing. Inspect flange for weld attachment (some flange assemblies appear to be welded, but are not). If not welded, add weld bead to flange assemblies in area shown in figure 1.

- c. If clearance is less than 0.40-inch, remove 60621-29 segment and rework by cutting segment off at sleeve. Remove sufficient material from segment provide adequate clearance and reweld segment to sleeve (see Figure 1).
