# **SERVICE LETTER**

## **No. SL-AG-112**

### **Rewiring the External Power Receptacle (APU) so that the Electrical System is Energized Immediately when Power is Applied to the APU**

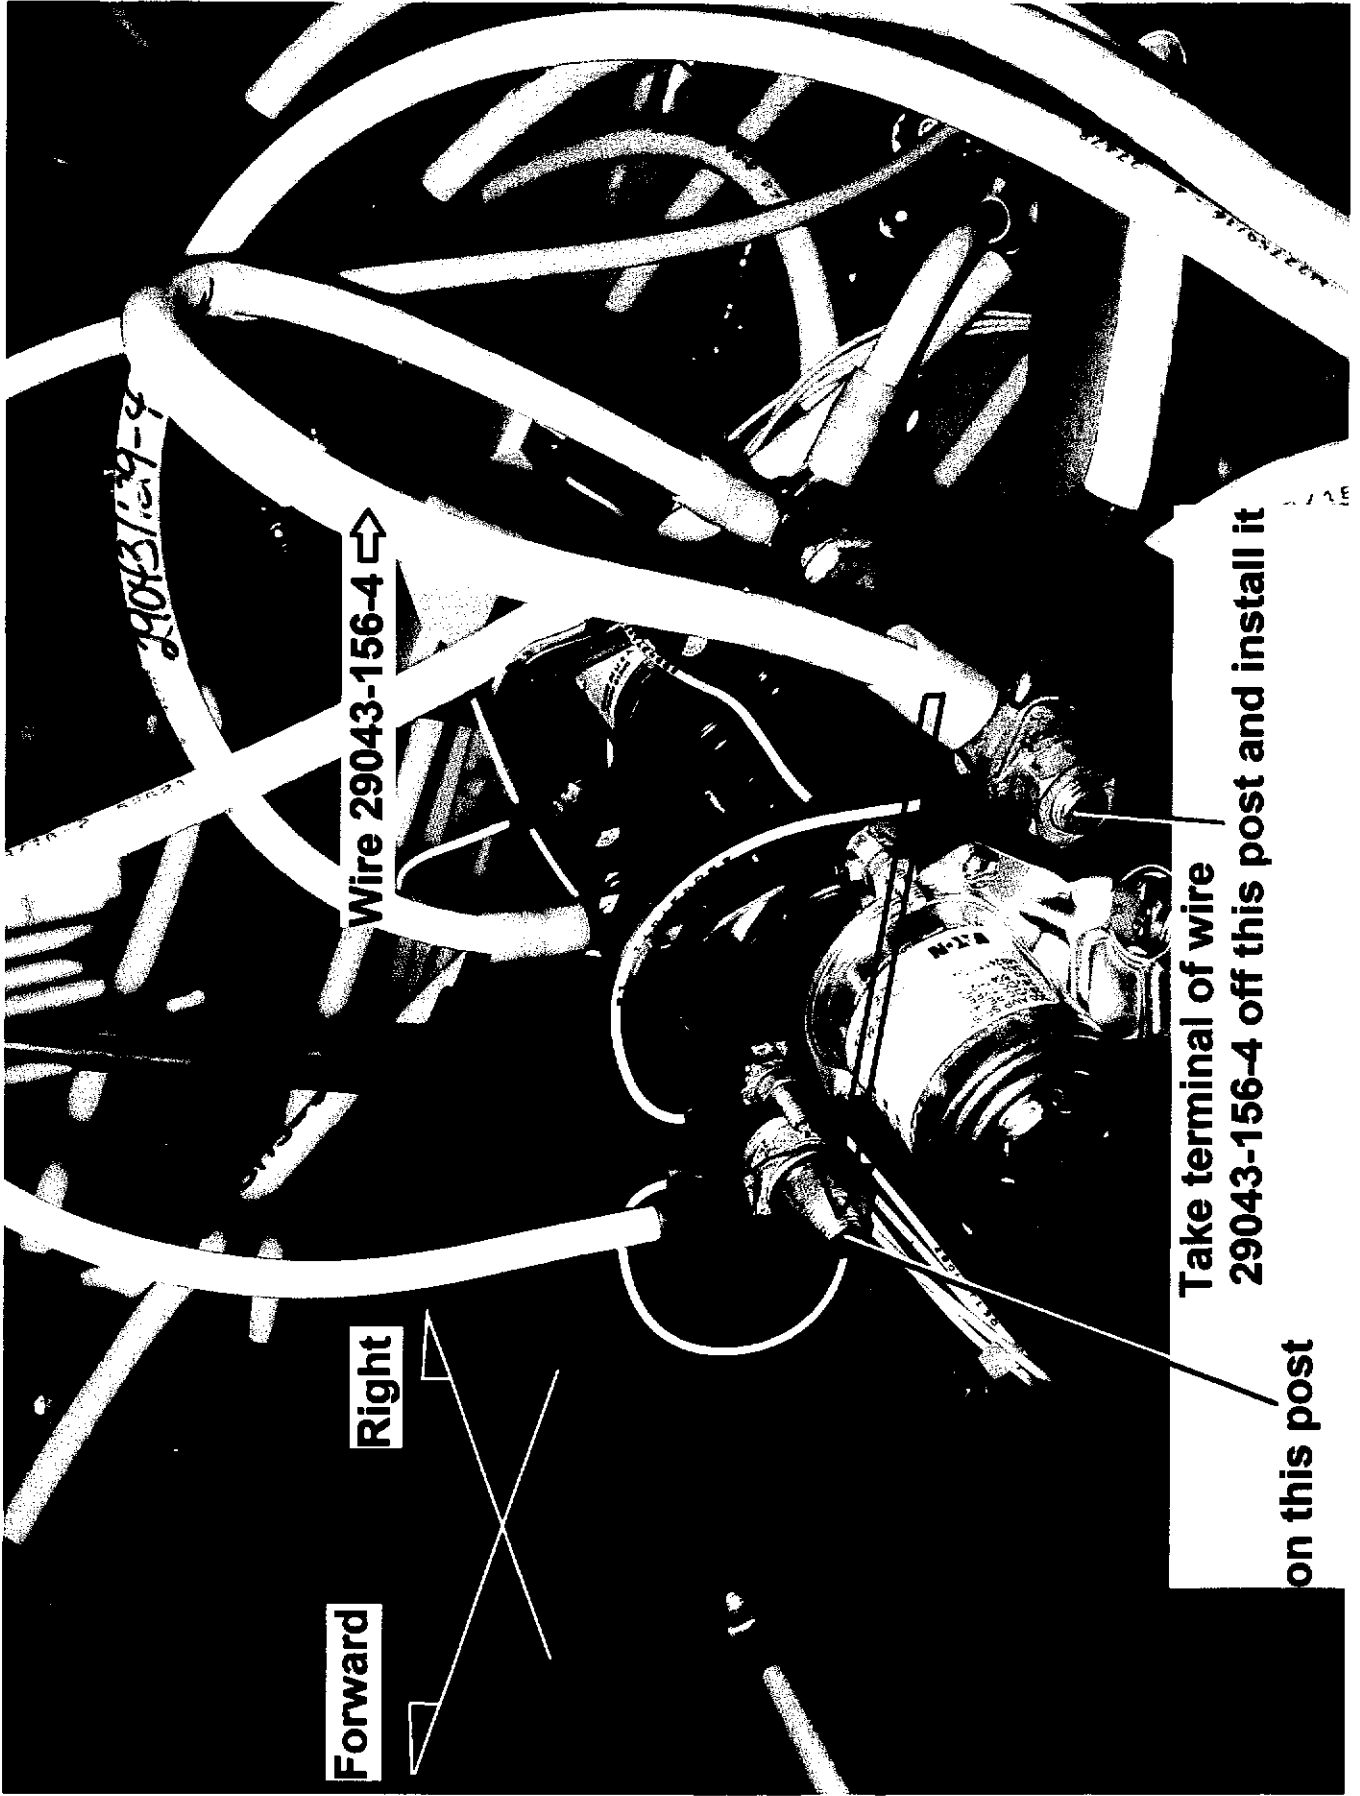
Wire 29043-156-4

Take terminal of wire  
29043-156-4 off this post and install it

on this post
