Service Bulletin No. SB-AG-37
27 June 1994
 Page 1 of 12

CRACKS IN HORIZONTAL STABILIZER SPAR

MODELS AFFECTED:

All models of the S2R with the Ayres metal tail using the 40087 Horizontal stabilizer assembly.

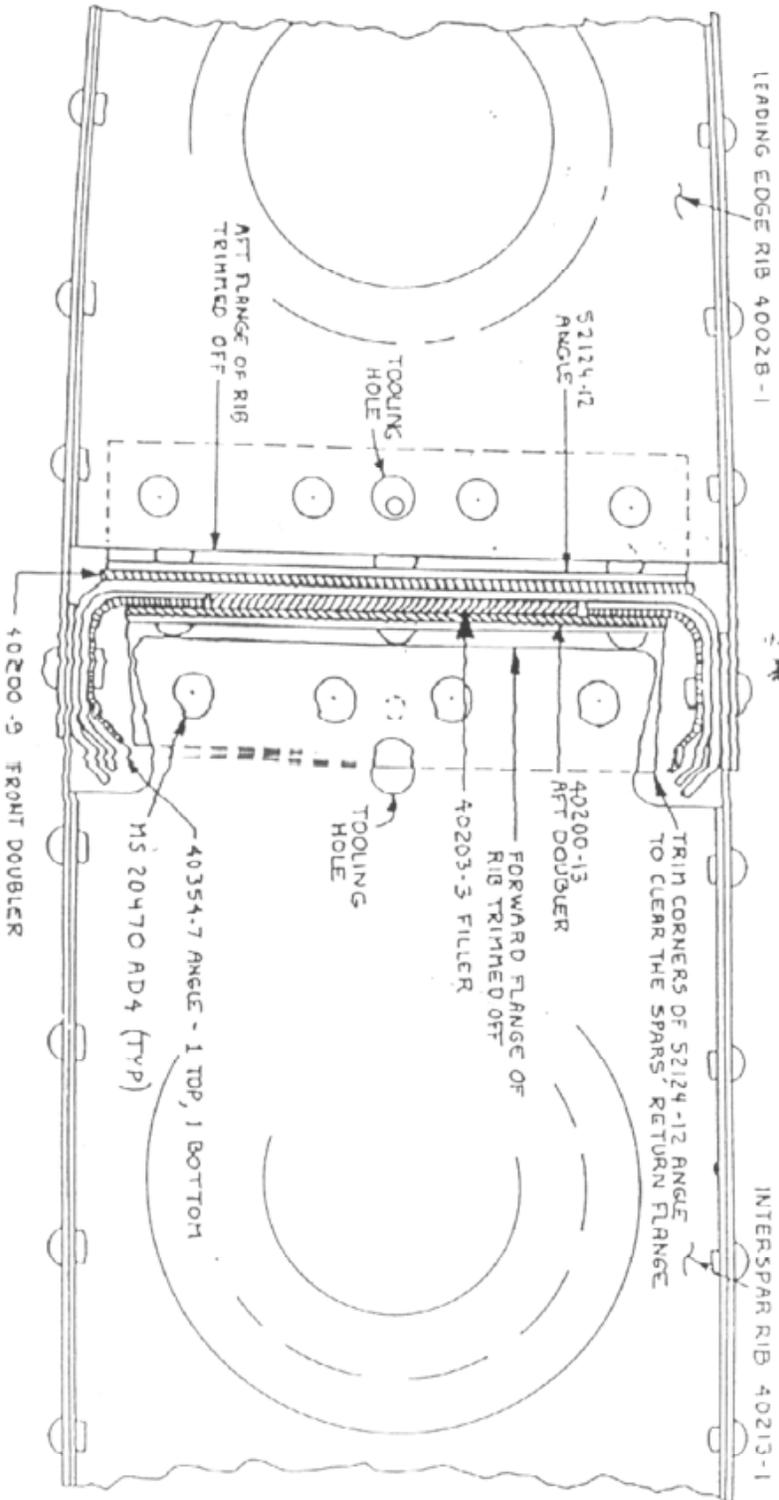
MODIFIED CROSS-SECTIONAL VIEW - REPAIRED FRONT SPAR VIEW A

SHIM THE S2124-12 ANGLE AS NEED TO PREVENT THE RIVETS IN THE SPAR FROM BEING IN THE FLANGE RADIUS

ATTACH FITTINGS NOT SHOWN FOR CLARITY - SEE VIEW B ON PAGE 10 FOR FITTINGS.

Clamp the 40200-9 doubler to the front of the spar, being sure it is centered vertically and horizontally. The center attach holes (3/16) should be in the exact vertical center of the spar web. The height of the spar web should be $3.92 \pm .03$. The dimension from either edge will be 1.96 to the center. Clamp the 40354-7 angles in place, top and bottom. The angles must be nested firmly to the spar face and flanges.

Match drill the spar webs and the nesting angles' 3/16 holes, 18 places where the fittings attach bolts go through. Use a 3/16 diameter drill, then ream the four corner holes of the pattern to .189 and bolt the doubler down and the angles temporarily.

Drill the remaining number 30 diameter holes in the doubler and the angles. Remove the parts and debur all holes.

Ream the four corner holes of the 40200-13 aft doubler to .189. Bolt it and the angles together in a stack. With the filler 40203-3, shim the top and bottom .040 full length, to account for the other angle on the spar assy. Match drill all remaining number 30 holes. Ream all remaining .189 diameter holes. Add a number 30 diameter hole at midspace between top and bottom, where the angles attach to the spar web. Disassemble and debur all holes.
