# Rockwell service letter No. SL-AG-71

Service Letter No. SL-AG-71  
June 6, 1975

### MODIFICATION OF EXHAUST MANIFOLD OUTLET

**MODELS AFFECTED:** MODEL S-2R, SERIAL NO'S 5000 THRU 5050.

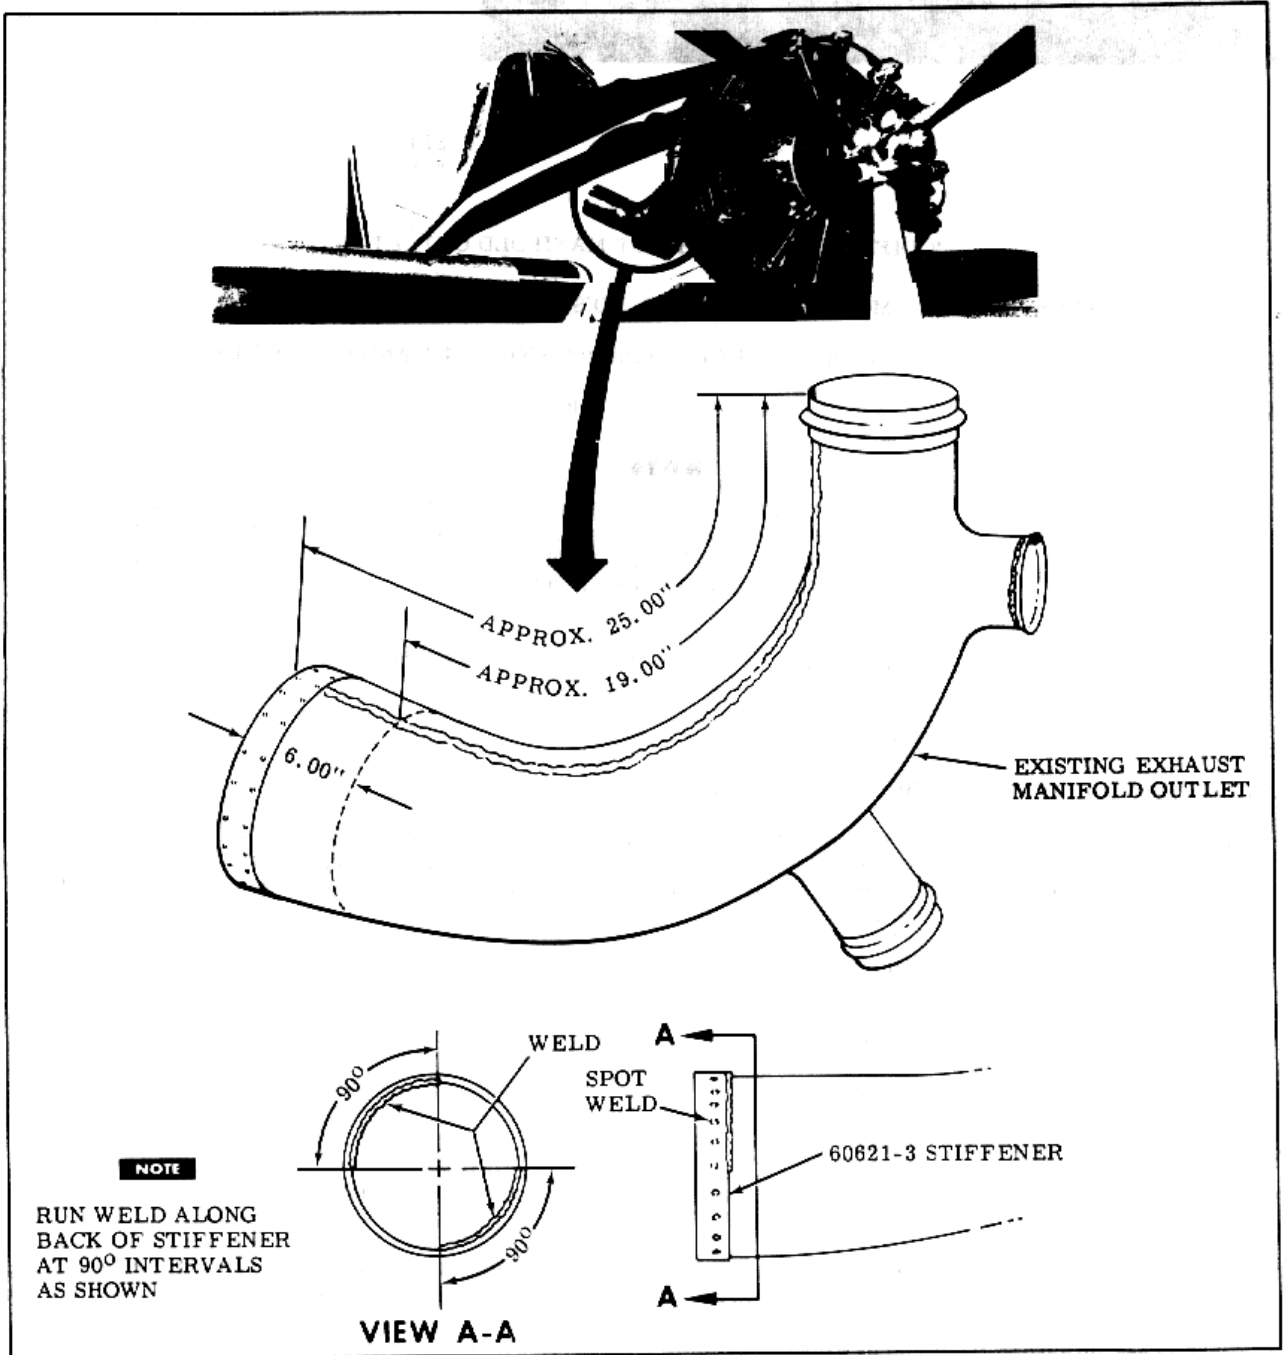
**REASON FOR PUBLICATION:** To prevent cracking of exhaust manifold outlet.

1. If length of exhaust manifold outlet, measured along seam as shown in Figure 1., is approximately 19.00" proceed to RECORD COMPLIANCE.
2. If length of exhaust manifold outlet, measured along seam as shown in Figure 1., is approximately 25.00", remove clamps attaching manifold outlet and remove outlet from engine.
3. Trim six (6) inches from end of exhaust manifold outlet (see Figure 1.).
4. Spot weld 60621-3 stiffener flush with end of exhaust manifold outlet (see Figure 1.).

Material is 321 stainless steel MIL-S-6721.
