Rockwell service letter

Service Letter No. SL-AG-87
8 November, 1976

SHOULDER HARNESS AND INERTIA REEL INSTALLATION

MODELS AFFECTED: S-2R, S/N 1416 thru 2240 AND 5000 thru 5082 Equipped with single inertia reel with dual shoulder harness.

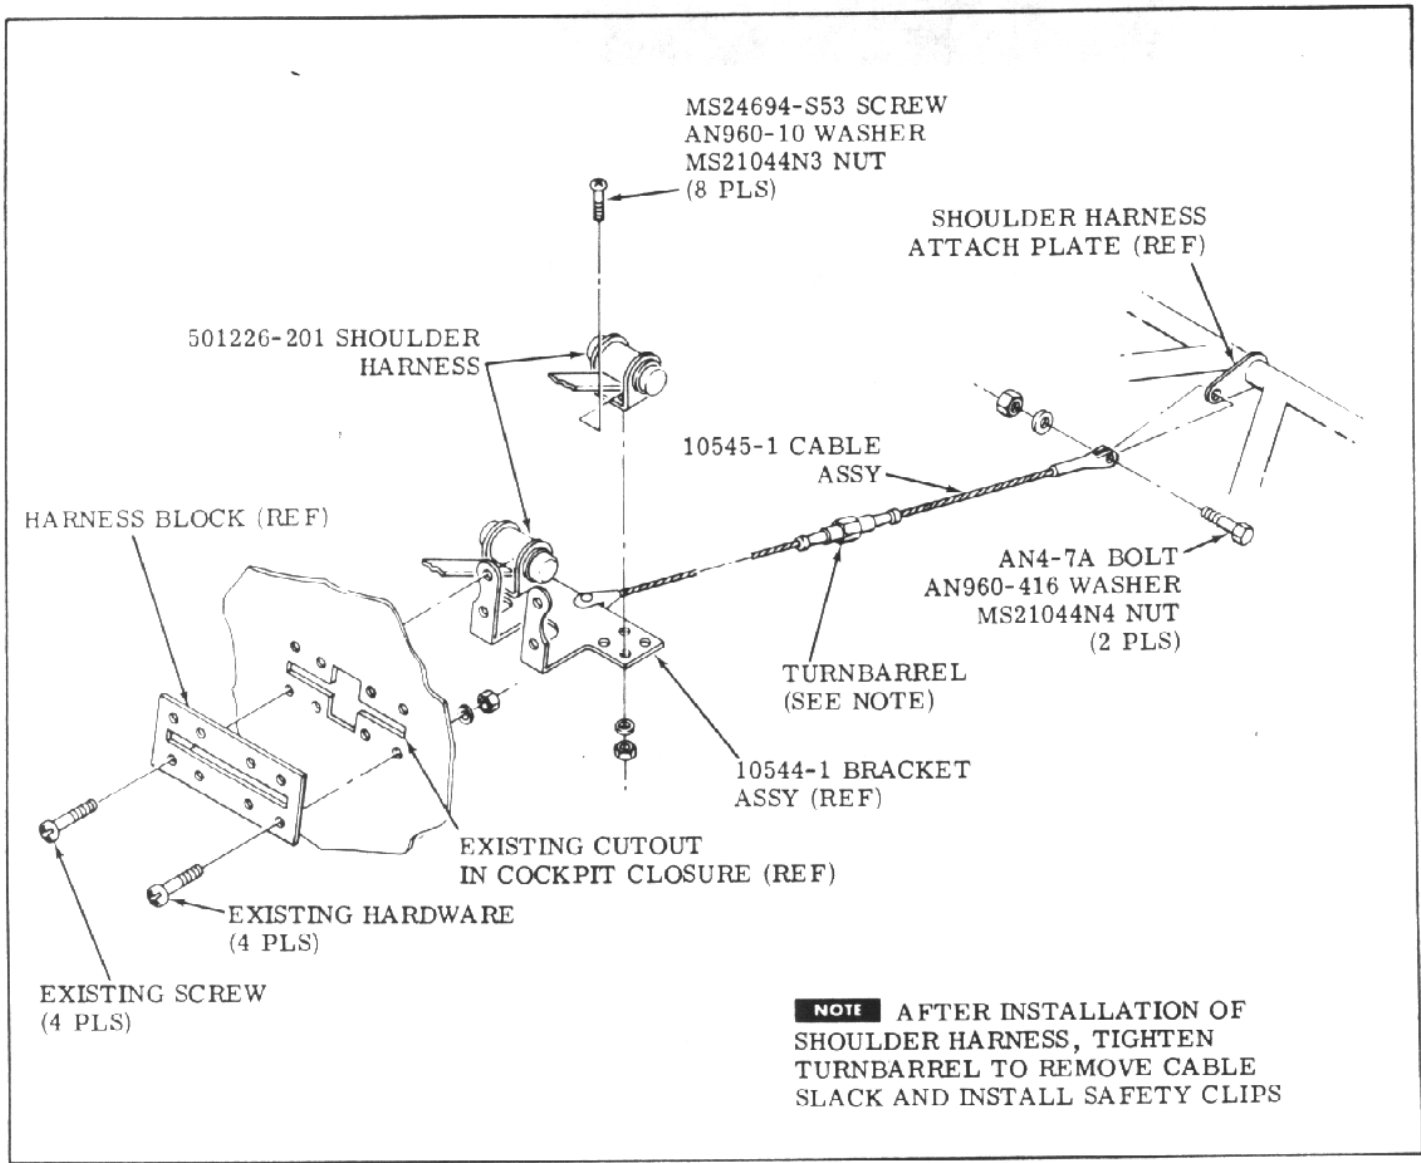
REASON FOR PUBLICATION: Provide dual inertia reel system to prevent possible shoulder harness sticking due to belt folding and sticking in guide slots.

- 4 Remove and discard existing shoulder harness assembly.
- 5 Install 501226-201 shoulder harness, 10544-1 bracket assembly and 10545-1 cable assembly (see Figure 1).
- 6 Reinstall fuselage skins if removed in step 1.
