Rockwell service bulletin No. SB-AG-6

Service Bulletin No. SB-AG-6 6 June 1975

REPLACEMENT OF ENGINE OIL COOLER VALVE

MODELS AFFECTED: MODEL S-2R, SERIAL NO'S 5000R THRU 5026R.

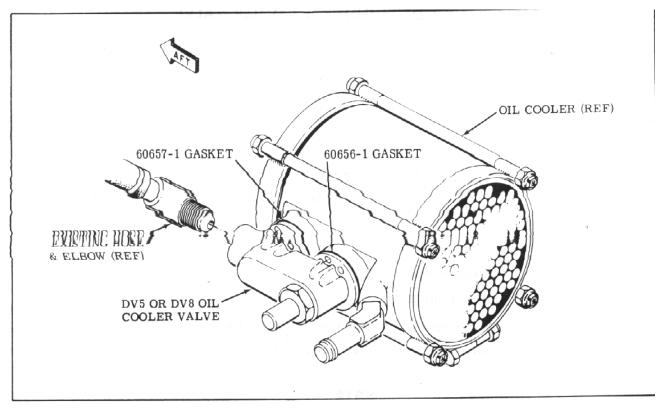
Figure 1.

REASON FOR PUBLICATION: TO ASSURE THAT CORRECT VALVE IS INSTALLED ON ENGINE OIL

COOLER.

- 3. Remove nuts and rod attaching engine oil cooler to airplane and remove oil cooler.
- 4. Remove existing elbow from oil cooler valve.
- 5. Remove and discard existing valve, thermostat and valve gaskets from engine oil cooler (see Figure 1.).
- 6. Install DV5 or DV8 oil cooler valve, 60656-1 gasket and 60657-1 gasket on oil cooler using existing hardware and safety wire attaching screws with 0.032-inch diameter stainless steel safety wire (see Figure 1.).
