Rockwell service bulletin No. SB-AG-11

Service Bulletin No. SB-AG-11 31 January 1977

INSPECTION AND/OR REPLACEMENT OF AILERON HINGE BRACKETS

MODEL S-2R, SERIAL NOS. 1416 THRU 2491 MODELS AFFECTED:

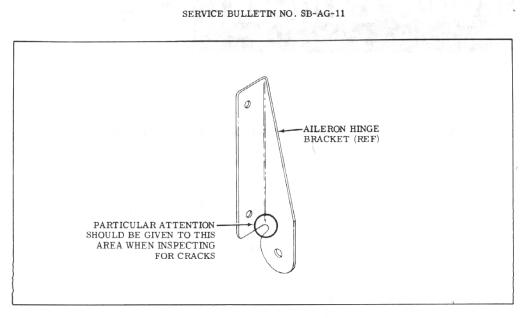
REASON FOR PUBLICATION: INSPECT FOR POSSIBLE CRACKS IN AILERON HINGE BRACKETS.

- 1. Visually inspect all aileron hinge brackets in area shown in Figure 1. For possible cracks.
- 2. If no cracks are evident, proceed to step 10. Of Part I.
- 3. If cracks are found, remove applicable aileron from airplane as outlined in the Airplane Maintenance Manual, Section VII.
- 4. Cut a 1.50-inch diameter hole (as necessary) in lower aileron skin in order to gain access to aileron hinge bracket attaching nuts (see Figure 2.).
- 5. Remove and replace cracked aileron hinge brackets as necessary.
