Service Bulletin No. SB-AG-15 Page 1 of 3 April 24, 1979

## RUDDER UPPER HINGE INSPECTION

MODELS AFFECTED: Model S2-R, S/N 1416 thru 2439: S/N 5000 thru 5100.

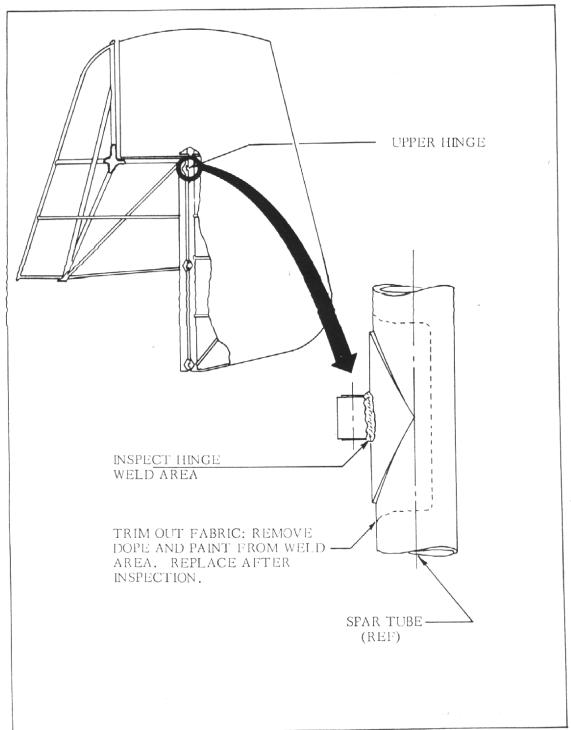
Figure 1

REASON FOR PUBLICATION: Inspect for possible cracks in rudder upper hinge.

- 3. Inspect in and around weld bead on rudder hinge bushing for cracks. (See Figure 1).
- 4. If no cracks are found, proceed to Step 7.
- 5. If cracks are found, order replacement Rudder Part Number 54030-987 through the nearest Ayres Thrush Dealer and install per Section VII of the Maintenance Manual PRIOR TO FURTHER FLIGHT.
- 6. Fill out and mail Compliance Card noting rudder replaced.
- 7. Repaint and recover rudder assembly In area around hinge with new fabric in accordance with FAA Advisory Circular AC 43.13-1, Chapter 3.
- 8. Re-install rudder assembly per Section VII of the maintenance manual.
- 9. Fill out and mail Compliance Card noting that no cracks were found.
