SERVICE BULLETIN

SB-AG-88

660 TAIL GEAR ADAPTER BOX INSPECTION & REPAIR

Affected Aircraft Models	Serial Number Range
S2R-T660	ALL

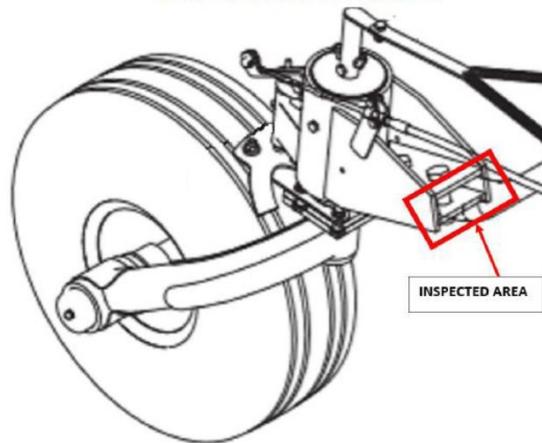
Figure 1

1. Locate forward end of tail gear adapter box and inspect for cracks and any other potential damage. (Reference Figure 1)

2. If cracks are detected, proceed in accordance with repair procedures outlined in following section.
