SERVICE BULLETIN

SB-AG-92

LOOSE FLAP MICROSWITCH RING

Affected Aircraft Models	Serial Number Range
S2R-510	145, 149, 151, 153, 154, 159DC, 525, 532DC, 534DC
S2R-T660	178DC, 187DC, 188, 192, 194

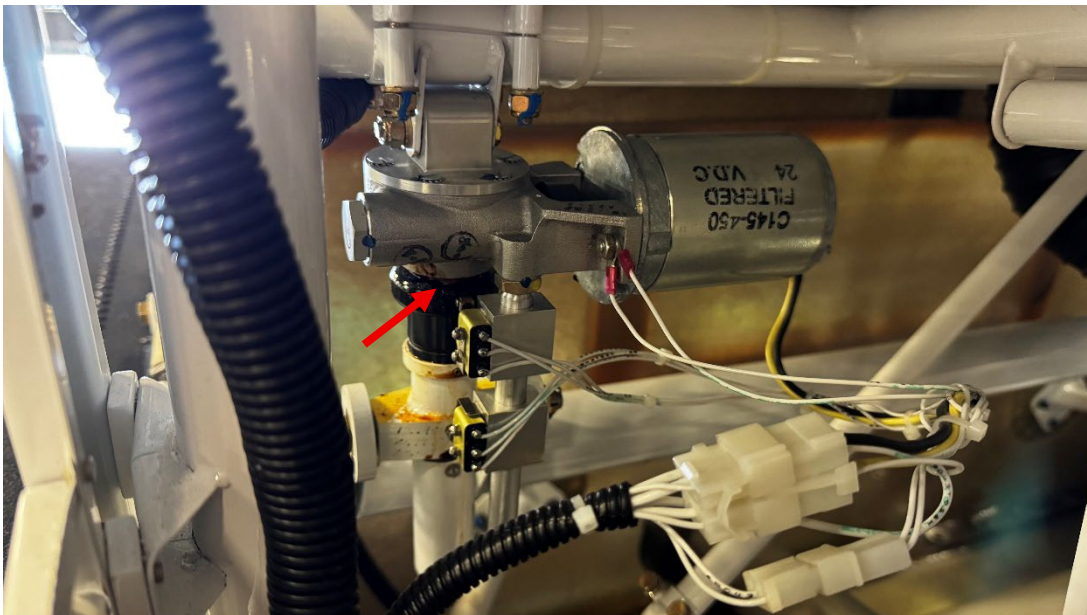
Figure 2 (510)

2. Locate flap actuator to find flap microswitch ring. (Reference Figures 2 & 3)

3. Confirm flap microswitch ring remains secure and is not movable by hand.
4. If movable by hand, report to support@thrushaircraft.com.
