# SERVICE BULLETIN

## SB-AG-94

## TORQUE TUBE/ END PLATE CHAFING

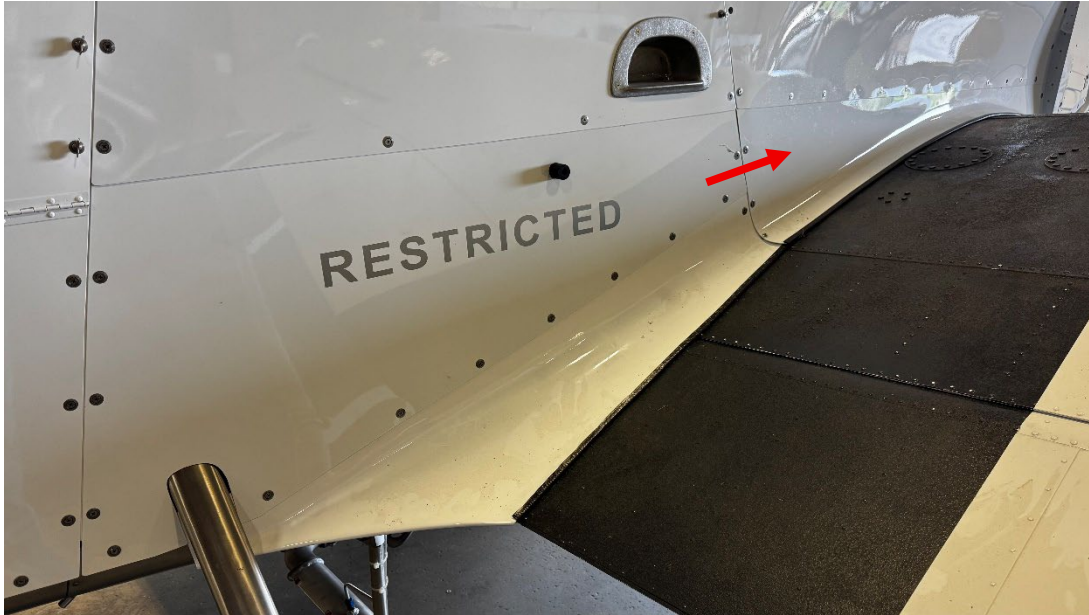
*Figure 1*

1. Remove and set aside R/H forward upper wing fairing to gain access to flap torque tube and end plate. (Reference Figure 1)

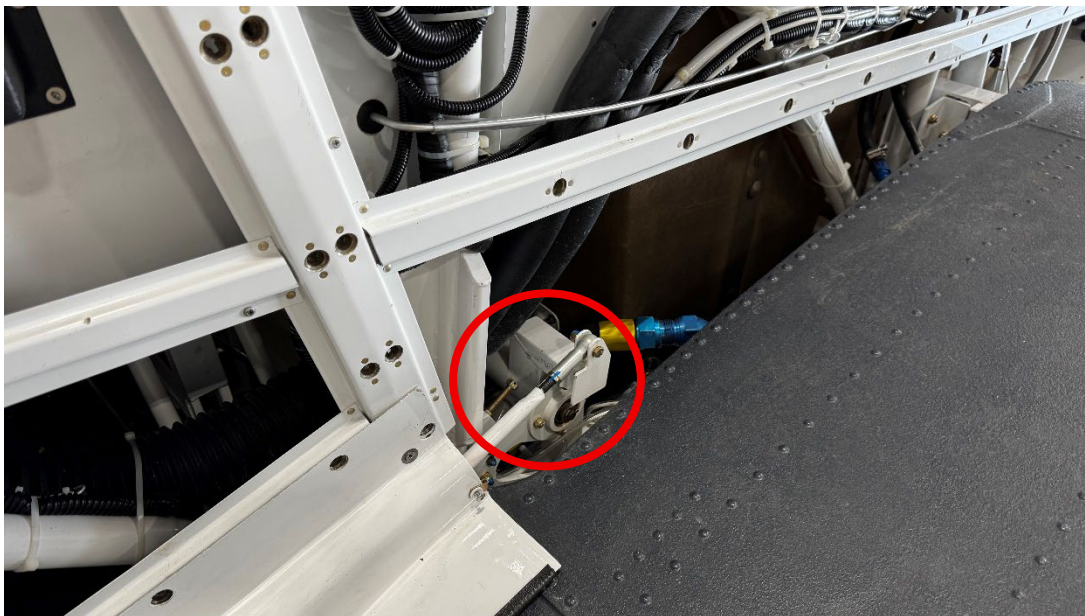
*Figure 2*

2. Locate flap torque tube and end plate. (Reference Figure 2)

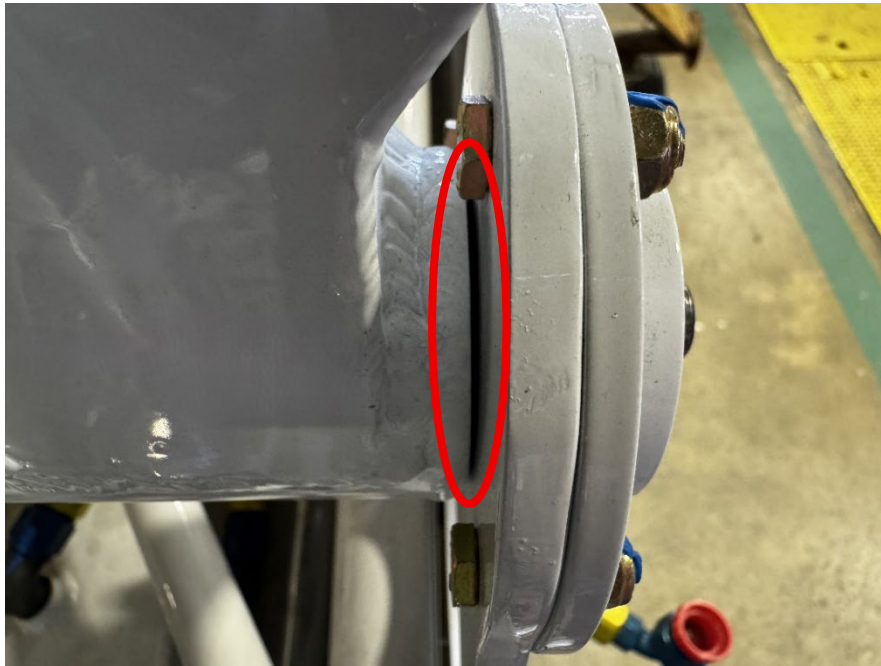
**Figure 3**

3. Visually inspect for chafing between torque tube and end plate. (Reference Figures 3 & 4)

**NOTE:** Evidence of chafing may be discovered by either metal shavings in belly skin below end plate or scratches revealing shiny metal on end plate.

4. If visible chafing present, report to [support@thrushaircraft.com](mailto:support@thrushaircraft.com).
