SERVICE BULLETIN

SB-AG-94

TORQUE TUBE/ END PLATE CHAFING

Affected Aircraft Models	Serial Number Range
S2R-510	145, 149, 151, 153, 154, 159DC, 525, 532DC, 534DC
S2R-T660	178DC, 187DC, 188, 192, 194

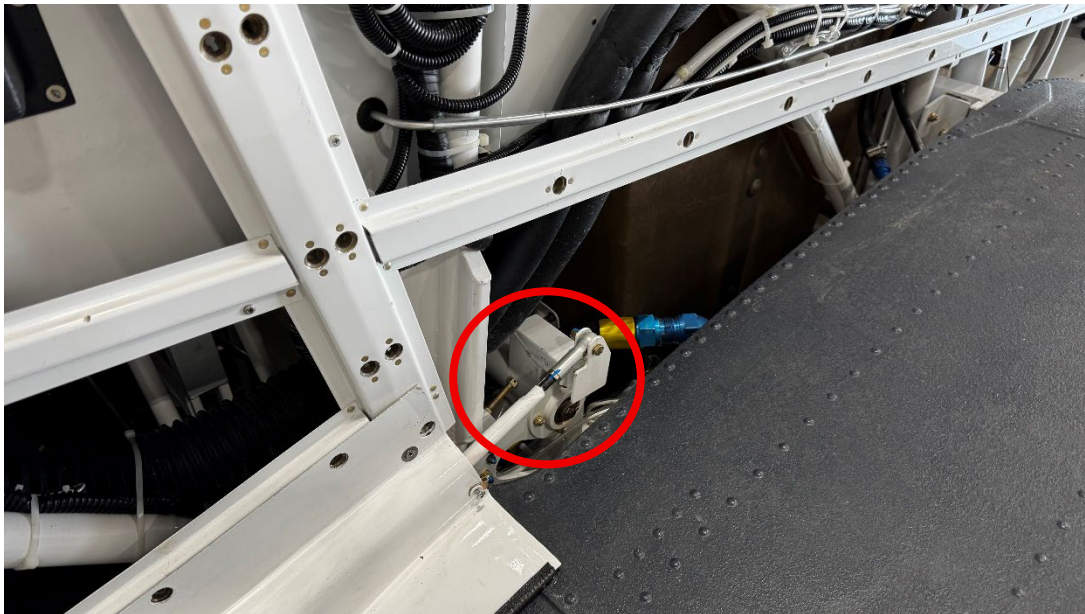
Figure 2

2. Locate flap torque tube and end plate. (Reference Figure 2)

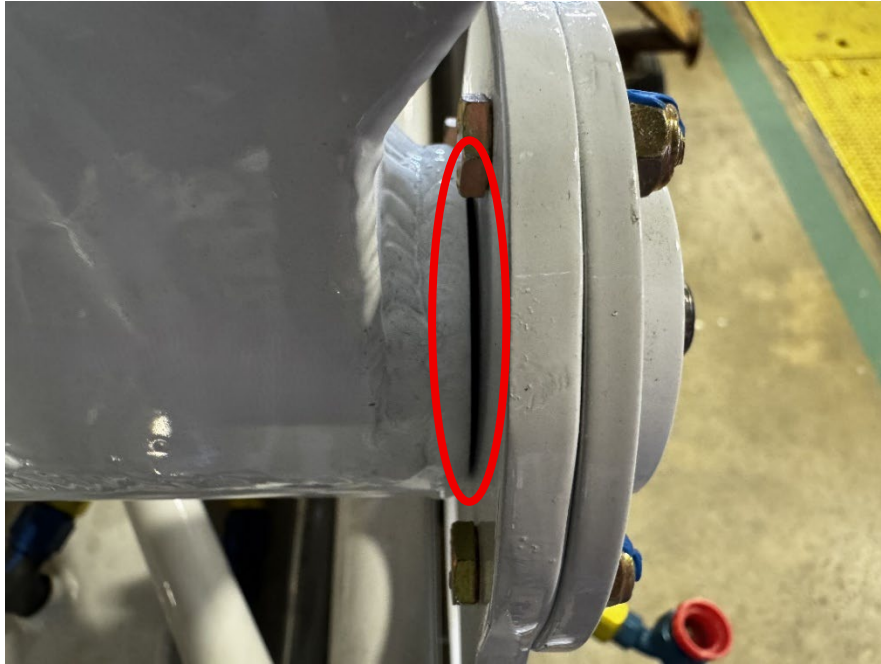
Figure 3

This Service Bulletin was issued after Production identified inadequate clearance between the flap torque tube and the right-hand side end plate. Contact between the tube and end plate is causing chafing on both parts.

3. Visually inspect for chafing between torque tube and end plate. (Reference Figures 3 & 4)

NOTE: Evidence of chafing may be discovered by either metal shavings in belly skin below end plate or scratches revealing shiny metal on end plate.

4. If visible chafing present, report to support@thrushaircraft.com.
