# SERVICE BULLETIN

## SB-AG-95

## RUDDER PEDAL INTERFERENCE CORRECTION

| Affected Aircraft Models | Serial Number Range |
|---|---|
| S2R-T660 DC/DC | 196DC & BELOW |

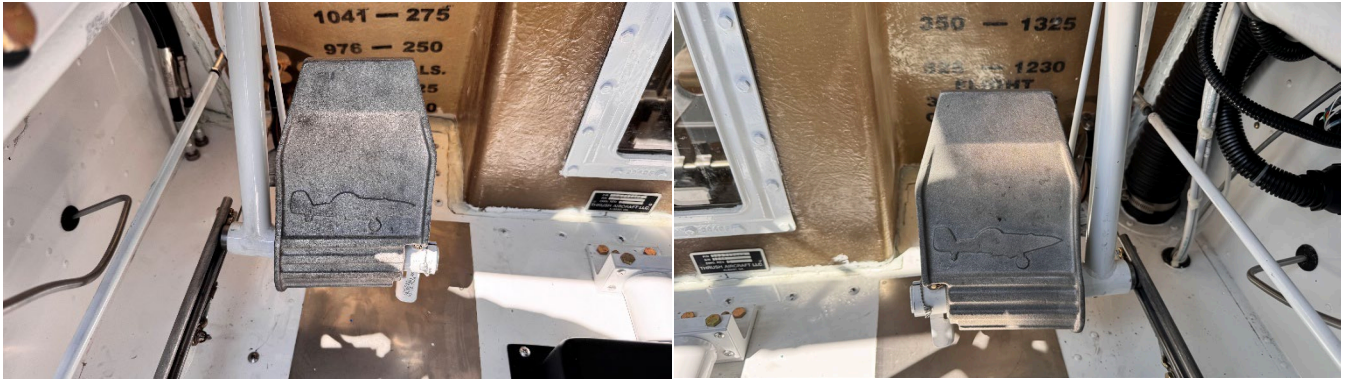
**Figure 1**

This Service Bulletin addresses potential interference, or part-to-part contact, discovered when the rudder pedals are adjusted to the full-aft position.

1. Remove existing L/H and R/H forward rudder pedal assemblies.
2. Install L/H and R/H rudder assemblies included in kit (reference Figure 1).
