Service Bulletin No. SB-AG-18 January 07,1985 Page 1 of 3

REINFORCE OF ENGINE CONTROL BELLCRANK SUPPORTS

MODELS AFFECTED: Model S2R-R1820 S/N R1820-001DC through

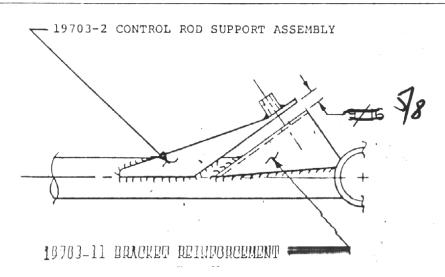
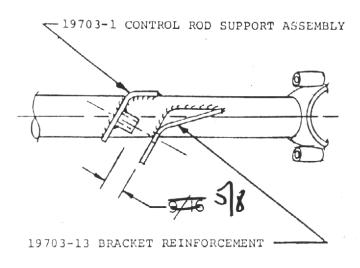
FIGURE 1

Immediately after receipt of this bulletin and within each 10 hour period of flight time until modification, inspect the 19703-1 and -2 control rod support assemblies for cracks in the bellcrank brackets. (See Figure 1). If cracks are found in the bellcrank brackets or their weld beads, immediately report this discrepancy to Ayres Corporation and complete this modification of the bellcrank brackets prior to further flight.

- 1. Remove the 19703-1 and -2 control rod support assemblies from the airplane.
- 2. Remove the paint and clean the metal surrounding the bellcrank brackets.
- 3. Weld closed any cracks found. Weld on the 19703-11 and –13 brackets reinforcements supplied with this kit. Prior to welding, clamp these brackets into position as shown on Figure 1.
- 4. Prime and paint the affected area with aircraft quality materials.
- 5. Reinstall the support assemblies and rerig the engine controls.
