Service Bulletin No. SB-AG-22

09-23-88

AILERON HINGE BRACKETS

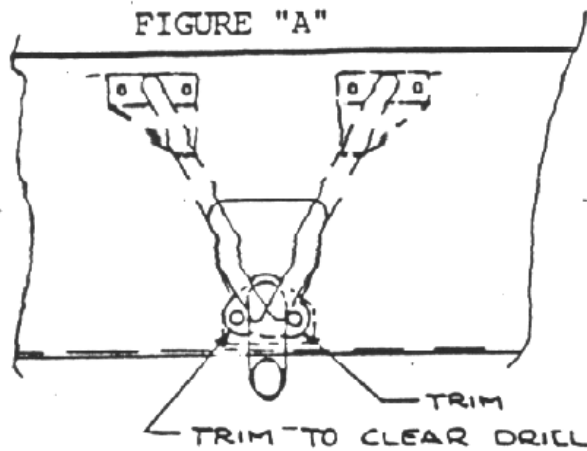
REASON FOR PUBLICATION: INCREASE FATIGUE LIFE OF THE LOWER AILERON BRACKET ATTACHMENT TO THE WING REAR SPAR.

Trim the opening in the aileron bay skin, P/N 20234-1, -2, to permit straight-in drill alignment with the open bolt holes. See Figure A.

Drill out these holes to ¼ inch diameter using a long drill bit.
