Service Bulletin No. SB-AG-24

June 20, 1990

HORIZONTAL STABILIZER STRUT ATTACH INSPECTION

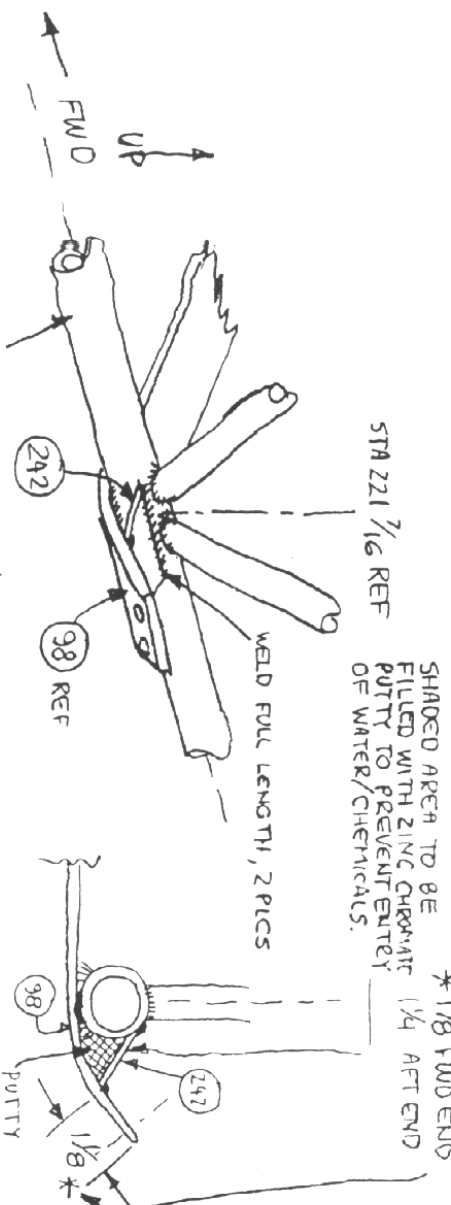
-242 GUSSET

TITLE		FRAME FUSELAGE	
REASON		TO STRENGTHEN STAB STRUT	
ATTACH POINT			
THIS ORDER TO BE USED AS PART OF DWG AND SUPERSEDES PARTS AS SHOWN IN			
REVISE P/D AND SW TO AGREE			
DWG REV		G	
L ETT/EM			
CHANGE EFFECTIVE ON		NOTED	
REV A			
REV B			
WAS		REQ	
CLASSIFICATION			
Alyes Corporation Albany, Georgia		10601	
MODEL		S2R	
DRAWING NUMBER		G-23	
EQU NUMBER			
CUSTOMER			
COMPANY			
REQUESTED BY			
VENDOR

LOWER LEFT LONGERON (REF)
R/P/SI DE SANGE AS SHOWN

6. If a crack is present on either side, install part 10601-242 in accordance with 10601 ECN G-23 provided as page 4 of this service bulletin. Prior to welding, drill a small (1/16") hole in one of the diagonal members near the attach tab. This will prevent a build up pressure in the frame. Weld the hole closed when the repair is finished. Sand, prime and paint the repair. Pack the resulting triangular cove with zinc chromate putty to prevent a build up of chemical residue from accumulating.

(1) CREATE ITEM -242 GUSSET, MATL 1/8" 4130 STEEL QTY REQD 2 PER FUSELAGE... PER VIEW.
