Service Bulletin No. SB-AG-29
15 June 1992

WING SPAR CORROSION

MODELS AFFECTED: S2D, All Serial Numbers
S2R, S/N 5000-5099, S/N 1380R, 1416R thru
2583R
2R-R1340, S/N R1340-001 thru -030*
S2R-R3S, S/N R3S-001 thru R3S-011*
S2R-R1820, S/N R1820-001 thru 035*
S2R-T11, S/N T11-001 thru 005*
S2R-T15, S/N T15 (or T27) -001 thru -029 and
031*
S2R-T34, S/N 6000-6049, S/N T34 (or T41) -001
thru -178 and 180*
S2R-T45, S/N T45-001 and -003*
S2R-T65, S2RHG-T65, S/N T65-001 thru -010*
S2R-G6, S/N G6-101 thru -107*

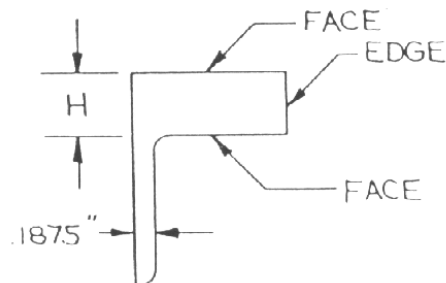
B. Steel Spar Caps

For the remainder of the spar cap (outside the fuselage area), up to 1/16" may be removed from either (not both) face or 1/8" from the edge. This is provided that dimension H does not become less than 23/32" (.719 inch) after removal of material.

Note that material removal may be locally deeper than specified above, provided that it does not average more than specified across the spar cap section.

It is acceptable to remove 1/32 from the face of the .1875 leg in any area over the length of the spar cap. Up to 1/16" may be removed in area of less than two square inches.

All evidence of corrosion must be removed before refinishing is begun. Steel wool, steel wire brush, or emery cloth may be used on the steel spar cap only. Sanding strokes should always be along the spar in an inboard-outboard direction so that any minute scratches that may remain will not be across the spar cap. Finish work should be done with a very fine grit paper. The edges of the damaged area must be blended or faired out to the undamaged area.

Before proceeding with finish operations, examine closely with a magnifying glass, to be sure that all traces of corrosion have been removed. Any corrosion that remains will soon break out again.

- * Clean and prime with zinc chromate or the primer recommended to be used under the finish coat.
- * Paint with a aircraft quality finish coat.

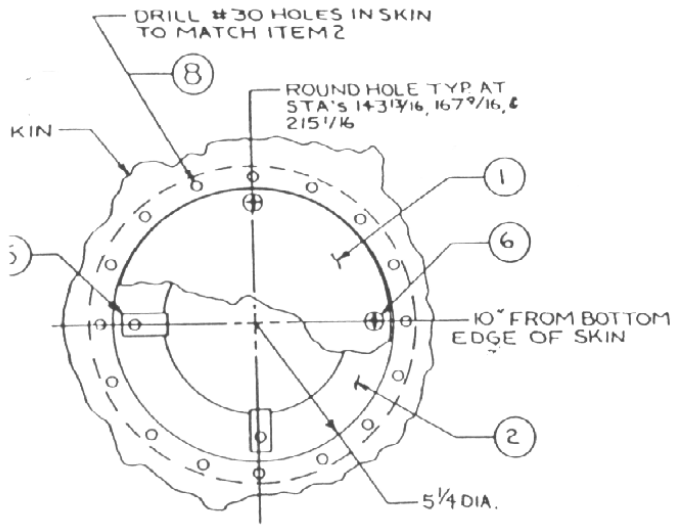
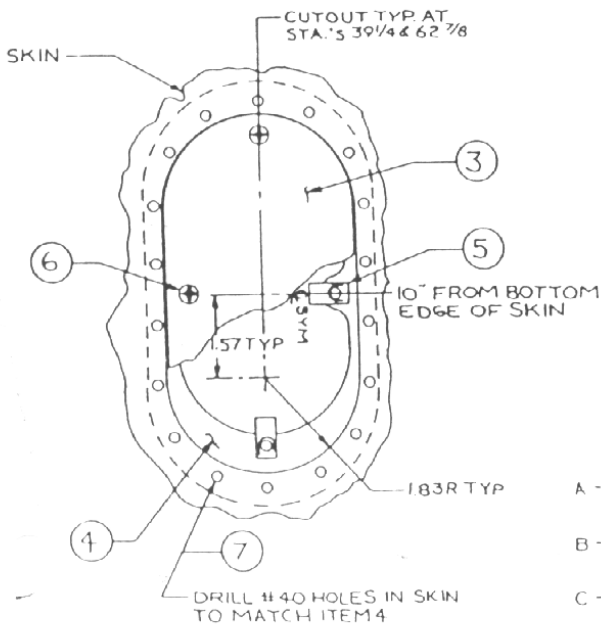
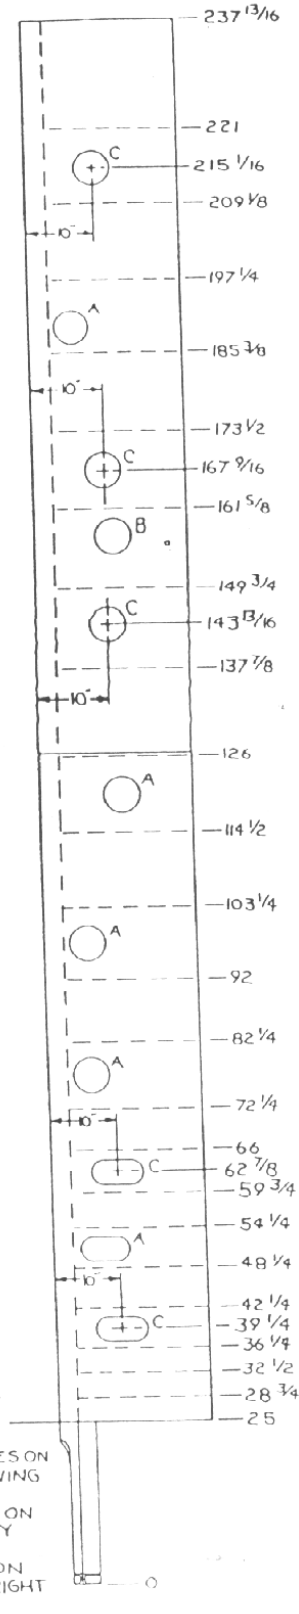
FIGURE 1
INSPECTION HOLES

- A - EXISTING HOLES ON LEFT & RIGHT WING
- B - EXISTING HOLE ON LEFT WING ONLY
- C - NEW HOLES ON BOTH LEFT & RIGHT WING

1. Remove existing inspection covers and cut additional inspection holes as illustrated in Figure 1. For these new openings, the necessary inspection covers, doublers and hardware can be obtained from your nearest dealer. When replacing the existing inspection covers, use 1/32 inch cork (or rudder) gaskets material glued to the cover plates with a good adhesive such as "3M1300". Precut gaskets are available from Ayres as P/N 20357-2 (oval) or P/N 10858-2 (round).
