**Service Bulletin No. SB-AG-30**

**1 October 1992**

### SPAR CRACKS UNDER AILERON BRACKETS

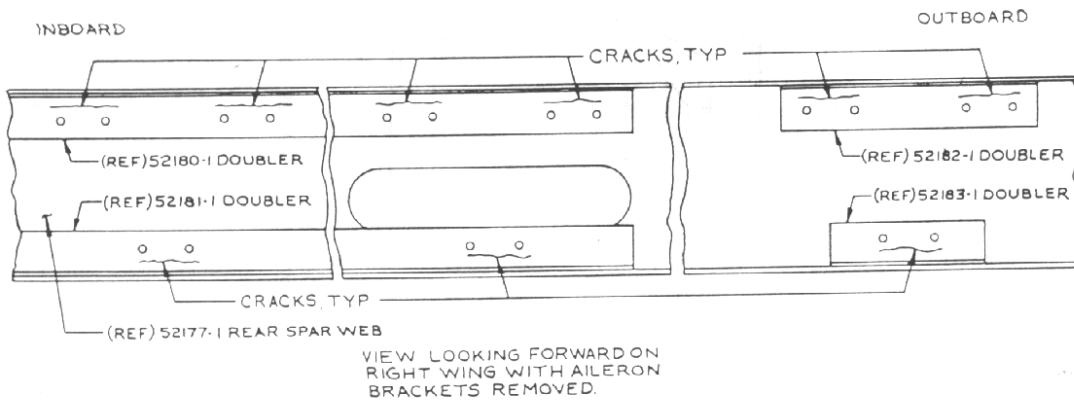
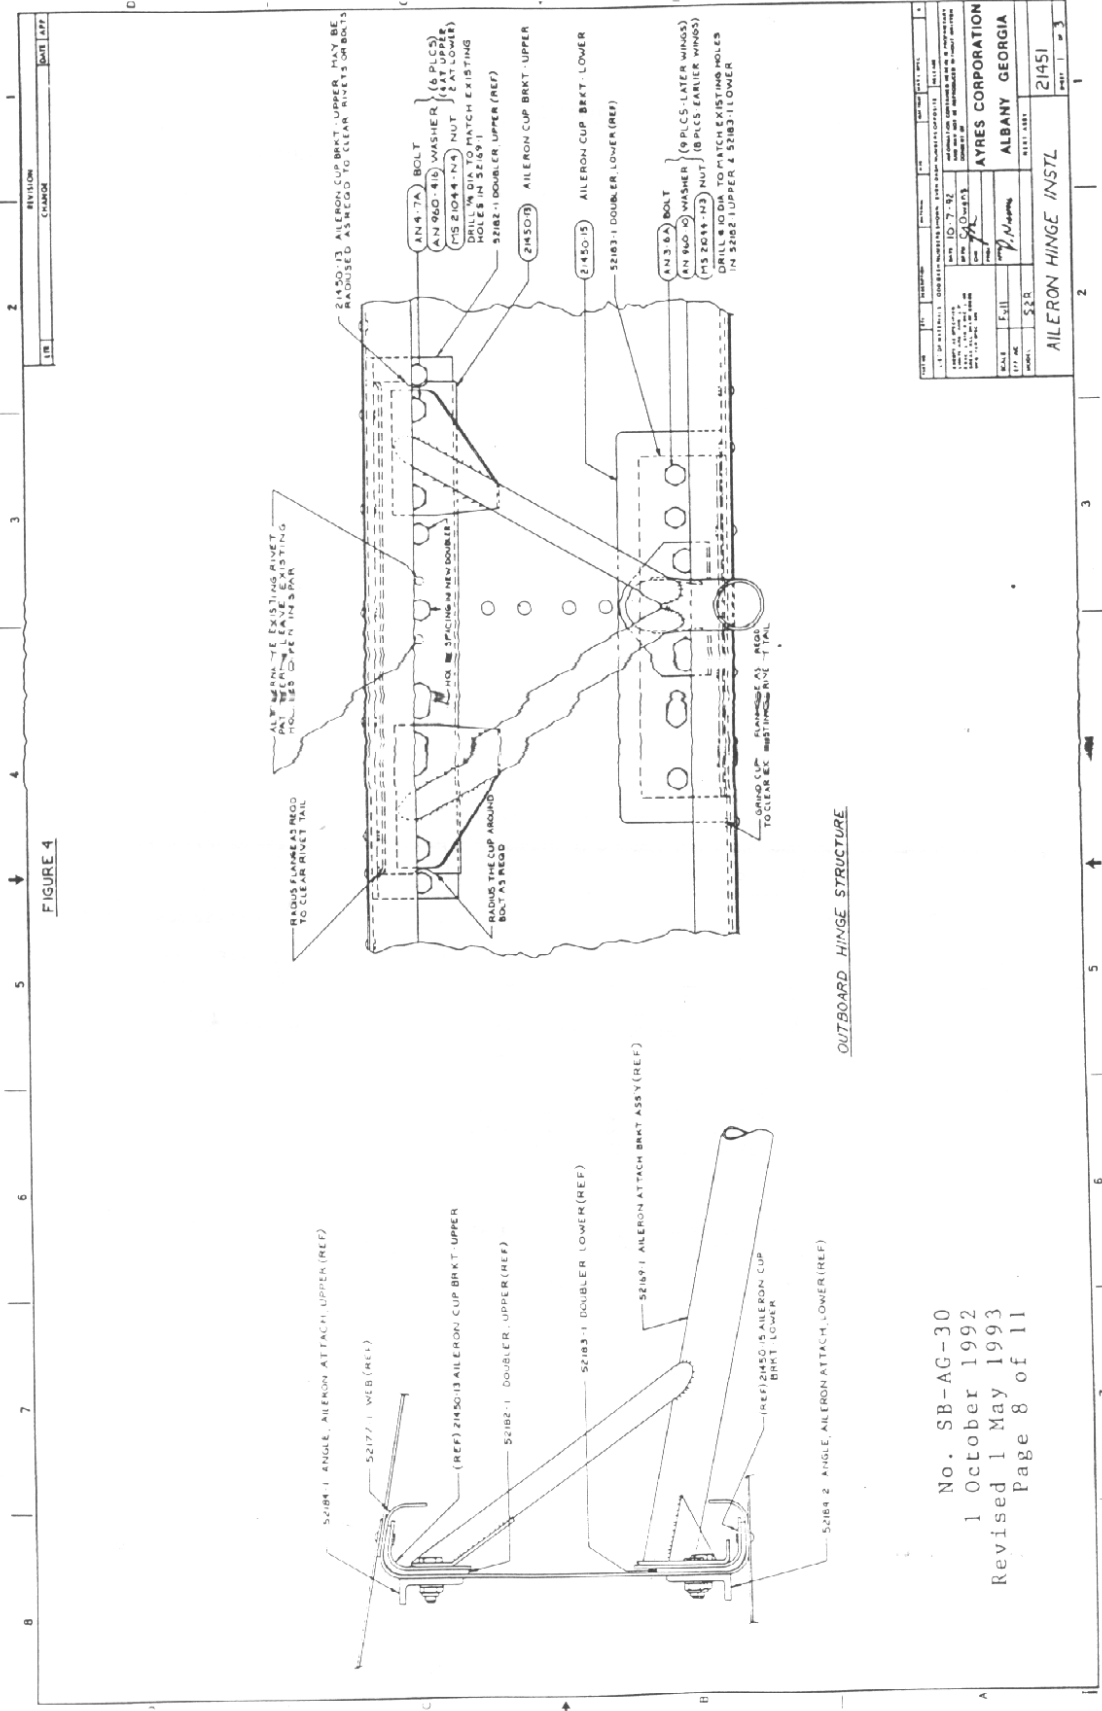
FIGURE 3

1. Inspect for cracks in the doublers, P/N 52182-1 upper and 52183-1 lower. If no cracks are found, install a new (or inspected and reworked) aileron bracket. Go to step III-1.
2. If cracks are found in these doublers, remove and discard them. Inspect the underlying spar web, P/N 52177-1, for cracks. If no cracks are found in the spar, install new doublers, cup brackets\*, P/N 21450-13 upper and 21450-15 lower, and the aileron bracket. Go to Step III-1.

TYPICAL CRACKS

3. If cracks are found in the underlying spar web, remove the extruded angles, P/N 52184-1 upper and 52184-2 lower, on the forward face of the spar and stop drill the web.
4. Reinstall angles, new doublers, cup brackets and a new (or reworked) aileron bracket. Go to Step III-1.

- NOTES (1) IF THERE IS ANY QUESTION REGARDING THE EXISTENCE OF A  
CRACK, USE A DYE PENETRANT TO AID THE INSPECTION.
- (2) STOP DRILL ALL CRACKS NO. 50.

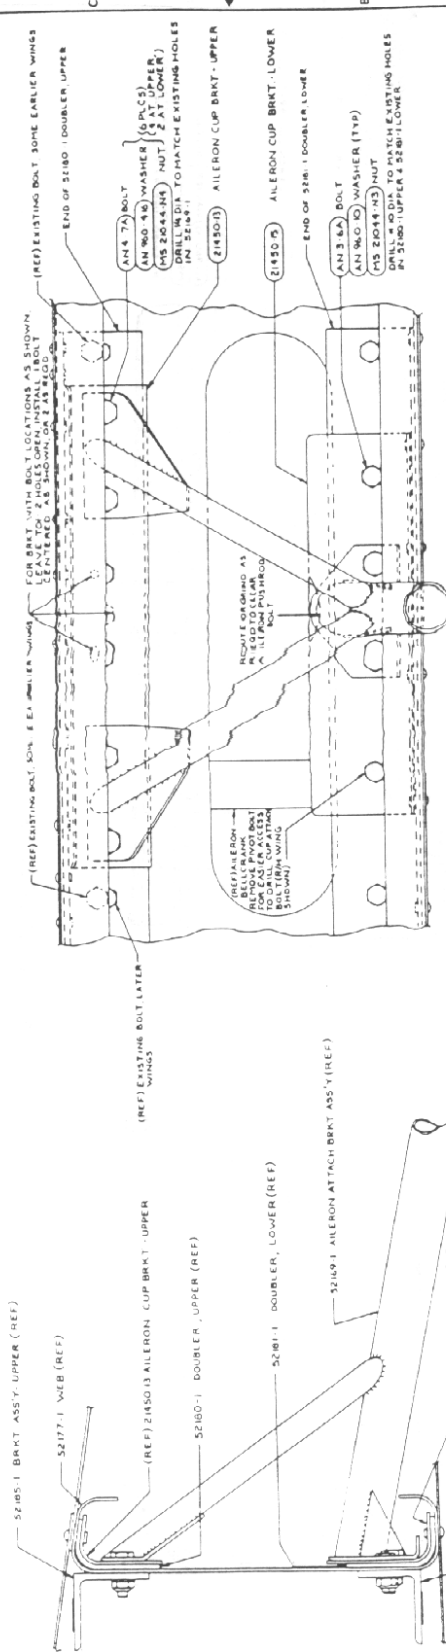
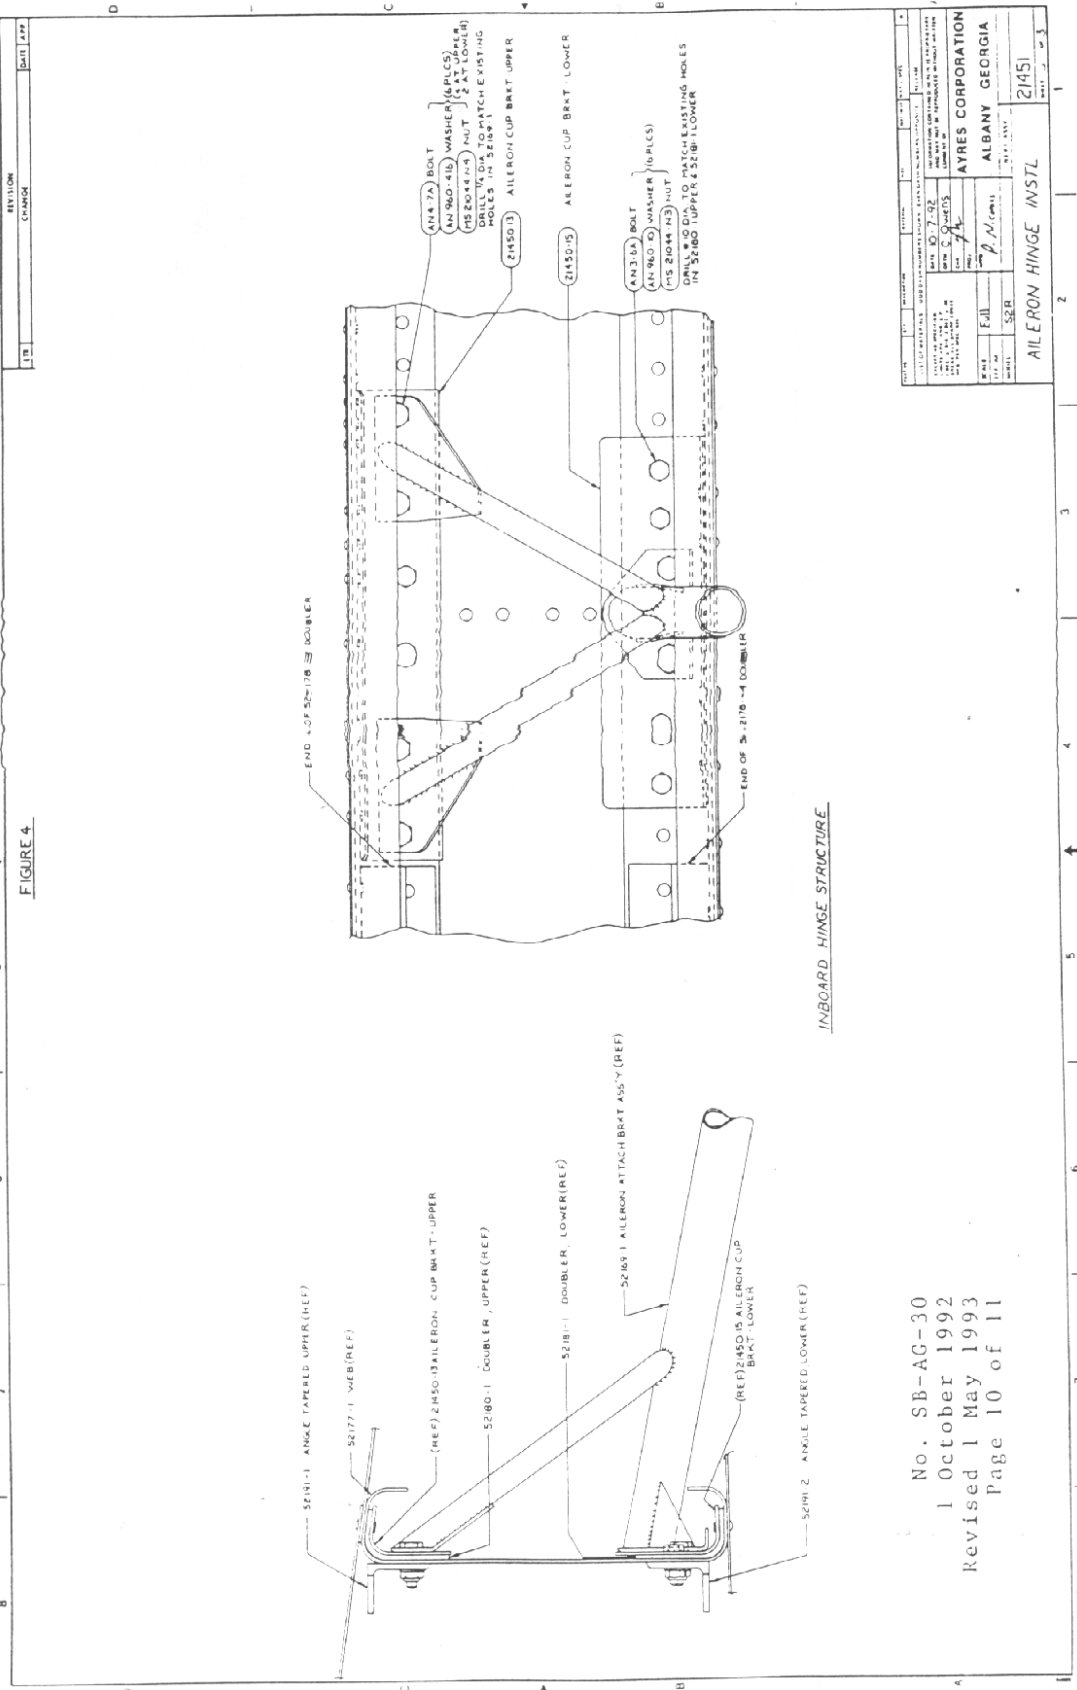
FIGURE 4.

1. Inspect for cracks in the doublers, P/N's 52180-1 upper and 52181-1 lower. If no cracks are found, install a new (or inspected and reworked) aileron bracket. Go to Step IV-1.
2. If cracks are found in these doublers, remove the angle brackets, P/N 52185-1 upper and 52187-1 lower, forward of the spar and inspect the spar web from its front side. If cracks are found in the spar, stop drill these cracks from the front side. Stop drill the doublers from the aft side of the spar. Reinstall the angles, together with the cup brackets\* and a new or reworked aileron bracket. Go to Step IV-1.

NOTE: If the two center bolts between the aileron brackets attach pads are too close to the radius of the cup brackets, leave the existing two holes open and drill one hole in the center, low enough to clear the radius. Ref. Drawing 21451, sheet 2. Grind the center of the bottom cup flange as required to clear the aileron push rod/bolt.
