Service Bulletin No. SB-AG-32
12 February 1993
Page 1 of 4

FIN FRONT SPAR ATTACHMENT TO HORIZONTAL STABILIZER

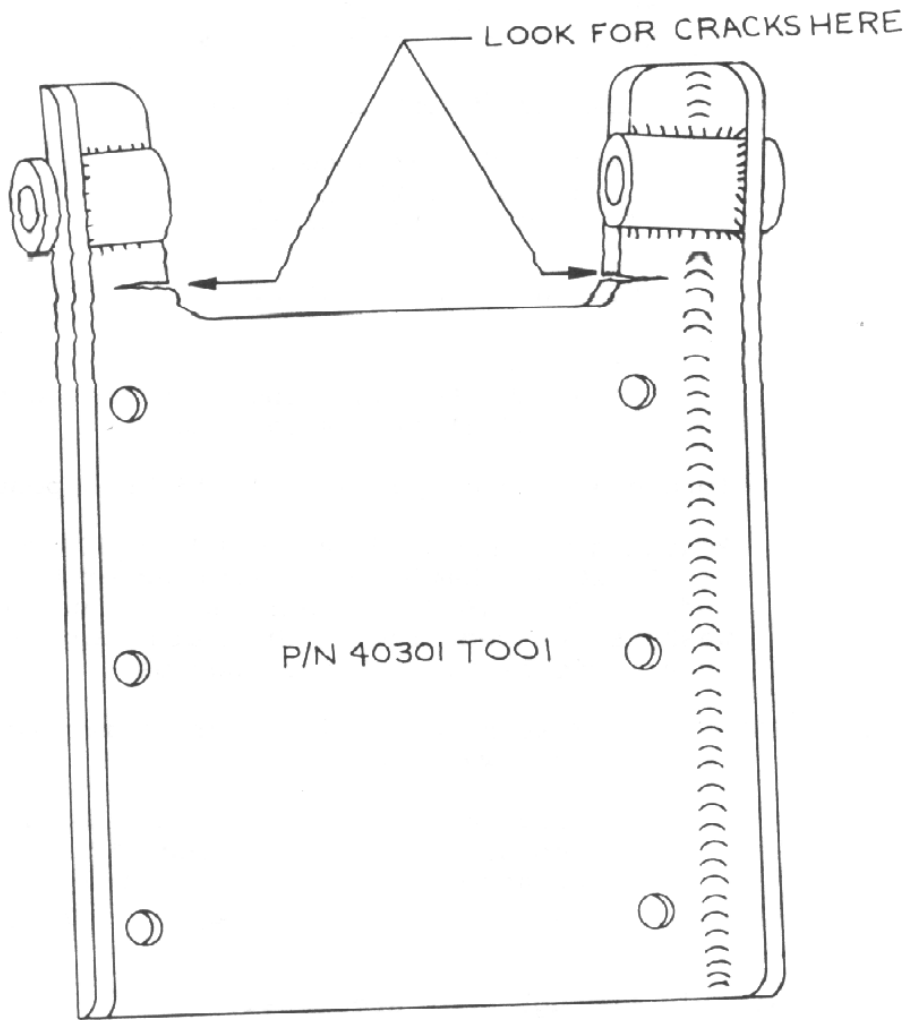
FIGURE 1

Fatigue cracks have been found in P/N 40301T001, as illustrated in Figure 1. This bulletin has been written to require the replacement of P/N 40301T001 with P/N 40301T007. Part No. 40301T007 is machined out of aluminum. It is designed to reduce the stress level that occurs in the attached lugs of P/N 40301T001.

The P/N 40301T001 bracket is bolted to the front face of the front spar of the horizontal stabilizer at the midship centerline. The cracks will occur in line with the small close out plate that is riveted to the upper skin of the stabilizer. This plate must be removed and the sealing compound thoroughly cleaned off. The vertical fin should be removed in order to drill off the close out plate and properly inspect the fitting. Look for cracks in the fitting as shown in Figure 1.

If the inspection reveals cracks in the P/N 40301T001, remove it and install a P/N 40301T007 (aluminum) bracket and a new P/N 40309T003 close out plate.
