SERVICE BULLETIN

No. SB-AG-54

S2R-T660 ELEVATOR

PUSH-PULL TUBE END

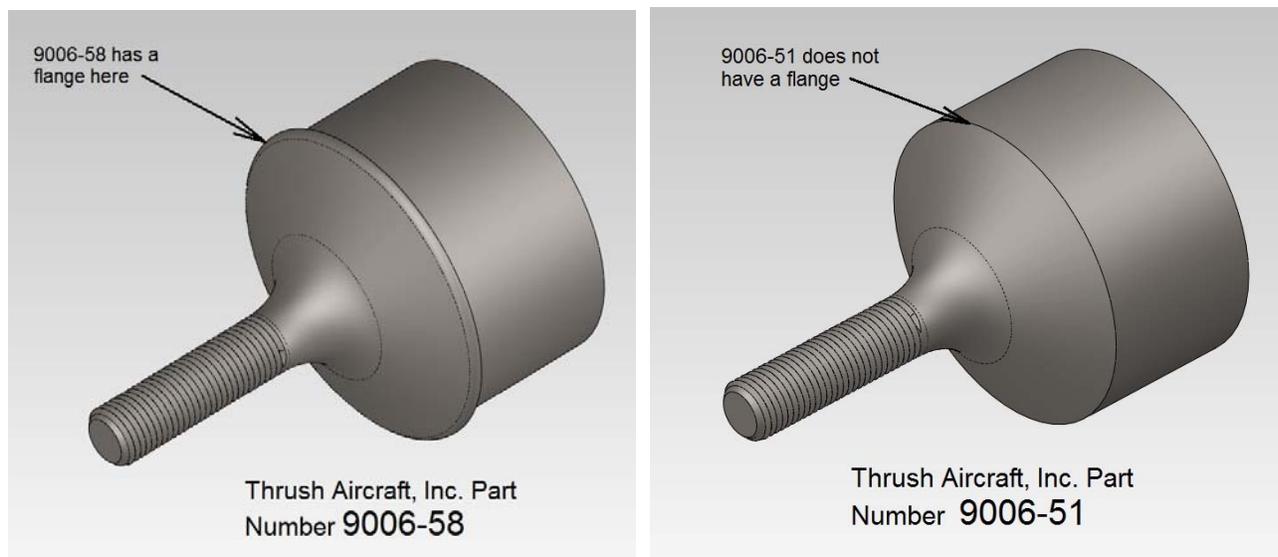
A Thrush S2R-T660 aircraft was severely damaged in a hard landing due to loss of elevator control. The cause of the loss of elevator control was traced to a failure of the elevator push-pull tube forward end fitting. The threaded shaft holding the rod end bearing had broken completely in two. The NTSB examined the broken threaded shaft and concluded that the cause of the failure was metal fatigue (ref. NTSB No. CEN09LA526). The exact cause of the metal fatigue was not determined. The threads of this part are machined and the fatigue crack started at the bottom of the last thread. This suggests that a stress riser was created by an overly sharp cut or by exposing a metal inclusion, and the stress riser lead to the fatigue crack.

Thrush Aircraft, Inc. has redesigned this end fitting to have rolled threads rather than machined threads. The rolling process displaces the material into the desired thread profile, rather than cutting away material to create the threads. Thread rolling has two advantages over machine cut threads: 1) the roots of the threads are not machined and therefore not as sharp, reducing the possibility of producing a stress riser, and 2) displacing the shaft material to form the threads cold works the material and thereby strengthens it.

To replace the existing P/N 9006-51 end fitting with the new P/N 9006-58 end fitting, accomplish the following steps: See illustrations below for visible difference between 9006-58 and 9006-51.

- 1) Remove P/N 9006-51 end fitting from the front end of the elevator push-pull tube:
 - ✓ Disconnect the rod end bearing and check nut from the belcrank and remove it from the end fitting. Note the position of the rod end bearing on the fitting for reference when installing it on the new end fitting.

- ✓ Remove both AN3-23A bolts holding the tube and end fitting together.
 - ✓ Remove the P/N 9006-51 end fitting from the aluminum tube, being careful not to distort the tube.

- 2) Install the P/N 9006-58 end fitting into the aluminum tube until the end of the tube is snug against the flange of the end fitting.
 - ✓ Being careful that the end fitting does not move in the tube, use a 3/16" transfer punch to mark the end fitting at the center of each of the four holes in the tube.

- ✓ Remove the end fitting and, using a drill press and vice, drill two opposite marked places 3/16" diameter through one side at a time.
 - ✓ Turn the drill press off and adjust the end fitting in the vice so the drill passes through both holes. It may be necessary to turn the drill press back on briefly to open the top hole slightly so the drill passes through. With the drill press off and the vice loosened slightly, pass the drill bit through the bottom hole. If necessary, when the drill is aligned with the bottom hole, tighten the vice, turn the drill press on, and drill through the bottom hole.

- ✓ Without moving the fitting in the vice, change to a #12 drill bit and line drill through both sides.
 - ✓ Repeat this drilling procedure for the other pair of holes in the fitting.
- 3) Reinstall the end fitting into the tube and align the tube and fitting holes.
- ✓ Install an AN3-23A bolt, with a washer under the head, into each of the aligned holes.
 - ✓ Install another washer and an AN365-1032 nut on the threaded end of the bolts and tighten to 25 to 30 in# of torque.
 - ✓ Torque-stripe both the nut and the head of both bolts.
- 4) Reinstall the check nut and rod end bearing on the new end fitting to the approximate position where it was on the old end fitting. Do not tighten the check nut yet.
- ✓ Rig the elevator control system per the S2R-T660 maintenance manual.
 - ✓ Tighten and torque-stripe the check nut to the rod end bearing and tube end fitting.
