SERVICE INFORMATION LETTER

SIL-AG-71

S2R-T660

Engine Isolator Inspection

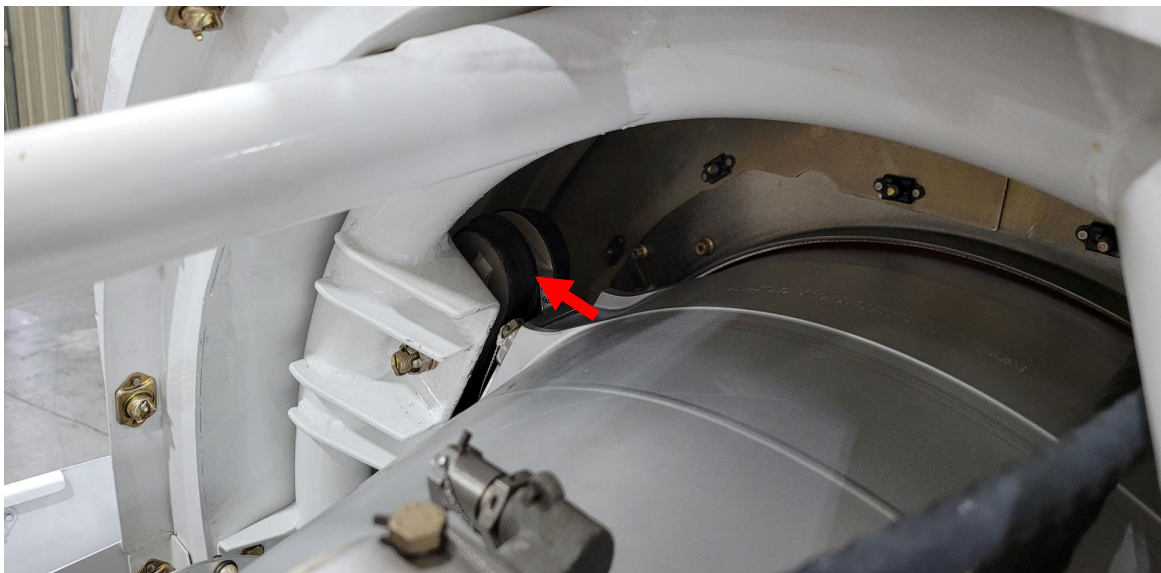
Figure 3.2.1 – LH Upper Engine Isolator

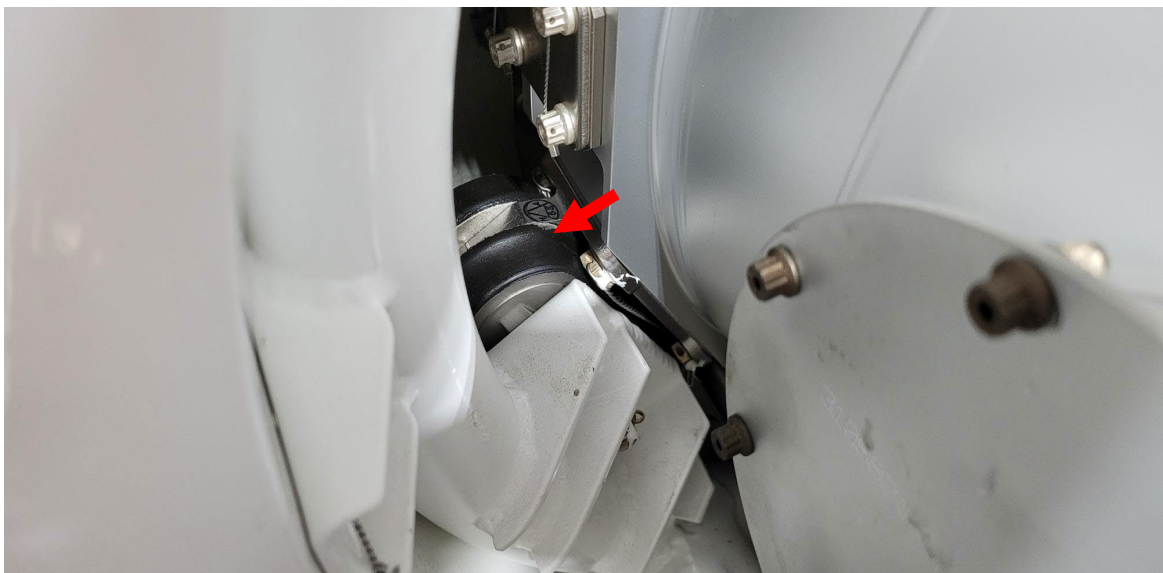
Figure 3.2.2 – LH Lower Engine Isolator

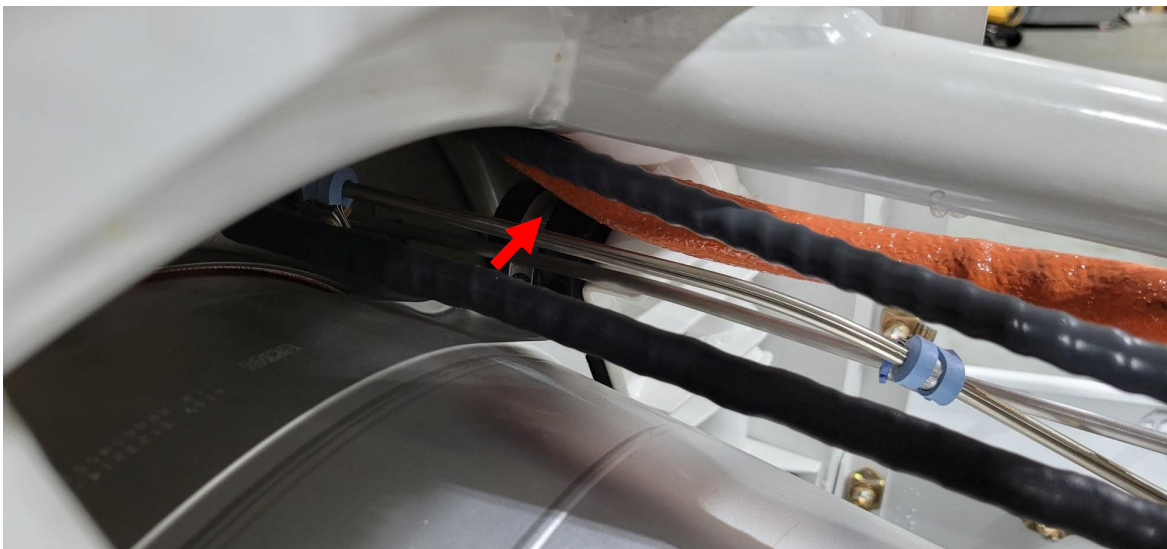
Figure 3.2.3 – RH Upper Engine Isolator

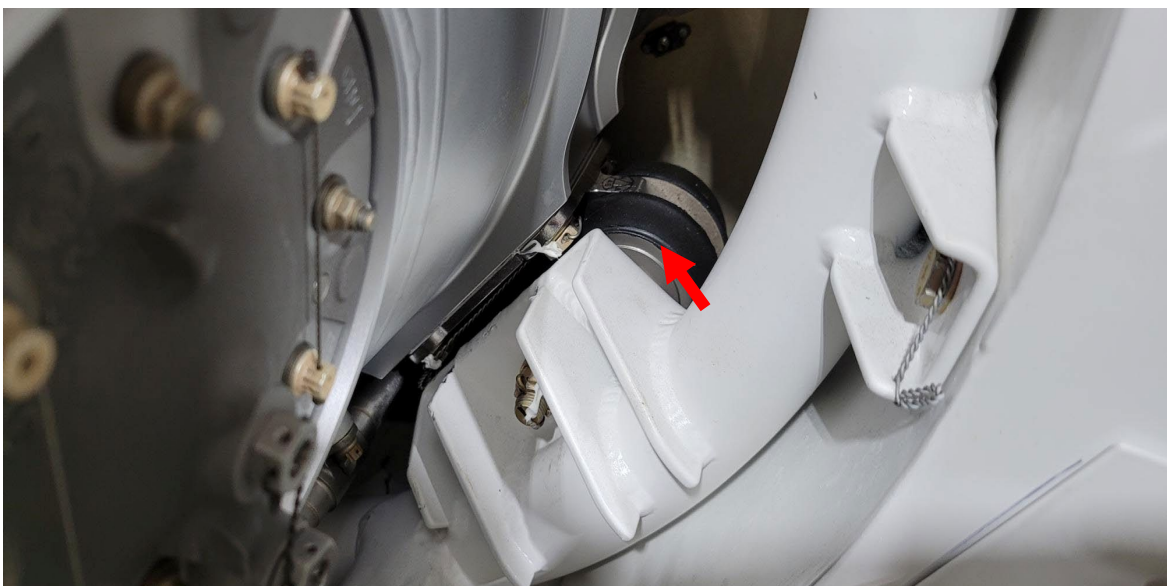
Figure 3.2.4 – RH Lower Engine Isolator

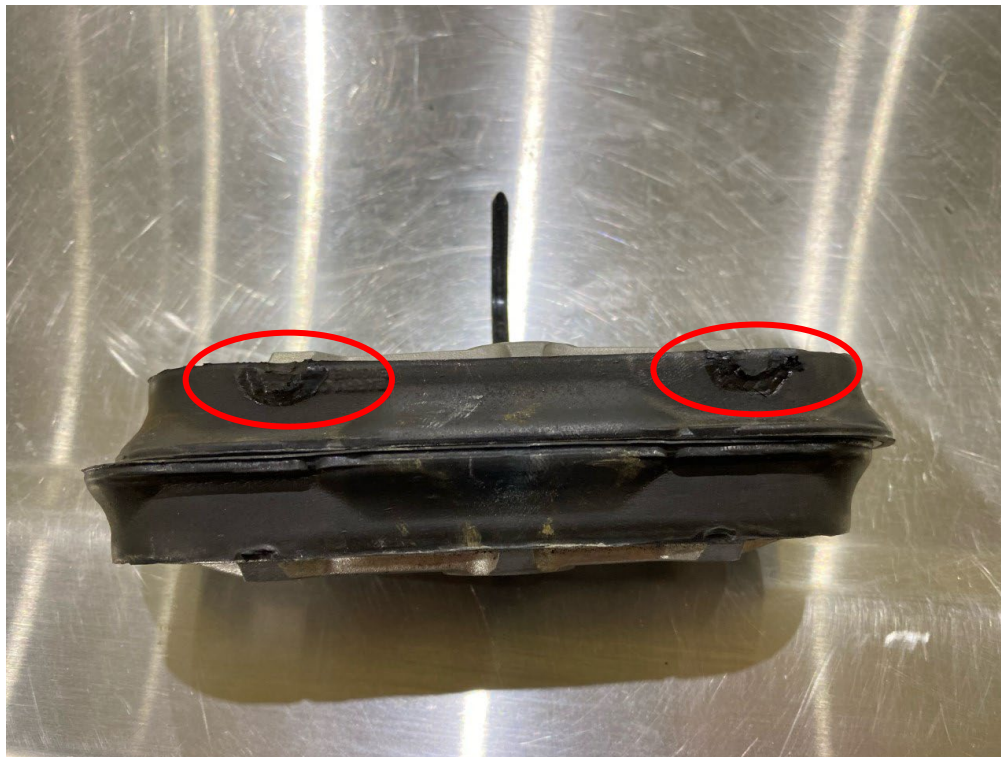
Thrush has been notified by more than one operator of premature wear or deformation of the Engine Isolators “Barry Mounts”. This Service Information Letter acts as an inspection notification to S2R-T660 Aircraft operators with PT6-65AG engines installed to inspect for this condition.

Figure 3.3.1 – Damage from Premature Wear

- If damage or premature wear is found, please contact us at support@thrushaircraft.com.

- Individual engine isolators may be replaced on an as needed basis.
- Operators may elect to upgrade to an improved isolator: See CK-AG-61, available on Thrush's website and Veryon subscriptions.
