Service Letter No. SL-AG-106
16 January, 2001

INSPECTION OF INLET BOWL COUNTERSUNK SCREWS

MODELS AFFECTED:	<u>MODELS</u>	<u>SERIAL NUMBERS</u>
	S2R-G1	G1-101 thru G1-108
	S2R-G5	G5-101 thru G5-105
	S2R-G6	G6-101 thru G6-156
	S2R-G10	G10-101 thru G10-166

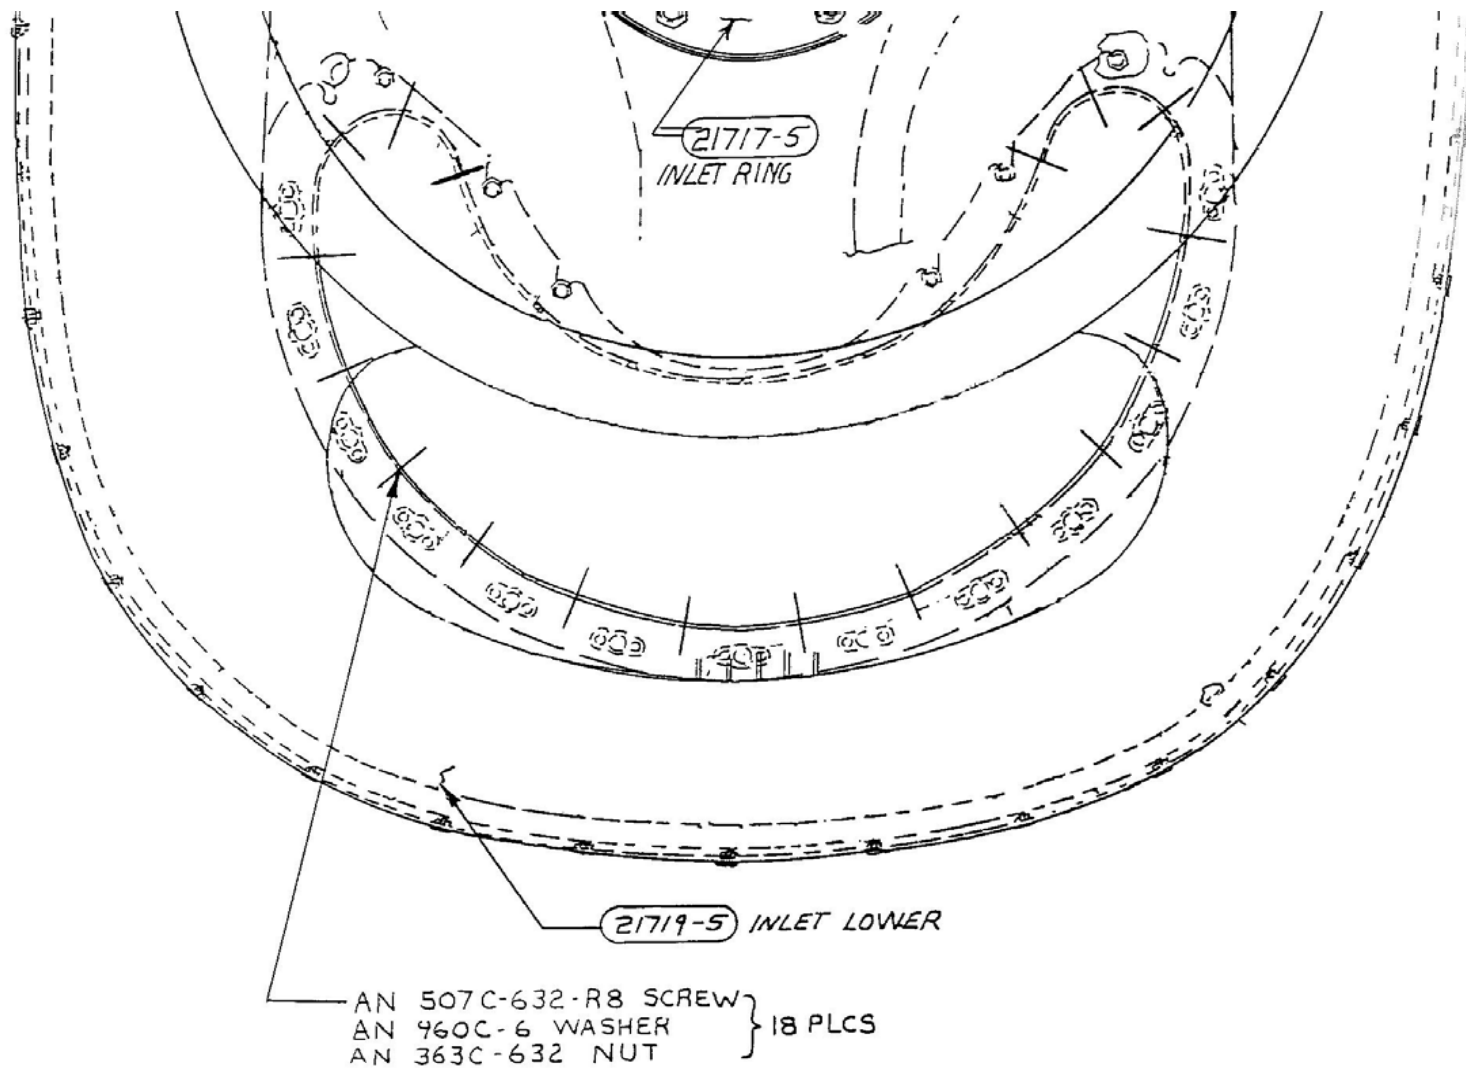
FIGURE 1

REASON FOR PUBLICATION: There have been reported instances of some of the AN507C-632-R8 screws utilized in the construction of the engine inlet backing out and being ingested into the engine causing damage to the first and second stage compressor.

- 1) Remove the inlet bowl from the aircraft to gain access to the AN507C screws in question. Refer to Figure 1 for location.
- 2) Remove the #6 countersunk screws and inspect both screws and nuts for overtorquing or other damage.

- 3) Replace any damaged screws and install new fiberlock nuts, P/N AN365-632 or equivalent using a maximum torque of 6-8 in. lbs. Coat the screws with LOC-TITE, P/N 271 or 290 or equivalent before installation.
- 4) Touch up paint as required
- 5) Replace inlet bowl.
- 6) Record compliance with this Service Letter as shown below and return aircraft to service.
