THRUSH AIRCRAFT INC.

WING SPAR STATUS UPDATE

No. SL-AG-110

IMMEDIATE WING SPAR IMPROVEMENT

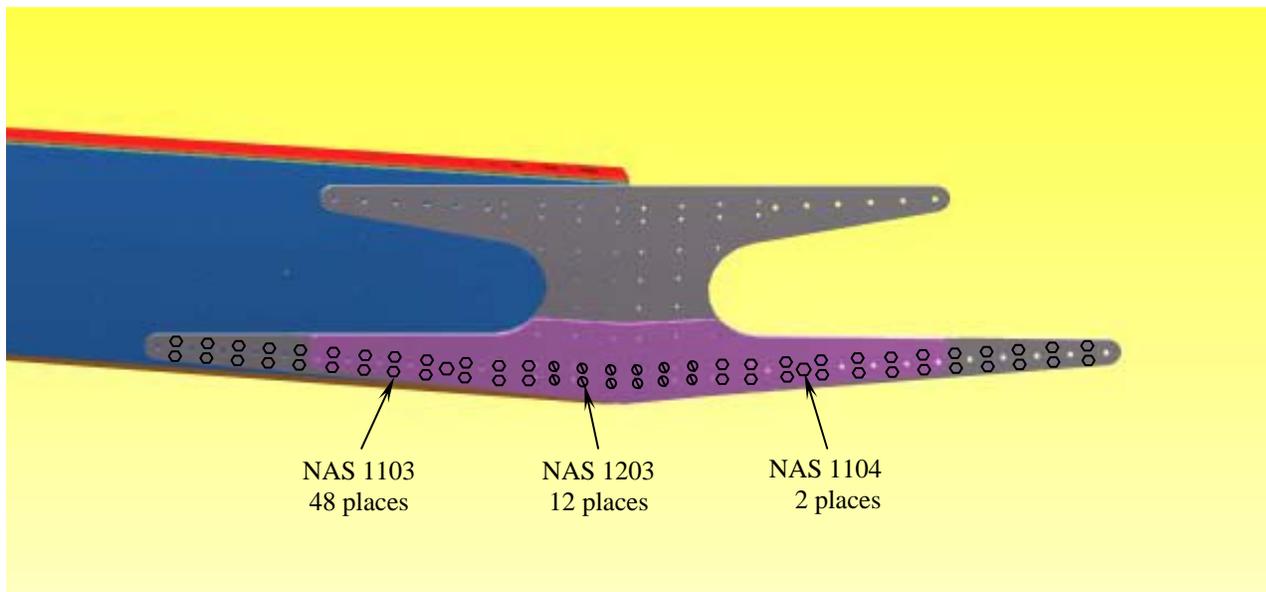
Additional Fasteners through Big Butterfly and Lower Splice Plate

Please note that this modification does not make your wing spars fail safe, nor is it a substitute for replacing cracked lower spar caps. It does, however, improve the ability of the “big butterfly” to pick up the lower spar cap tension load in the event it does fail at one of the first two splice block holes. Analysis shows that in this event, the “big butterfly” modified per this Service Letter will keep the wing on in normal 1g flight, but will not withstand much maneuvering. Thus it is necessary for all pilots to be on the alert for any unusual noises coming from the wing center section area, any unusual flexing of a wing, or any unusual handling qualities. If any of these occur, level out and land immediately! Before the next flight, inspect the wing center section structure, especially the lower spar caps around the first two splice block holes. If these “warning signals” are caused by a cracked lower spar cap, the crack will be visible, especially when significant up-force is applied at the wing tip.

- Install the two new NAS 1104 bolts with MS21042-4 nuts and AN960-416 washers on the aft side, torqued to 80 to 100 inch pounds.
- Reinstall the lower splice blocks and fasteners per the maintenance manual.

- It is recommended that the joints where the “big butterfly” and lower splice plate meet the aft spar web be sealed with fuel tank sealant or a high quality silicone sealer, to keep corrosive chemicals out.
