THRUSH AIRCRAFT, INC.

SERVICE LETTER

No. SL-AG-111

ENGINE MOUNT AND MOUNT ISOLATOR INSPECTION AND REPAIR

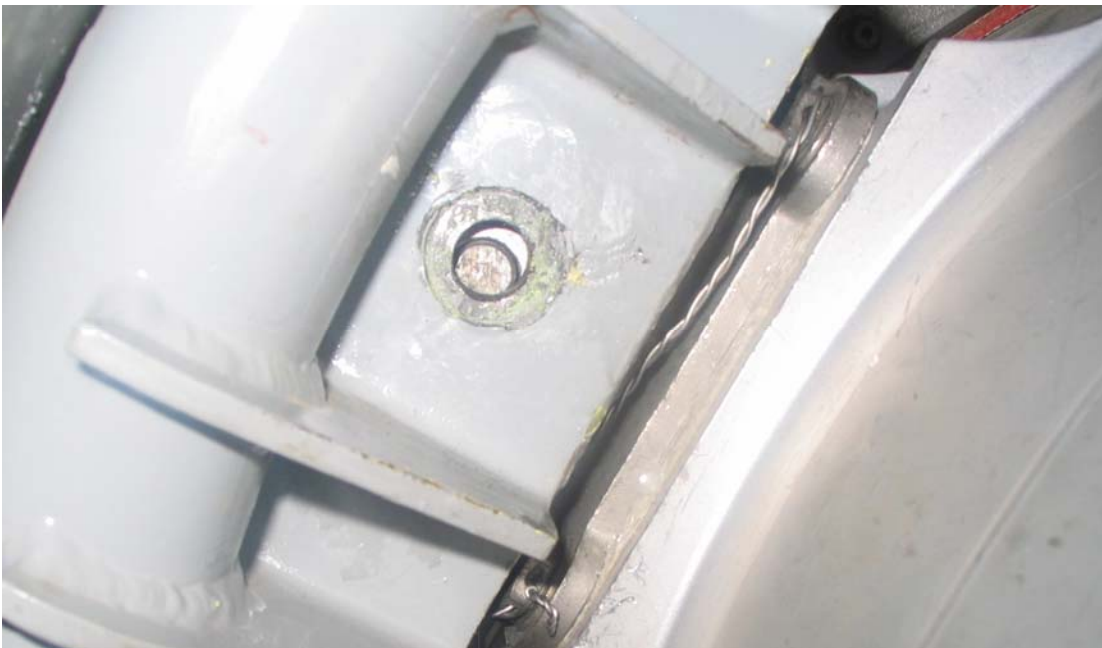
Figure 1: Misalignment Example

1. The presence of misalignments between the engine isolators and the engine mount isolator attach holes in the engine mount. The concern is pre-loading of the isolators caused by this alignment. Thrush Aircraft, Inc has determined that a misalignment of more than .050" may decrease engine isolator life.
2. Heads of bolts attaching vibration isolators to the engine may be contacting and damaging the rubber of the isolator.

1. Support the engine weight using a sling before it is disassemble from the engine mount. While keeping the engine suspended, proceed with removing the engine isolator bolts from the mount. Compare the alignment between the Barry mount bolts and the engine mount bracket holes. There should not be a misalignment more than 0.050". If a misalignment larger than the tolerance is detected (See Figure 1), proceed with repair instructions.

1. Misalignment: See figures 2 and 3.
2. Rubber damage: See figure 3.

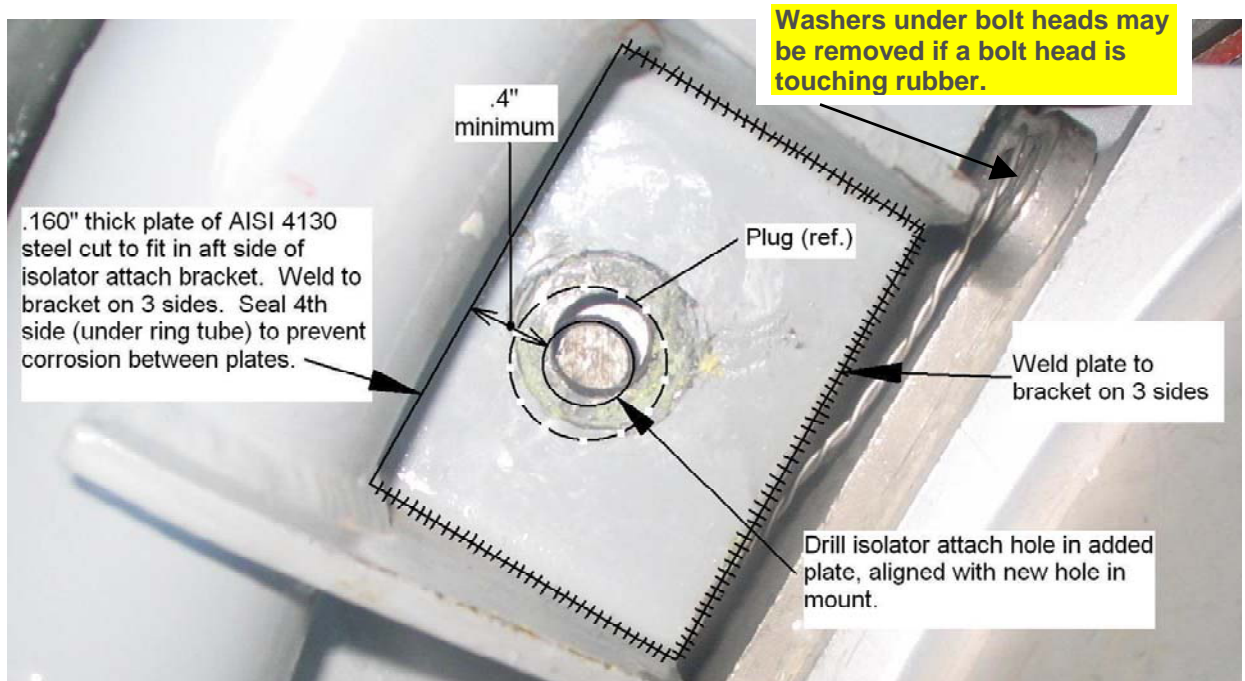
Figure 3: Plate Installation

2. Inspect the isolator rubber on the under side for evidence of bolt head contact with the isolator rubber.
