Rockwell service letter No. SL-AG-74A

Service Letter No. SL-AG-74A
(Supersedes Service Letter No. SL-AG-74)
October 24, 1975

MASTER RELAY CONTROL CIRCUIT

MODELS AFFECTED: MODEL S-2R, SERIAL NO'S 1640R THRU 2173R AND 5001R THRU 5075R.

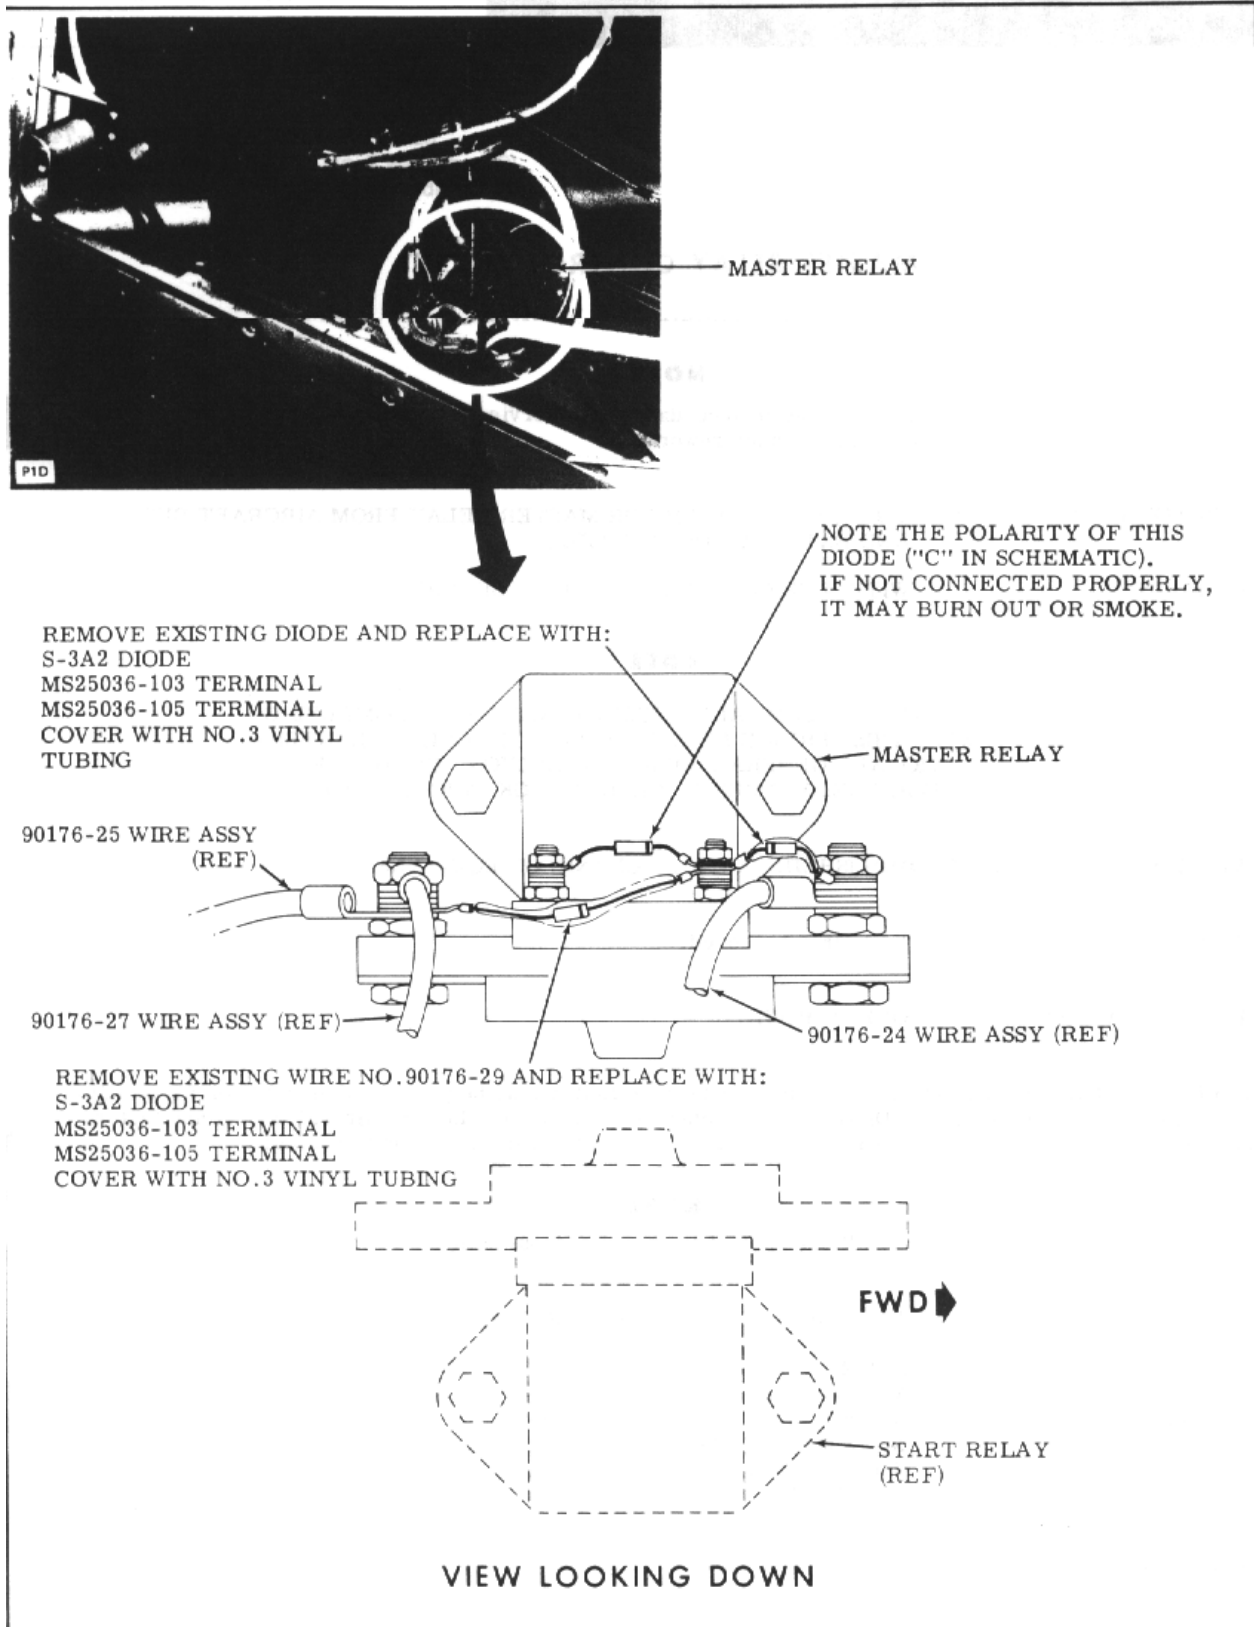
Figure 1.

REASON FOR PUBLICATION: To provide power for master relay from aircraft bus and battery positive side.

1. Assure that battery switch is OFF.
2. Remove right fuselage skin below cockpit to gain access to battery.
3. Disconnect battery.
4. Remove and discard wire No. 90176-29, and existing diode from master relay (see Figure 1.).
5. Install S-3A2 diode (2 places), MS25036-103 terminal (2 places), MS 25036-105 terminal (2 places), and No. 3 vinyl tubing (see Figures 1. And 2.).
6. Reconnect battery.
7. Reinstall fuselage skin.

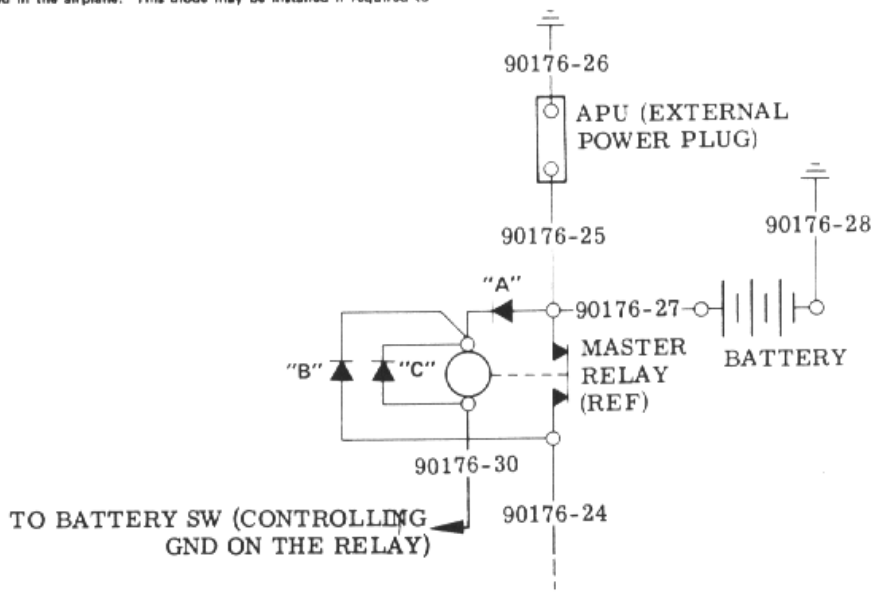
Figure 2.

3. In all cases follow the schematic to check the connections from positive of battery to relay contact terminal (large stud) and External Power connection to relay contact terminal (large stud). Other side of relay contact (large stud) is output of Battery Power and External Power. Coil terminal of the relay which accepts positive voltage from Battery and/or External Power. Coil terminal of relay which is connected to Battery switch.

1. In case of conflict between illustration and installation shown in Figure 1., and this schematic, follow the schematic.
2. Wire numbers shown are for guidance only and may vary in different airplanes.

4. Delete diode "B" from airplane.
5. Install new S-3A2 diodes "B" and "A" as shown in schematic (read step 3. above).
6. Diode "C" may or may not be installed in the airplane. This diode may be installed if required to suppress minor noise or voltage spikes.
