Service Letter No. SL-AG-83 5 February, 1976

REWORK OF VERTICAL FIN INSPECTION PLATE ATTACHMENT

MODELS AFFECTED: S-2R, SERIAL NO'S 1416R THRU 2173R AND 5001 THRU 5075.

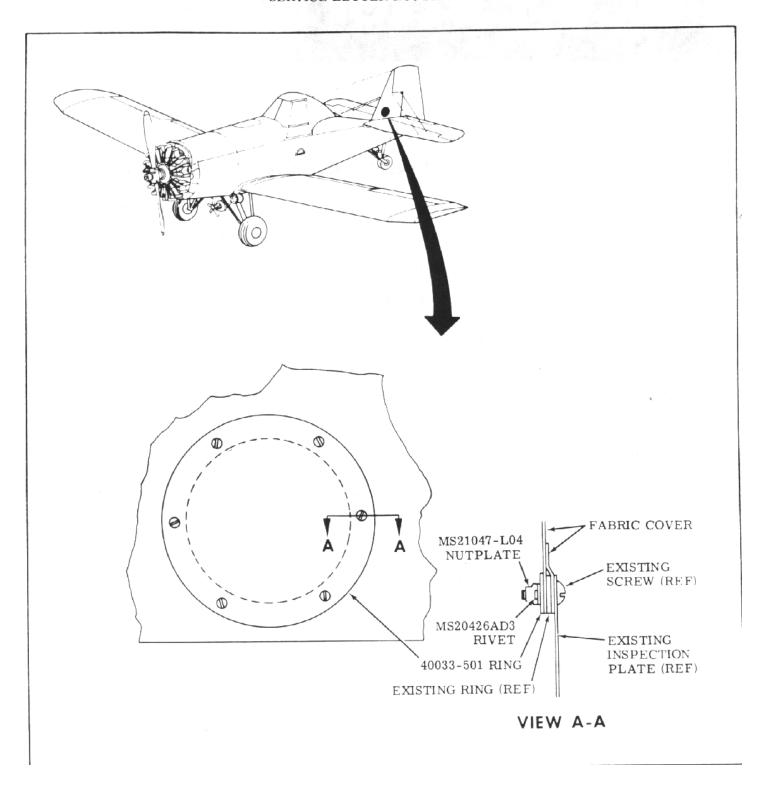
REASON FOR PUBLICATION: PREVENT INADVERTENT LOSS OF VERTICAL FIN

INSPECTION PLATE.

- 1. Remove existing vertical fin inspection plate.
- 2. Remove and discard existing nutplates.
- Locate 40033-501 ring in place and drill six (6) No. 30 holes in ring picking up existing inspection plate attach holes (see Figure 1.).
- 4. Install MS21047-L04 nutplate (6 places) (see Figure 1.).

Pick up existing nutplate attach holes in existing ring and fabric.
