Service Letter No. SL-AG-86 1 June, 1976

OIL SUPPLY HOSE REPLACEMENT

MODELS AFFECTED: S-2R, S/N 2070R thru 2206R.

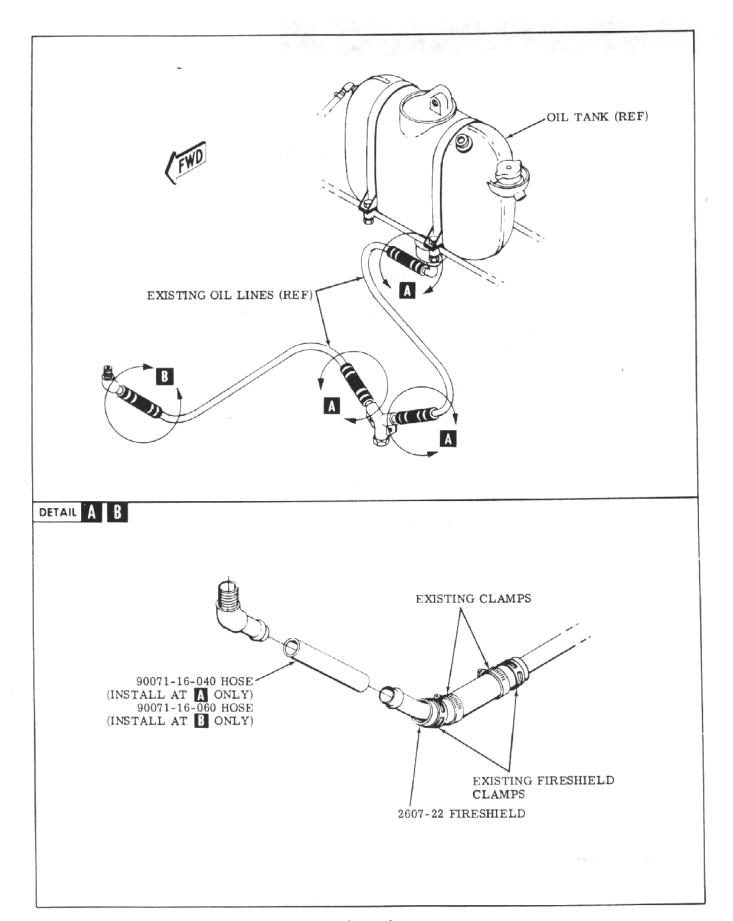
Figure 1.

REASON FOR PUBLICATION: Reduce the possibility of leakage of the oil supply line.

- 1 Remove engine cowling.
- 2 Drain oil tank as outlined in the Airplane Maintenance Manual, Section II.
- 3 Remove and discard existing hose and fireshield (4 places) (see Figure 1).
- 4 Place 2607-22 fireshields (4 places), existing fireshield clamps and existing hose clamps over existing oil supply tubes and install 90071-16-040 hose (3 places) and 90071-16-060 hose on airplane (see fFgure 1).
- 5 Connect existing oil supply tubes to new hoses, slide fireshields in place over hoses and tighten fireshield and hose clamps (see Figure 1).
- 6 Fill oil tank with approved type and grade of engine oil as outlined in the Airplane Maintenance Manual, Section II.
- 7 Reinstall engine cowling.
