Service Letter No. SL-AG-88 8 December, 1976

FLYING WIRE BRACKETS INSTALLATION

MODELS AFFECTED: S-2R, S/N 1825, 1851 thru 2240 AND 5000 thru 5082.

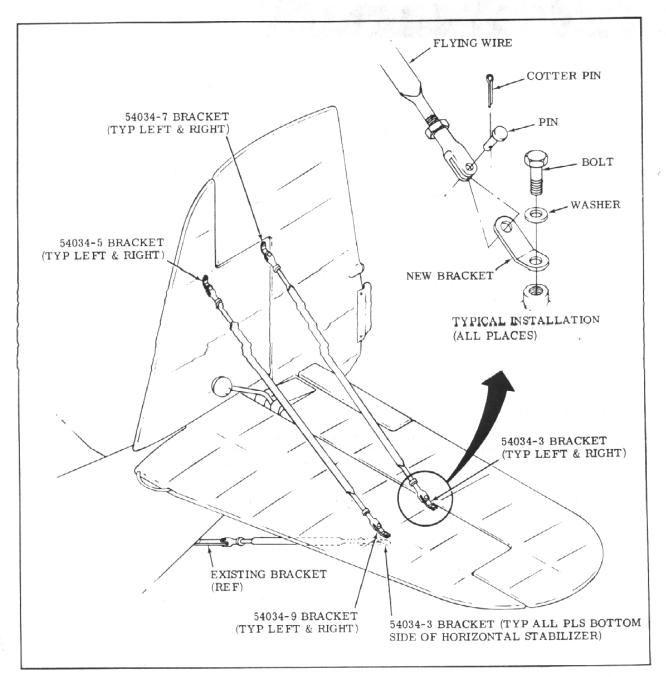
Figure 1.

REASON FOR PUBLICATION: Provide improved flying wire brackets.

- 3 Install 54034-5 bracket (2 places) and 54034-7 bracket (2 places) on vertical stabilizer using existing hardware removed in step 2. (see Figure 1).
- 4 Install 54034-3 bracket (6 places) and 54034-9 bracket (2 places) on horizontal stabilizer using existing hardware removed in step 2. (see Figure 1).
- 5 Reinstall existing flying wires using existing hardware.
- Rerig empennage as outlined in the Model S-2R Airplane Maintenance Manual (Change 2, dated May 14, 1976 or later), Section VII.
