Service Letter No. SL-AG-97 1 October, 1982 Revised 23 August 1994

LOWER WING SPAR INSPECTION

MODELS AFFECTED: All S-2D, S-2R, S2R-T15, S2R-T34, S2R-R1820 AND S2R-

G10 operating in the Commonwealth of Australia

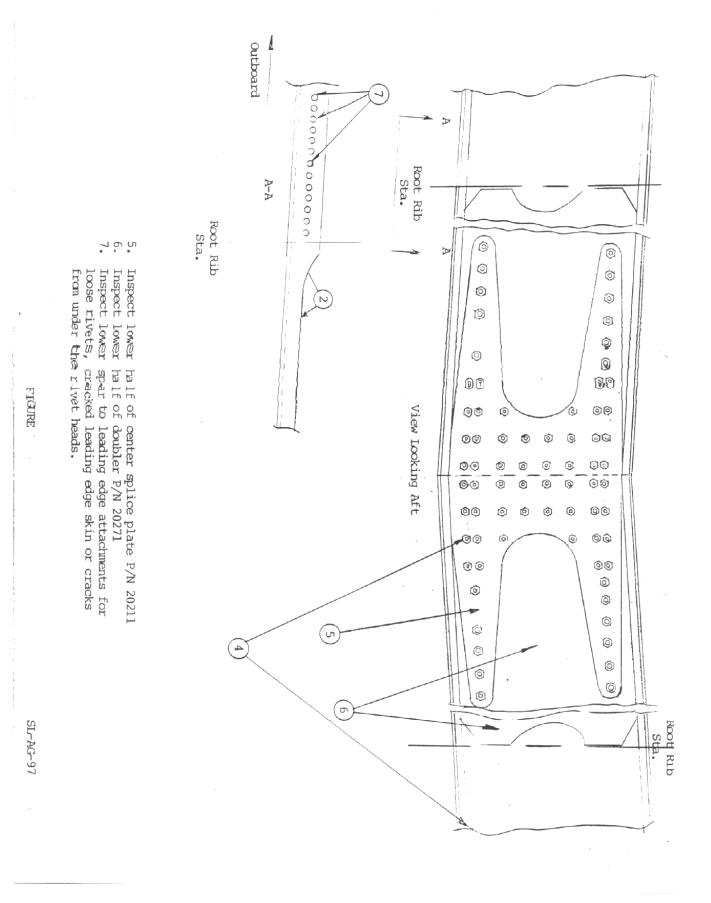
- 2. Remove lower wing root fairings to provide access to the lower spar web flange.
- 3. Visually inspect the lower spar for fatigue cracks from the airplane centerline outboard to the wing root rib paying attention to the following: (See Figure 1 & 2)

- a. Lower spar web flange P/N 20273
 - b. Lower half of forward doubler P/N 20230
 - c. Lower half of center splice plate P/N 20211 (aft side of spar assembly).

- d. Lower half of doubler P/N 20271 which is located on the aft side of the spar assembly and terminates at the root rib.
 - e. Inspect each huck pin head and collar for signs of looseness or evidence that the pins are "working". Check for cracks radiating from under the huck pin head or collar.

- f. Inspect all bolt heads and nuts for looseness or cracks radiating from them.
 - g. Outboard of the root rib along with lower spar to leading edge attachments, check for loose rivets, cracked leading edge skin or cracks from under the rivet heads.

- 4. If cracks are found, remove wing from aircraft and replace the cracked part using established, standard aircraft practices.
- 5. Fill out enclosed compliance card indicating the results of the inspection noting which part was replaced.
