# Rockwell service bulletin

No. SB-AG-5

## RE-ROUTING OF FUEL VAPOR AND PRIMER LINES

MODELS AFFECTED: MODEL S-2R, SERIAL NO'S 5000R THRU 5027R.

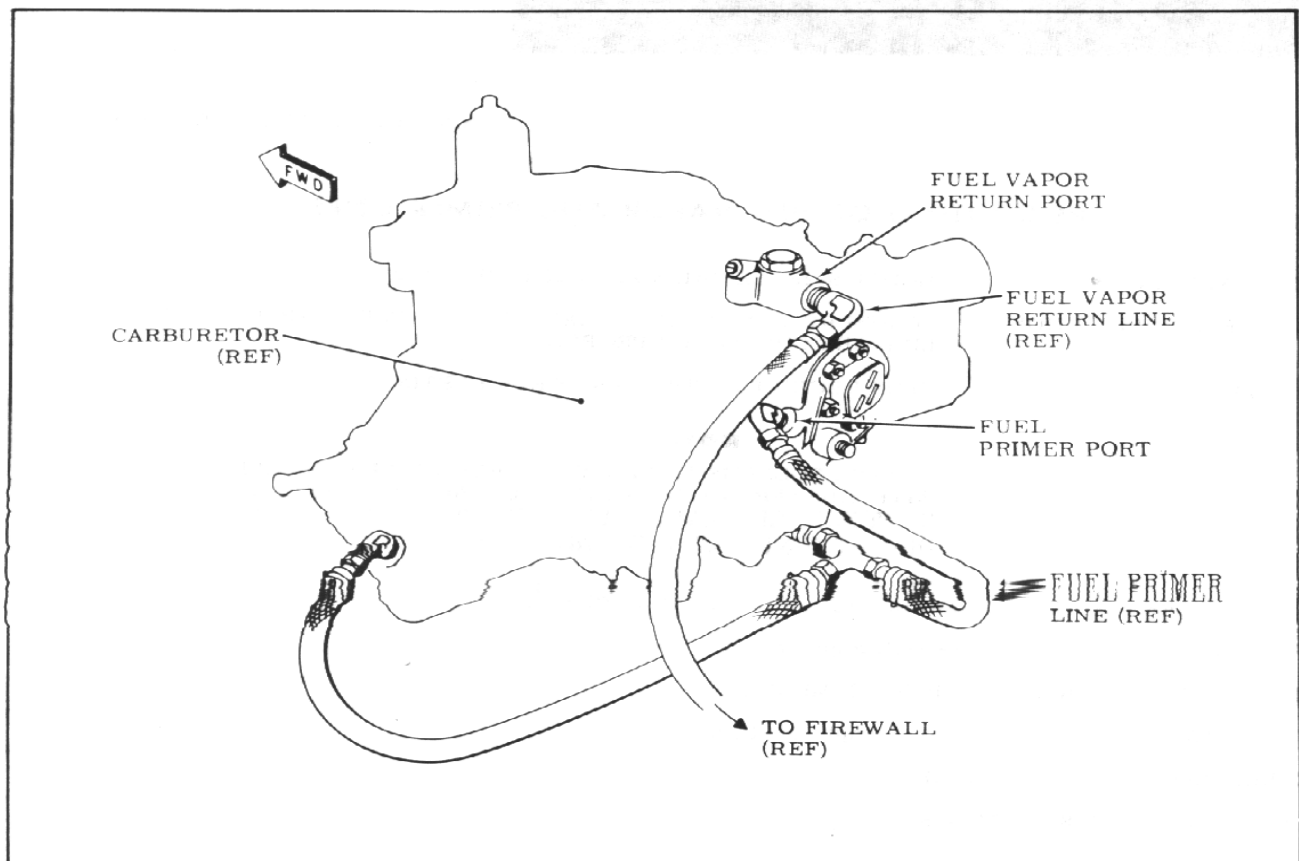
REASON FOR PUBLICATION: TO ASSURE THAT FUEL PRIMER LINE AND FUEL VAPOR RETURN LINE ARE CONNECTED PROPERLY.

1. Remove upper engine cowling.
2. Check and assure that the fuel primer line and the fuel vapor return line are connected to the carburetor as shown in Figure 1.
3. If the fuel primer line and fuel vapor return line are connected to the carburetor as shown in Figure 1., proceed to step 6.
4. If the fuel primer line and fuel vapor return line are reversed, disconnect and reconnect as shown in Figure 1.
