Service Bulletin No. SB-AG-16

FUSELAGE UPPER LONGERON REPAIR

MODELS AFFECTED: Model S2R-R1820, S/N R1820-001DC
thru R1820-031DC

REASON FOR PUBLICATION: PREVENT POSSIBLE FATIGUE CRACKING OF THE LONGERON

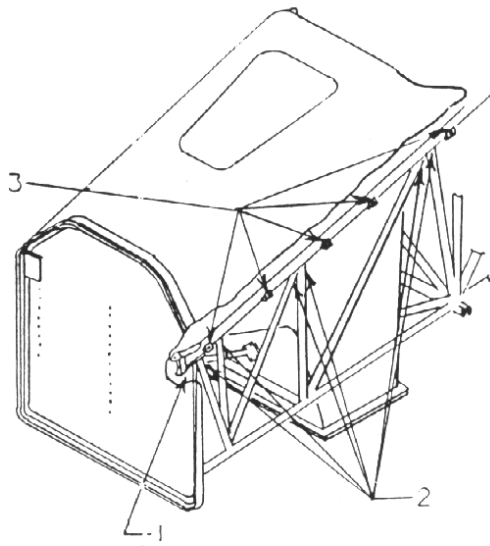
FIGURE 1

1. Remove the fuselage side skin located between the wing upper surface and the hopper. This will provide access to the upper longeron from the firewall to the cockpit.
2. Visually inspect the longeron paying particular attention to: (See Fig 1).
 1. Area around the upper engine mount attach points.
 2. Each vertical and diagonal tube intersection at the upper longeron.
 3. Each hopper attachment bracket.

- 1. UPPER ENGINE MOUNT ATTACH POINT
- 2. VERTICAL AND DIAGONAL TUBE INTERSECTION
- 3. HOPPER ATTACHMENT BRACKETS

3. If no cracks are found proceed to Record Compliance and return aircraft to service.
