# **SERVICE BULLETIN**

## **No. SB-AG-45 Rev. C**

**February 16, 2018**

### **FIN SPAR & ATTACH FITTINGS INSPECTION AND UPGRADE**

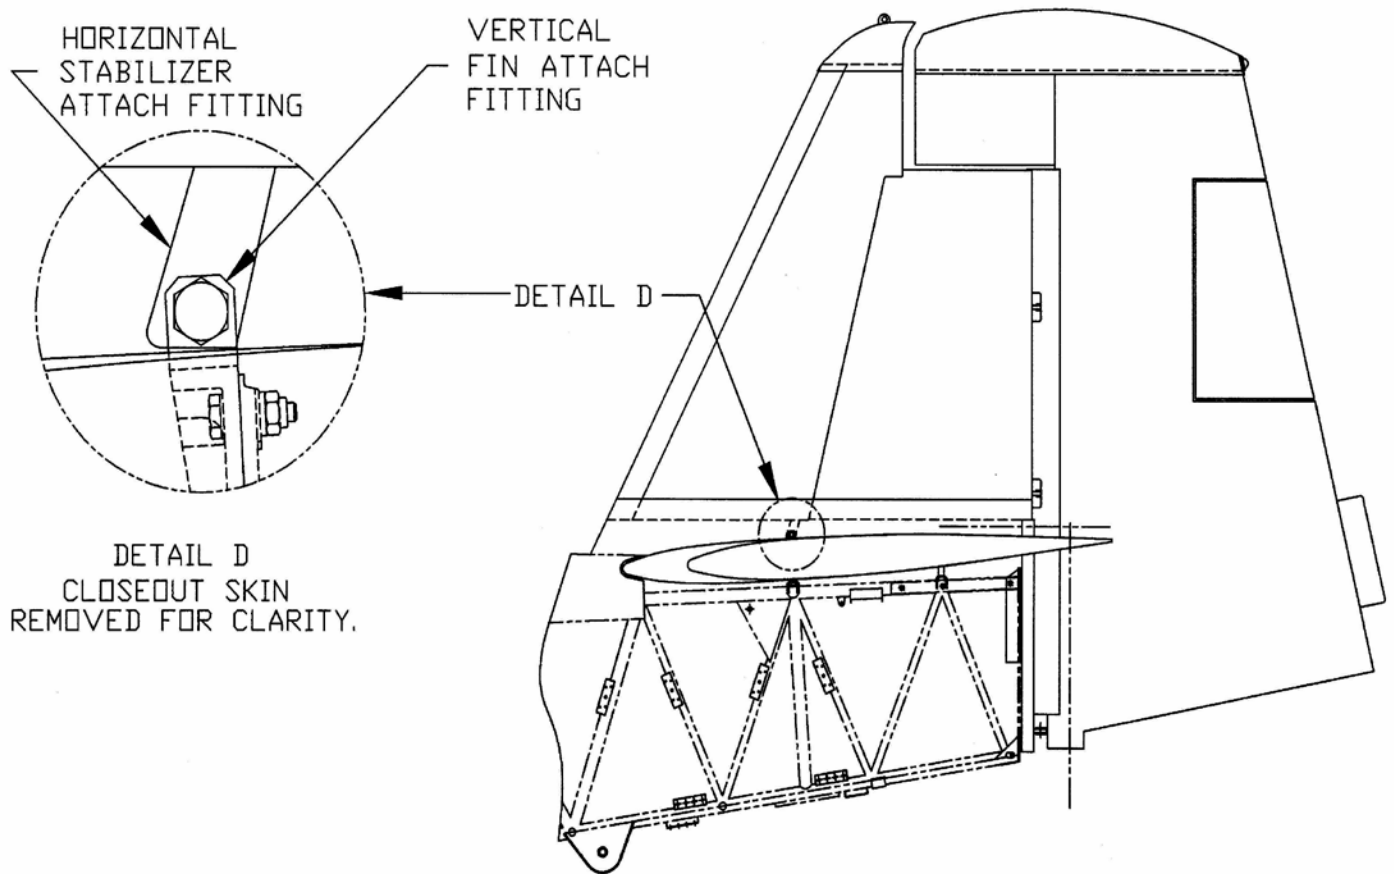
**Figure 45-1: Location of Attach Fittings**

Inspection of the 40301-7 vertical stabilizer attach fitting, 40303-1, 4 or 7 horizontal stabilizer attach fitting (95267-1 on the T660) and bolt must be accomplished immediately upon receipt or downloading of this service bulletin. It must be re-inspected every 100 hours thereafter until they are replaced with the 95266-11 vertical fin attach fitting, 95267-5 horizontal stabilizer attach fitting, and larger bolt per SB-AG-45 Rev. C. See Figure 45-1 for the location of these fittings and bolt.

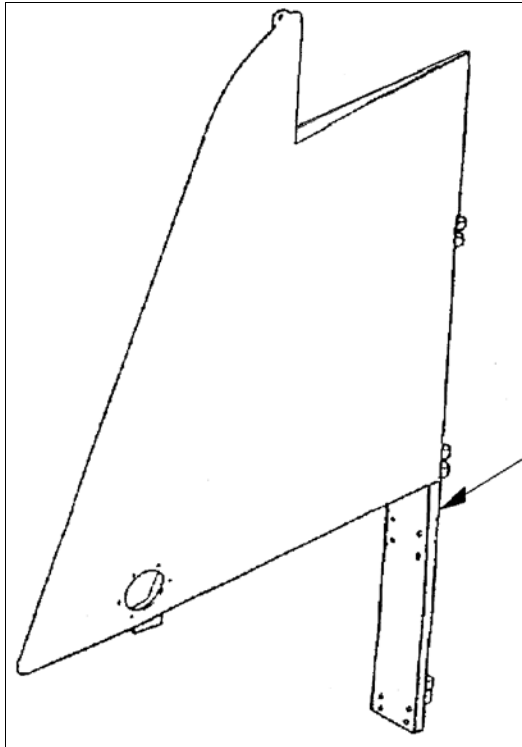
**Figure 45-2: Inspect Vertical Fin Spar Assy., Using a 10X magnifier at the Upper Attach Bolts**

Remove the rudder from the aircraft. Remove vertical fin fairings, dorsal fin if installed, and the top four bolts attaching the aft vertical stabilizer spar to the fuselage frame. Loosen the bottom four bolts attaching the aft vertical stabilizer spar to the fuselage. While in this area, carefully inspect the vertical fin aft spar for cracks, using a 10X magnifier, especially in the area between the top attach bolts and the center rudder hinge (Ref. Fig. 45-2). Repair, replace and/or refinish the aft spar as necessary.

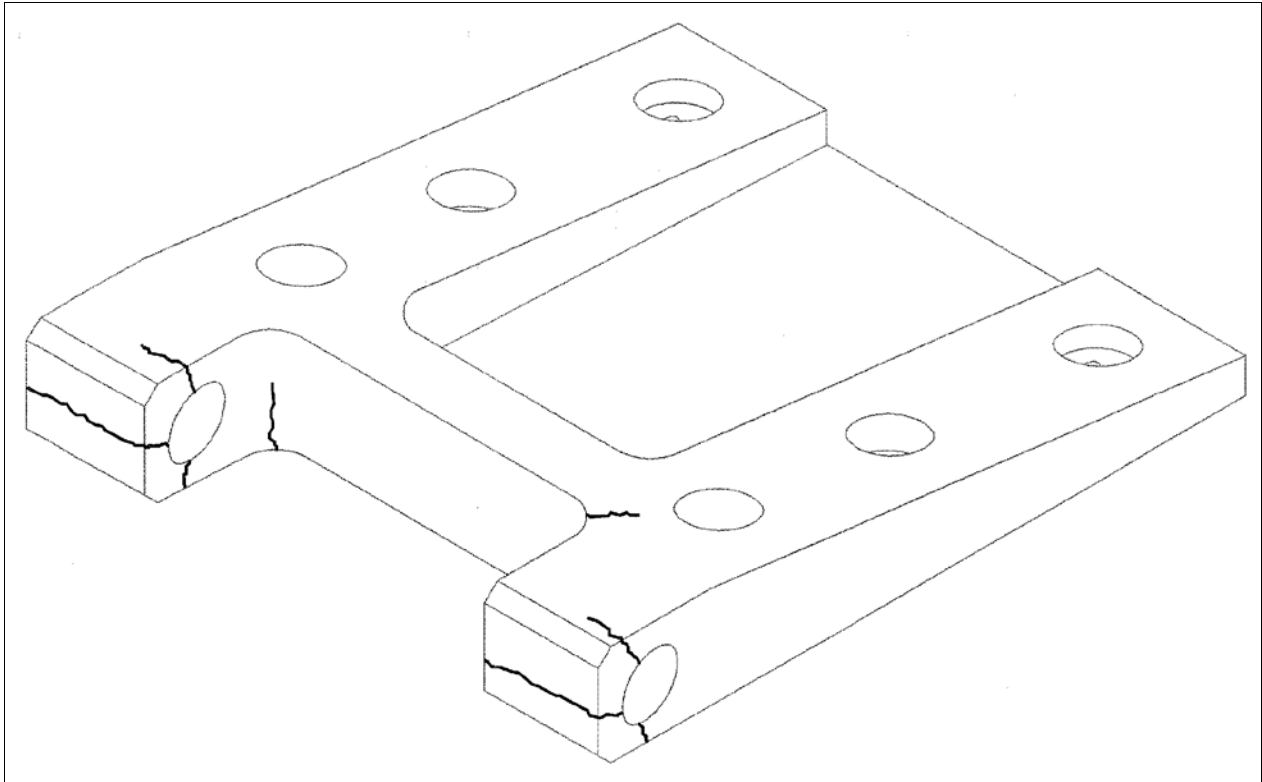
**Figure 45-3: Areas of vertical fin attach fitting to be inspected for cracks**

Remove the bolt holding the horizontal stabilizer attach fitting, 40301-7 (95266-1 for the T660), to the vertical fin\_attach fitting on the horizontal stabilizer. **(This terminology may be confusing. The vertical fin attach fitting is on the horizontal stabilizer, and the horizontal stabilizer attach fitting is on the vertical fin.)** Tilt the vertical fin aft until the inner faces of the horizontal stabilizer attach fitting lugs are easily visible. Block the vertical fin in this position with wood blocks. Using a 10X magnifier, visually inspect both lugs of the vertical fin attach fitting on the horizontal stabilizer and the rest of its exposed surfaces for cracks. If the paint is cracked, discolored or bubbled, remove loose paint prior to inspection, as this can hide cracks or corrosion. Also inspect the inside of the holes as much as possible. See Figure 45-3 for areas most suspect for cracks.

While there have been no reported cracks in the lug of the horizontal stabilizer attach fitting on the vertical fin, 40303-7 or -11 (95267-1 for T660), it too must be thoroughly visually inspected with a 10X magnifier at this time, while it is easily accessible and visible. Cracked, discolored or bubbled paint may indicate hidden corrosion or cracks, and should be removed for further inspection.

Corrosion, as indicated by white powder or scale on the aluminum surface, if found on either fitting, requires the following repair **prior to further flight**. If there is corrosion, there will be stress corrosion, which will eventually lead to failure. The new fittings are much more stress corrosion resistant.

If fittings and bolt are in satisfactory condition, repeat the above inspection at 100 hour intervals until the following repair is accomplished. If bolt, fittings or aft spar is found cracked or deformed, accomplish the following repair **prior to further flight**.
