SERVICE BULLETIN

SB-AG-82

H80 PROPELLER SHAFT CARE

ENGINE – PROPELLER SHAFT – (72-10-00) – Importance of careful handling of propeller shaft during propeller's installation and removal

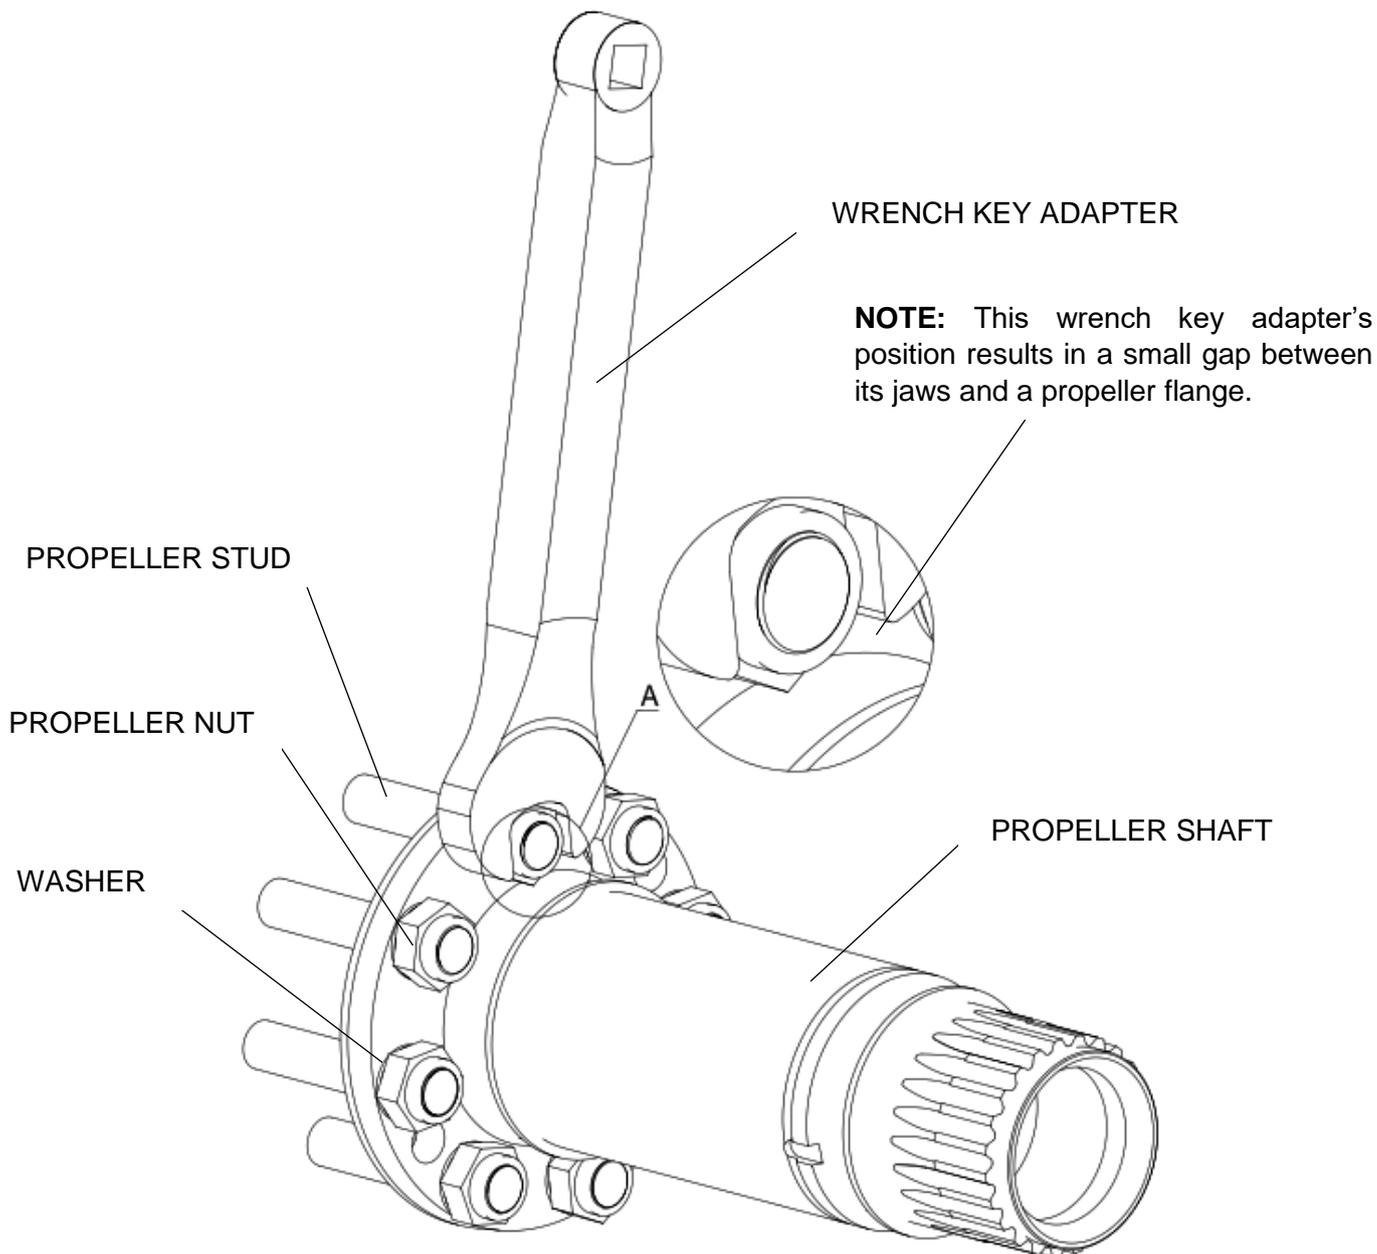
Fig. 1. Correct wrench position – no contact between wrench key and flange

This Non-Modification Service Bulletin informs and provides recommendation for careful handling of the propeller shaft during installation or removal of the propeller. Below drawings show, how to properly use the tooling and avoid damages to the flange area of the propeller shaft.

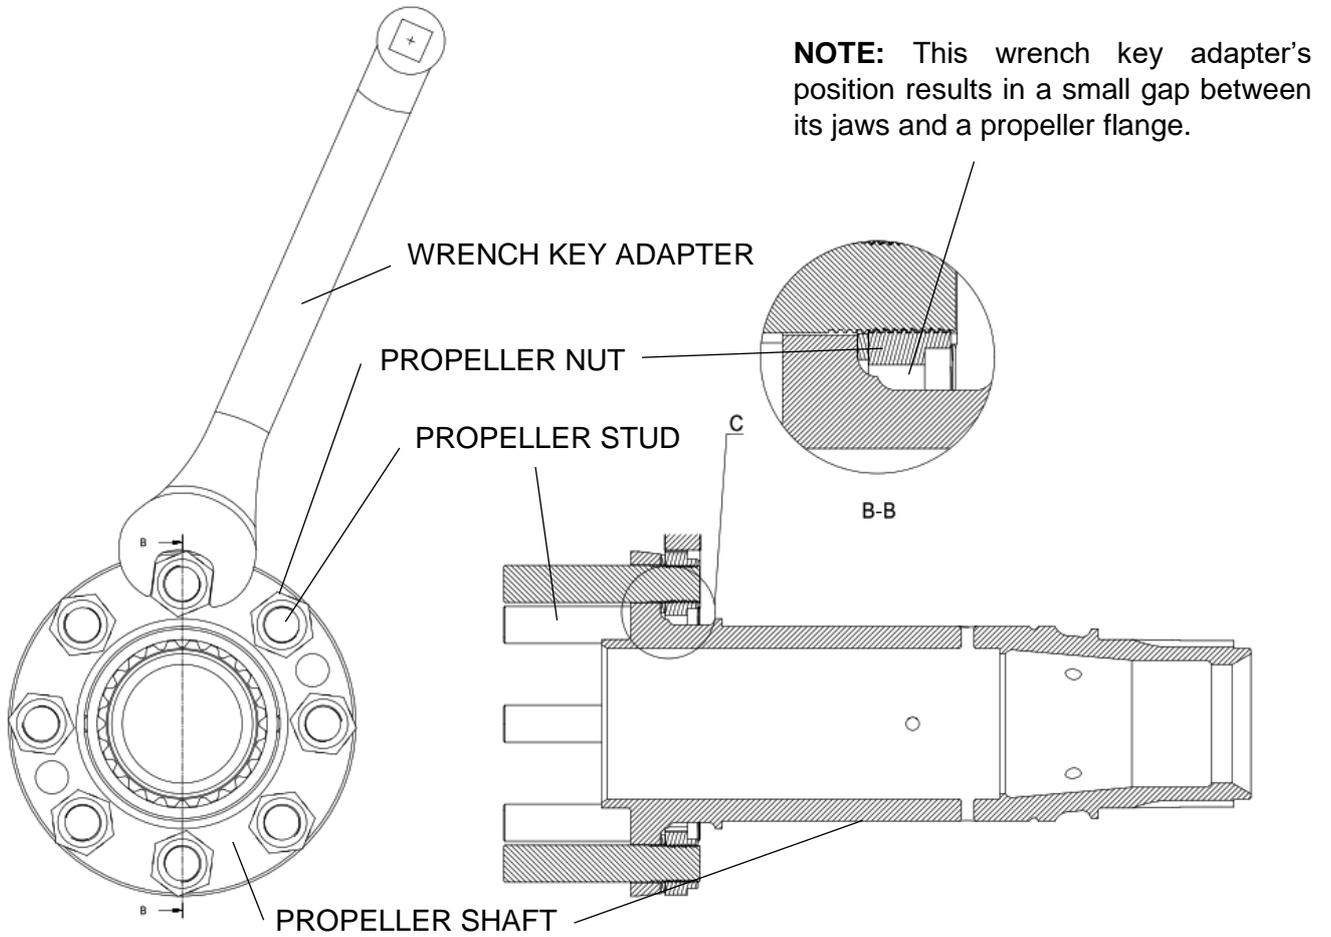
Fig. 2. Correct wrench position – alternate view.

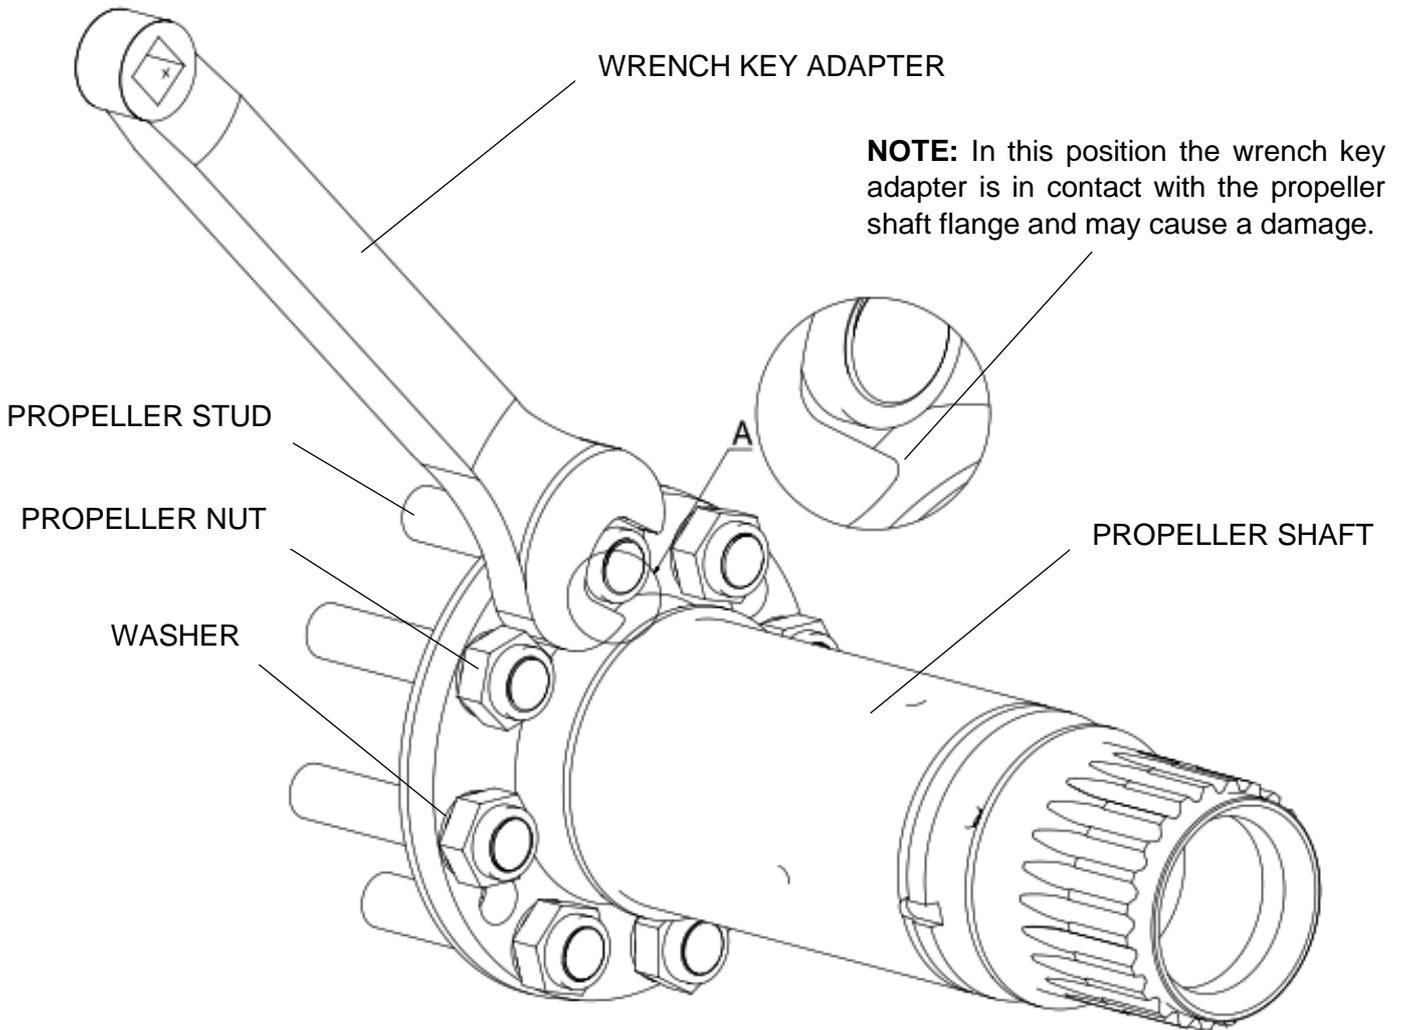
Fig. 3. Incorrect wrench position – contact between wrench key and flange

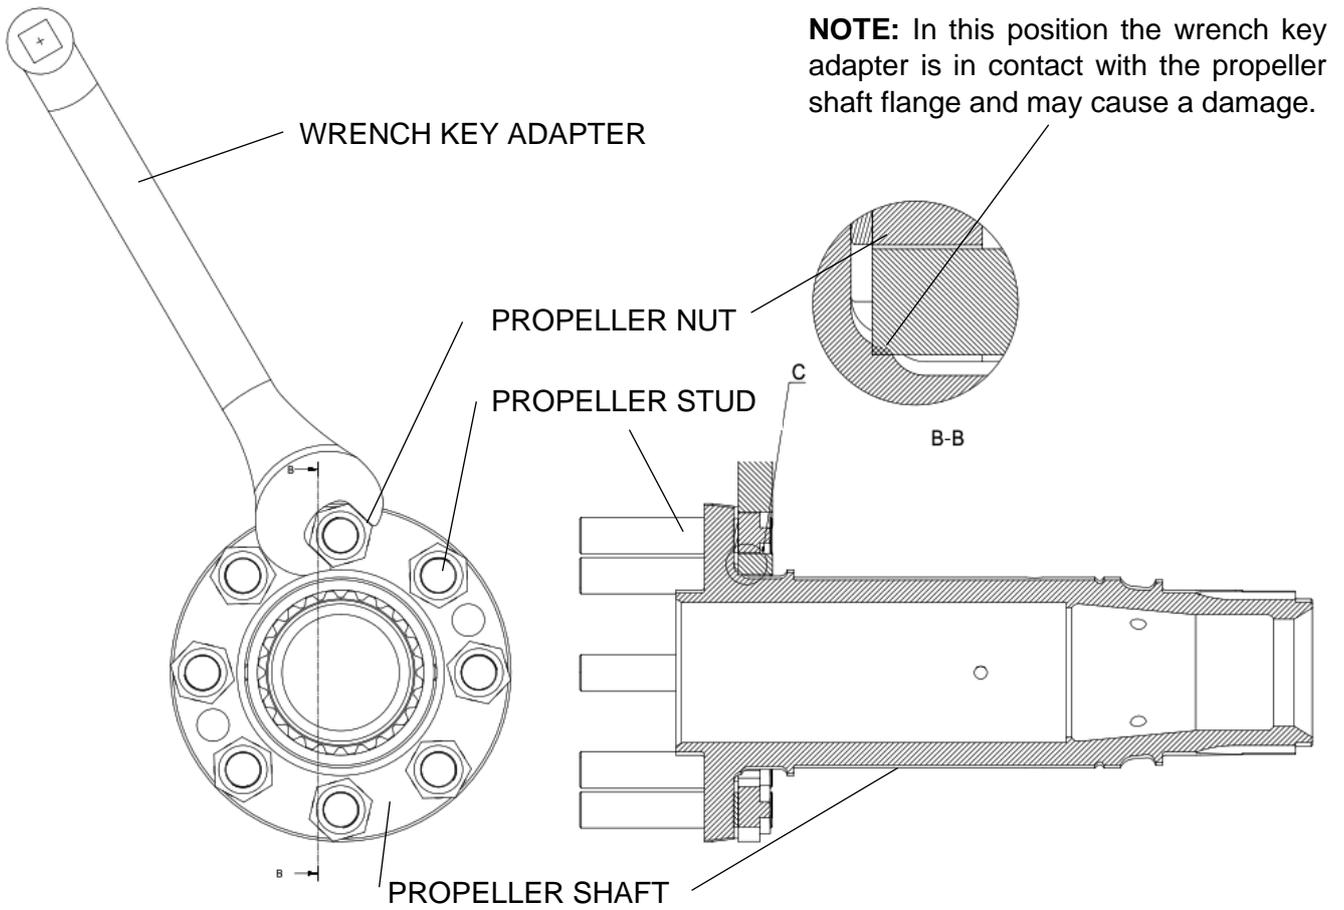
Fig. 4. Incorrect wrench position – alternate view.

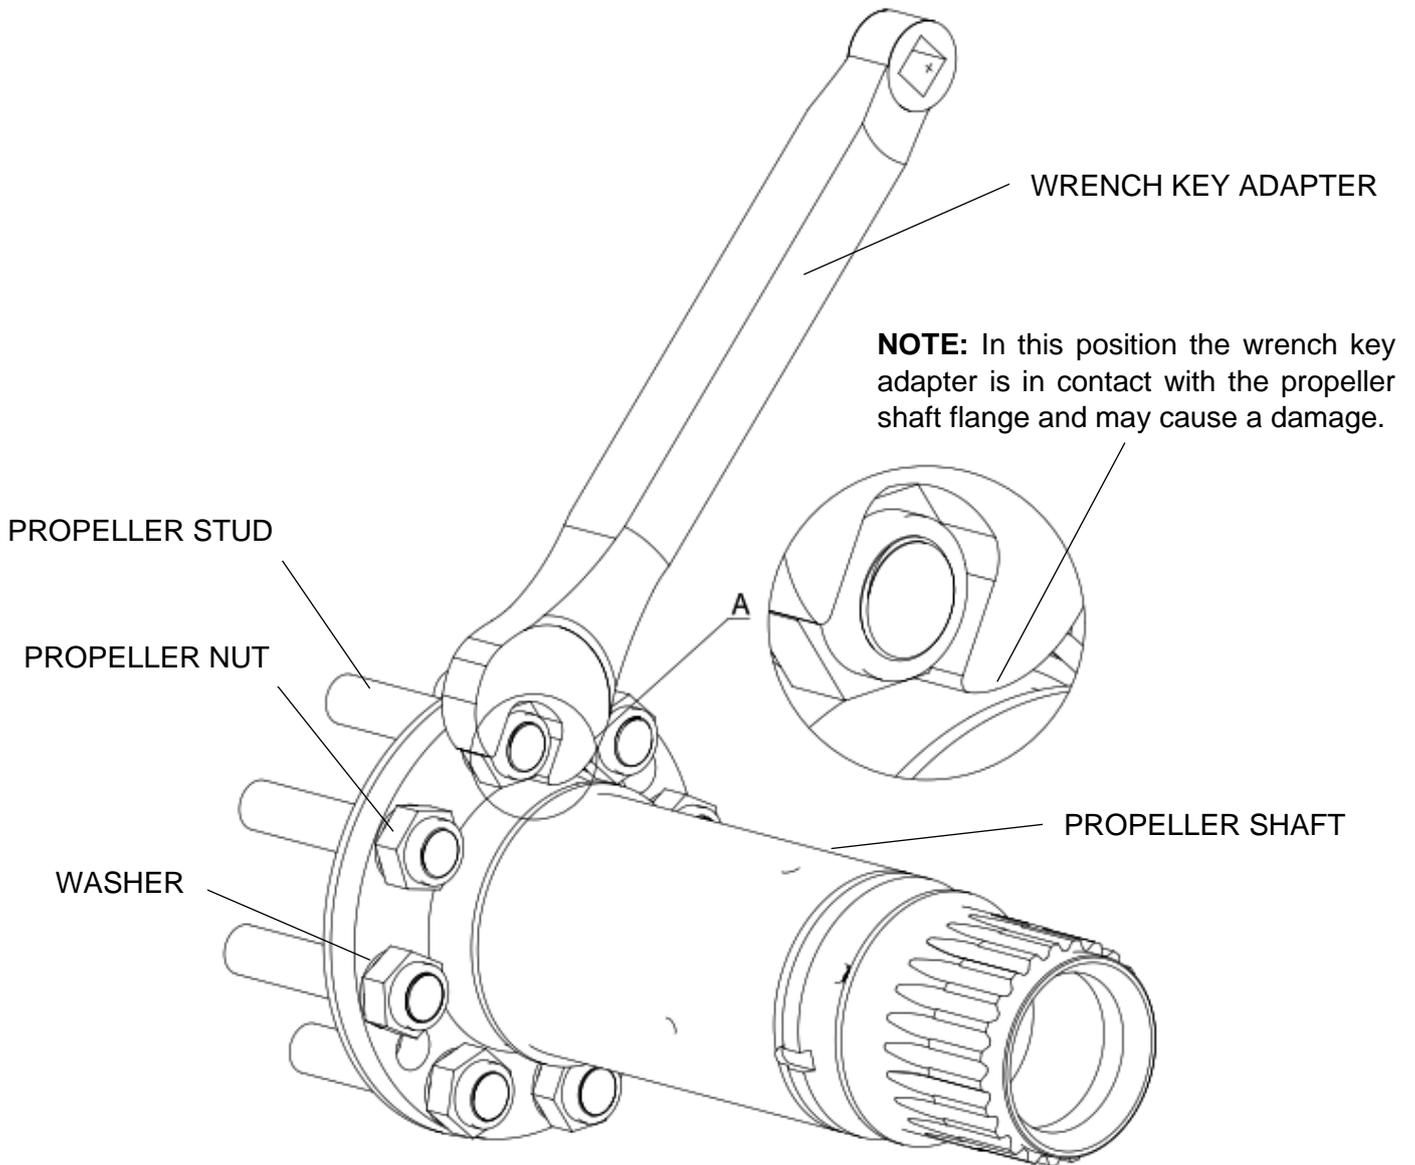
Fig. 5. Incorrect wrench position – contact between wrench key and flange

NOTE: In this position the wrench key adapter is in contact with the propeller shaft flange and may cause a damage.

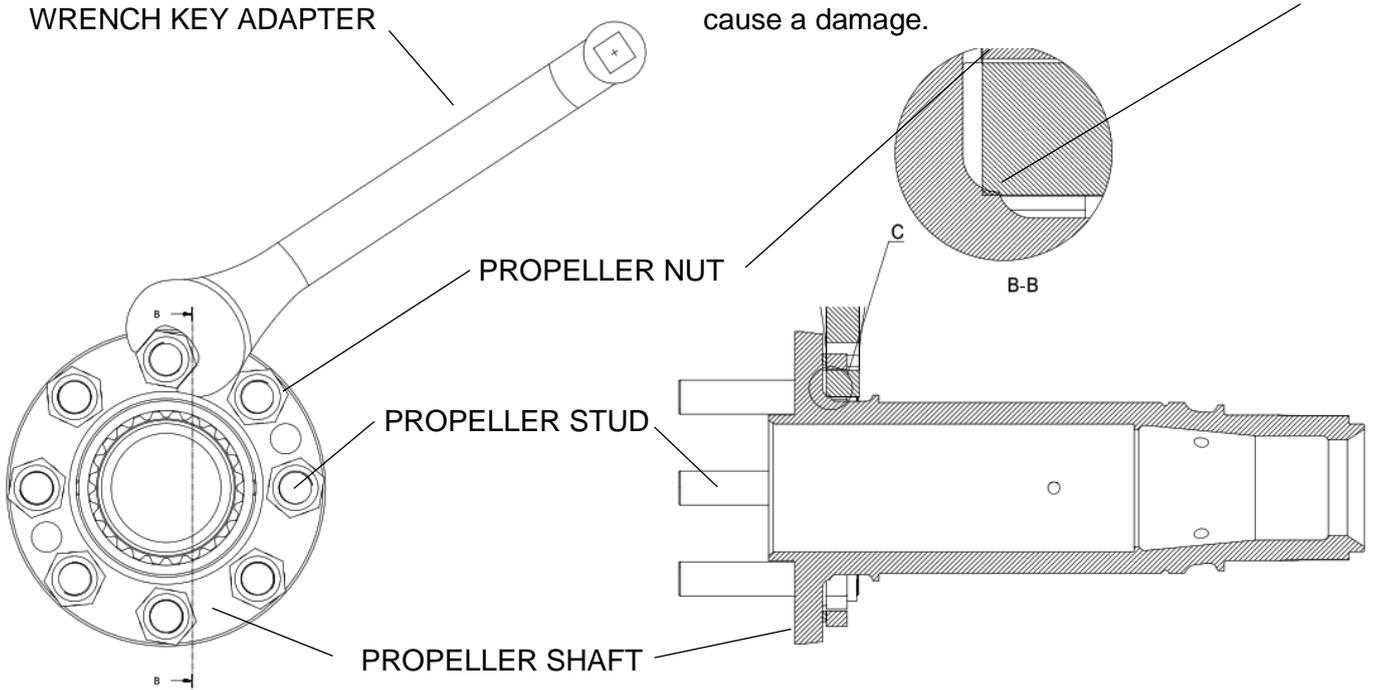
Fig. 6. Incorrect wrench position – alternate view.

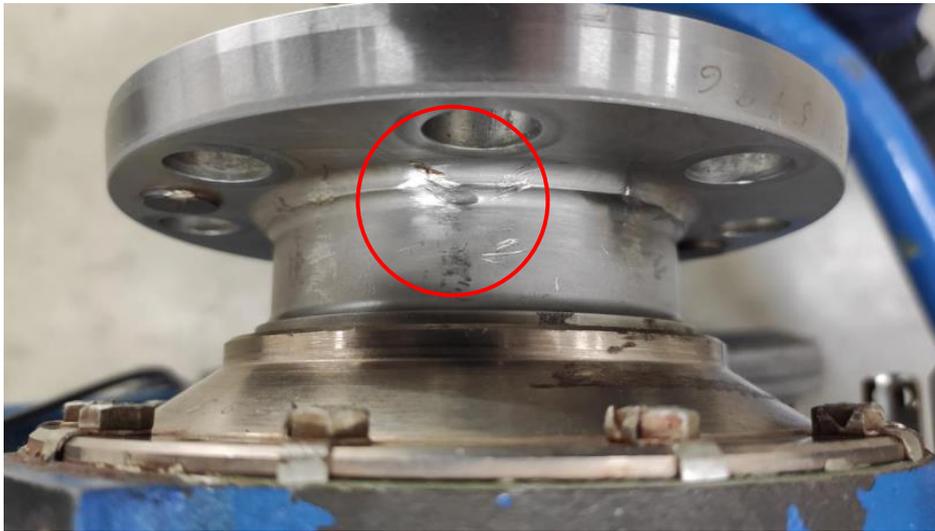
On some engines received for overhaul dents and scratches are found on the propeller shaft in the propeller flange area close to the bolts/nuts, which fix the propeller to the shaft. Investigation indicates that damage may be caused by using unsuitable tooling or improper handling of the tooling.

Inappropriate tools or handling may cause damage shown in the following pictures.

Fig. 7. Possible damage to the propeller shaft, when using tooling improperly.

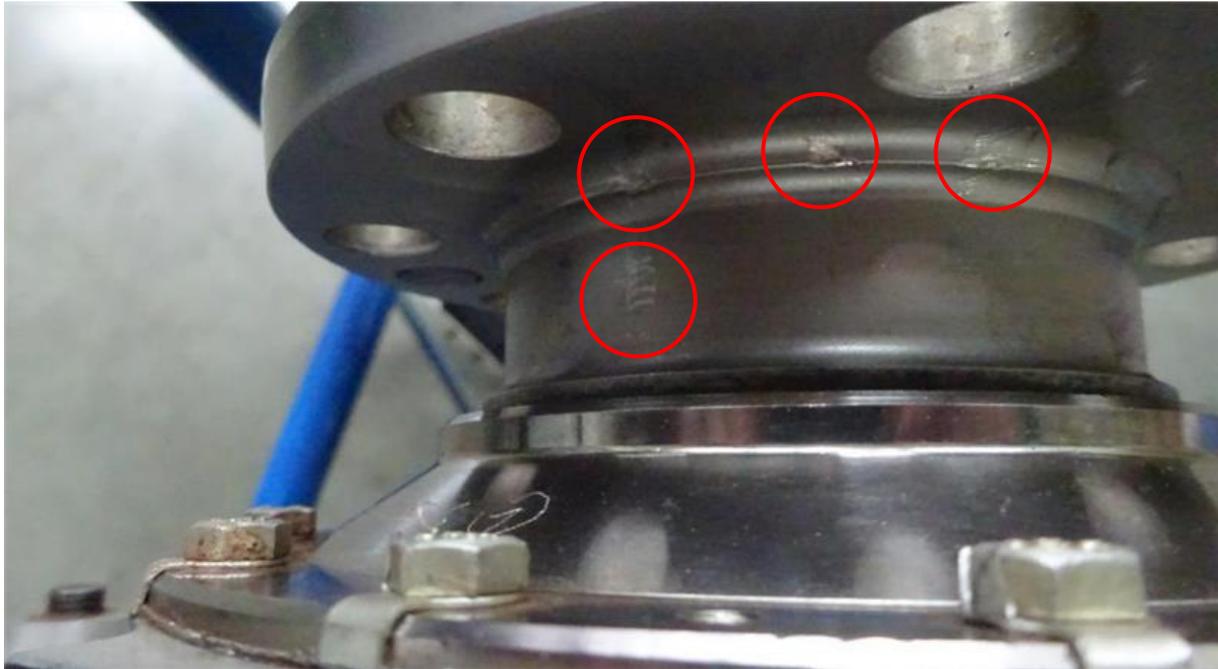
Fig. 8. Possible damage to the propeller shaft, when using tooling improperly.

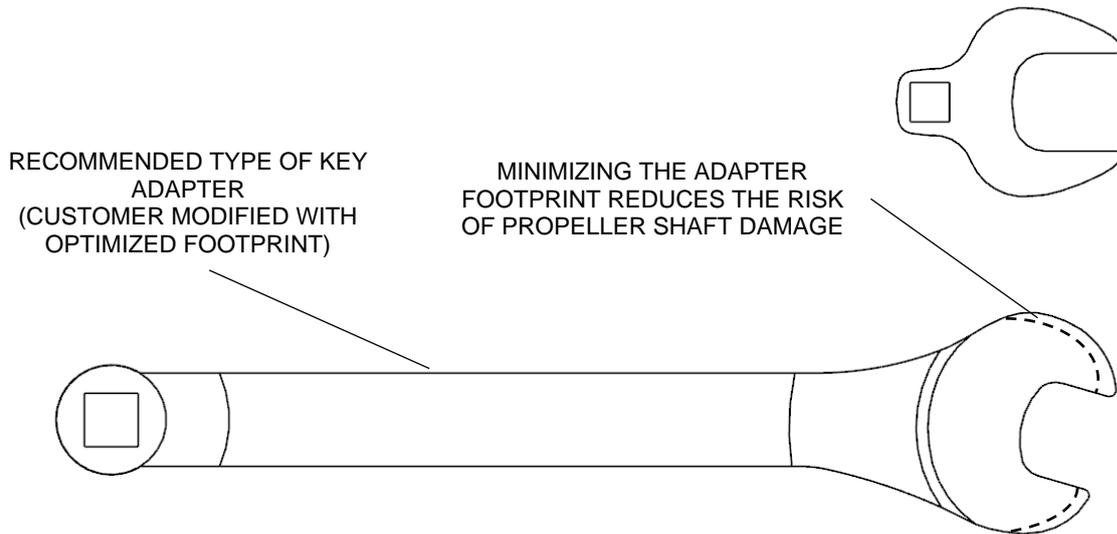
Fig. 10. Comparison of different type of key adapters used for installing and removal of the propeller.

It is important to use adequate tooling. Note for an appropriate length of the wrench key adapter and shape of its jaws.
