FUSELAGE UPPER LONGERON INSPECTION AND REPAIR

MODELS AFFECTED: Model S2R, S/N 1416R thru 2574R
Model S2R-R1340, S/N 1340-001 thru R1340-010
Model S2R-R3S, S/N R3S-001 thru R3S-010

REASON FOR PUBLICATION: Preclude possible fatigue failure of the upper fuselage longeron.

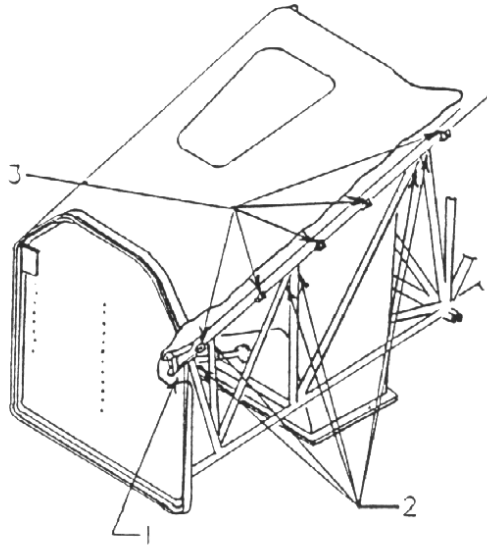
FIGURE 1

1. Remove the fuselage side skin located between the wing upper surface and the hopper. This will provide access to the upper longeron from the firewall to the cockpit.
2. Visually inspect the longeron paying particular attention to: (See Figure 1)
 1. Area around the upper engine mount attach points.
 2. Each vertical diagonal tube intersection at the upper longeron.

3. Each hopper attachment bracket.
3. If no cracks are found, fill out and mail Compliance Card noting that no cracks were found. Proceed to Record Compliance and return aircraft to service.
4. If cracks are found, fill out and mail Compliance Card noting that cracks were found, then proceed to Part II.

- 1. UPPER ENGINE MOUNT ATTACH POINT
- 2. VERTICAL AND DIAGONAL TUBE INTERSECTION
- 3. HOPPER ATTACHMENT BRACKETS
