**THRUSH AIRCRAFT, INC.**

## **SERVICE BULLETIN**

**No. SB-AG-48**

# **FLAP CONTROL TORQUE SHAFT** **REPLACEMENT**

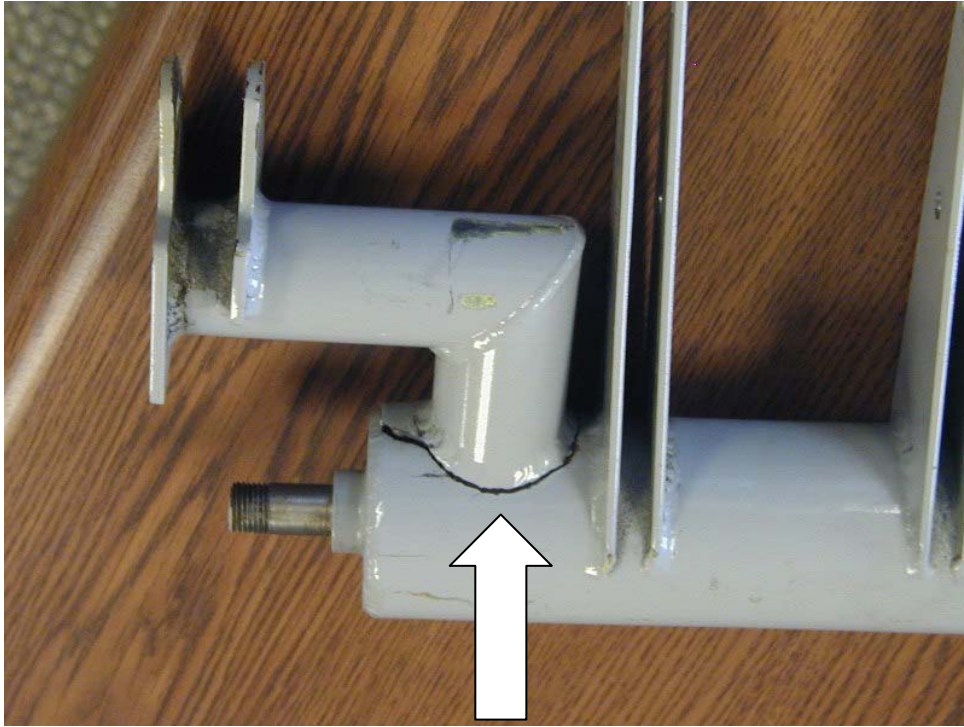
Service Letter SL-AG-108 was issued a year ago because cracks were found on a flap torque shaft assembly P/N 95661-3 where the P/N 95678-1 flap linkage arm welds to the torque shaft. (the problem torque shaft was incorrectly identified as a 95661-1 on SL-AG-108) A similar problem with the same parts was recently reported. Examination of these latest parts makes it evident that the linkage arm joint at the torque tube is not robust enough.

A failure of the linkage arm in flight will cause a sudden roll input, potentially causing an accident. This is especially true when using flaps for a full gross weight take-off. For this reason it is mandatory that the 95661-3 torque shaft assembly be replaced with a strengthened 95661-5 torque shaft assembly.

**Figure 48-1: 95661-3 torque shaft crack at linkage arm**

Repair of a cracked 95661-3 torque shaft is not permitted.

The 95661-3 torque shaft must be replaced by the 95661-5 torque shaft within 200 flight hours of receipt of this service bulletin.

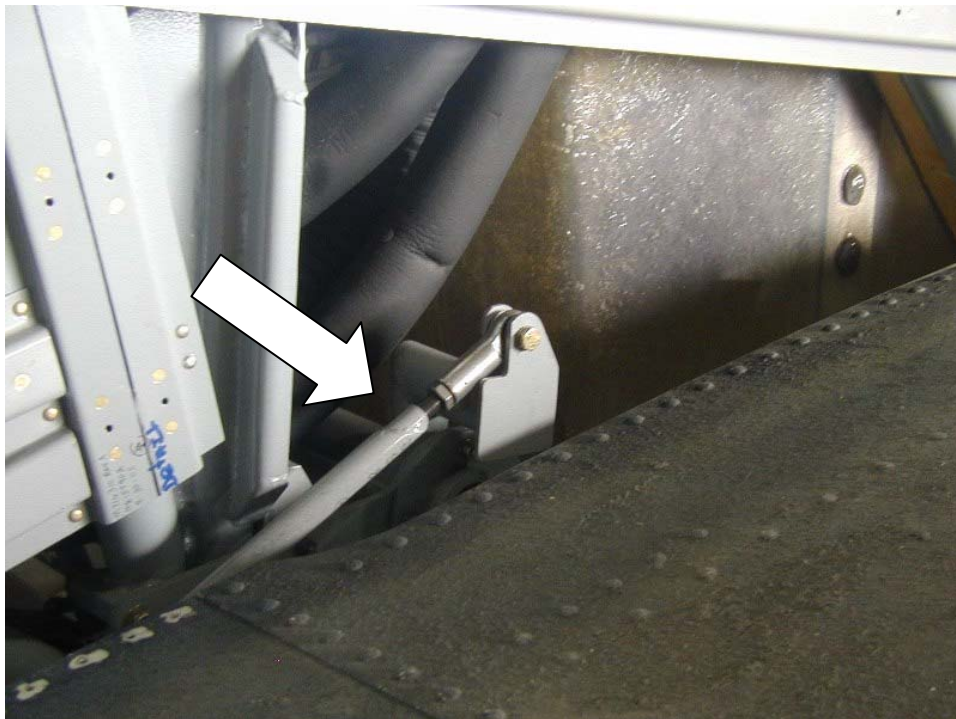
**Figure 48-2: Inspection location for right end of torque shaft. Left opposite.**

Inspection requires the removal of wing root fairings and cockpit side skins on both sides of the aircraft, in order to have clear access to the torque shaft assembly. Carefully inspect the weld junction of the flap linkage arm to the torque shaft on both sides of the aircraft.

Cracked, bubbled or discolored paint in the vicinity of the weld must be removed with paint stripper and the weld visually inspected with a minimum 5 power magnifying glass. If a crack is found, the torque shaft must be replaced with the new 95661-5 torque shaft prior to further flight.
