THRUSH AIRCRAFT, INC.

SERVICE BULLETIN

No. SB-AG-50

PT6A-60AG P3 LINE CHAFING

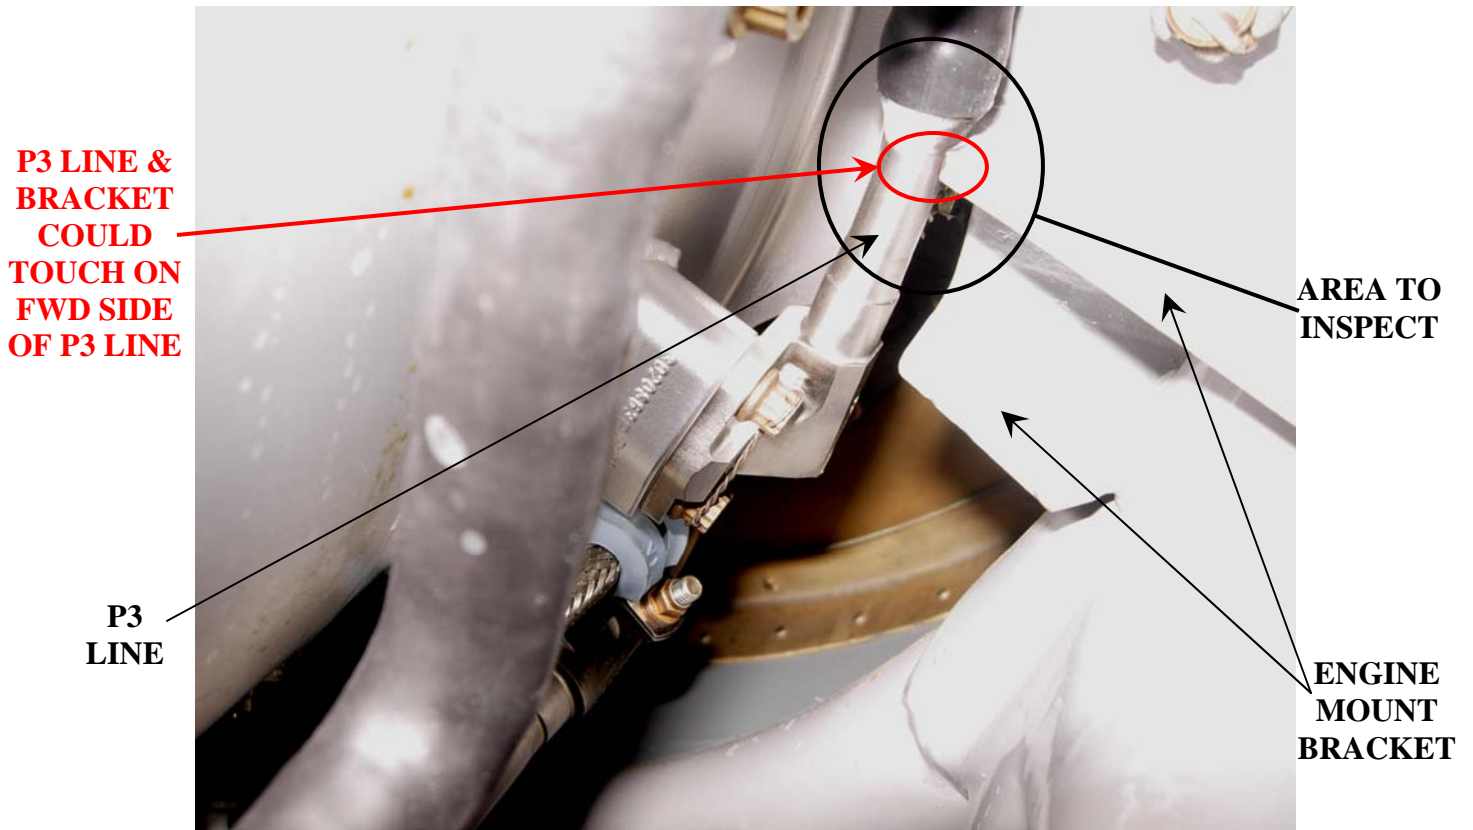
FIGURE 50-1: P3 Line and Lower Right Engine Mount Bracket
View looking up from behind mount ring

A case has been reported of the P3 line on a Pratt & Whitney PT6A-60AG engine chafing on the aft side of the lower right hand (as seen from cockpit) engine mount bracket. The chafing had nearly worn through the P3 line.

Locate the P3 line attached to the engine case slightly aft of the lower right engine mount bracket (ref. Figure 50-1). The P3 line runs circumferentially counter-clockwise from the engine case pressure tap, turns aft through the fireseal and then goes to the fuel control.

Because of the location of the P3 line pressure tap on the engine case, the P3 line passes close to the aft side of the lower right engine mount bracket (specifically the stiffening flanges pointing aft).

Check to see that the P3 line is no closer than .20" to any part of the lower right engine mount bracket. If the P3 line meets this requirement, you need only log compliance with Thrush Aircraft, Inc. Service Bulletin SB-AG-50 in the airplane maintenance log and fill out and mail the compliance record back to Thrush Aircraft, Inc.
