# Rockwell service letter No. SL-AG-64

Service Letter No. SL-AG-64  
March 9, 1971

### ELEVATOR TRIM TAB MECHANISM

**EFFECTIVITY:** Aero Commander Model S-2R Thrush, Serial No. 1416R thru 1580R

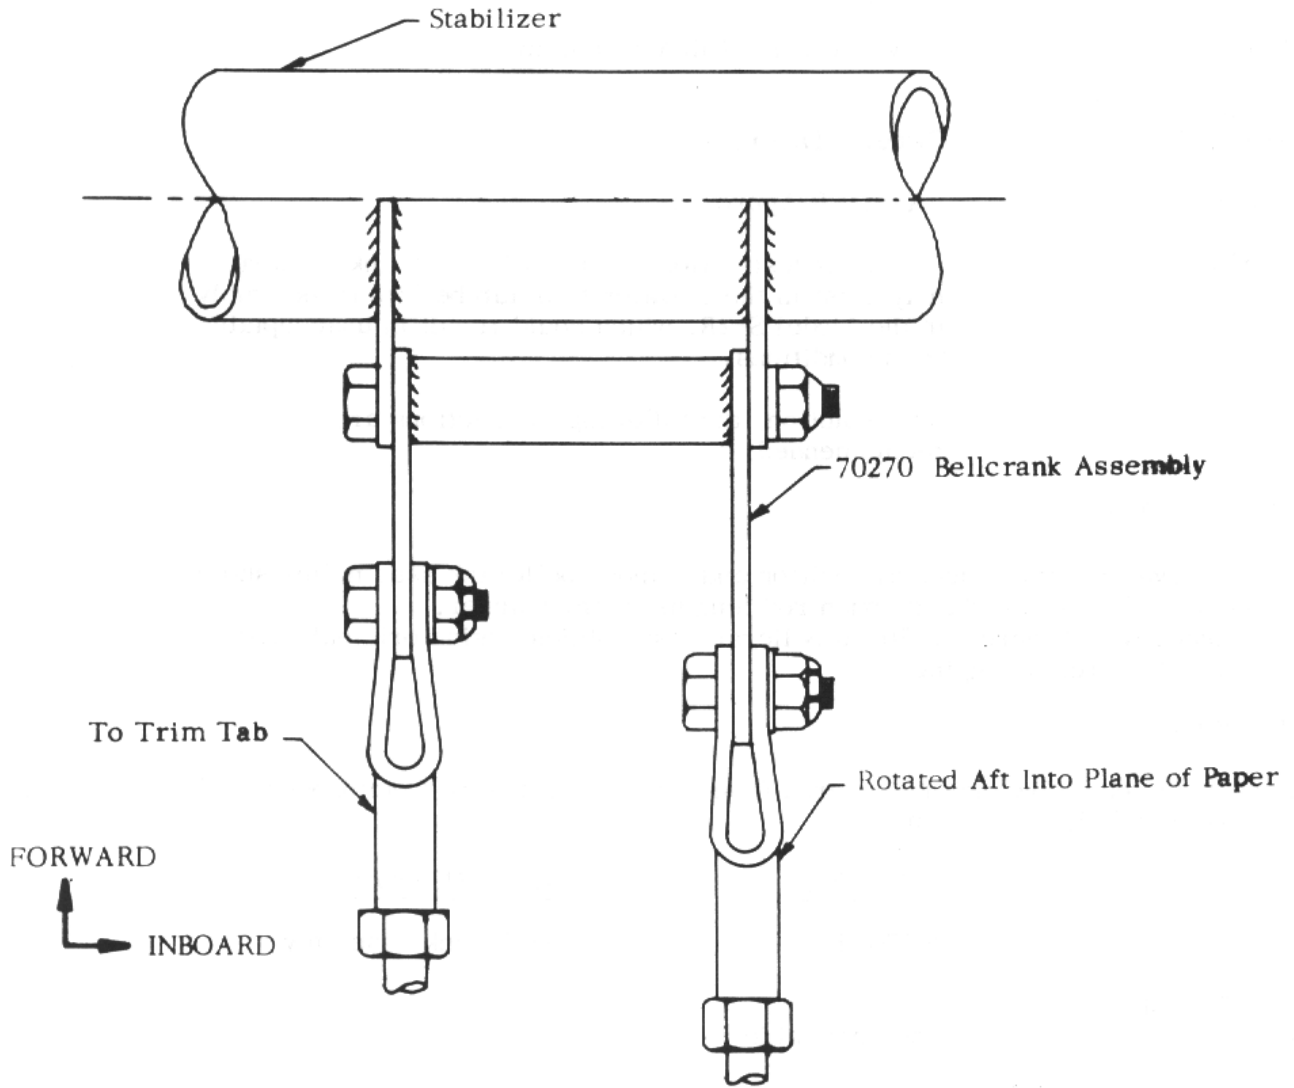
VIEW LOOKING DOWN  
(L.H. SHOWN - R.H. OPPOSITE)

**REASON FOR PUBLICATION:** Service investigation has revealed that linkage wear may exist in the elevator trim tab bellcrank assembly in the Model S-2R, which could result in unacceptable trim conditions.

1. Set elevator trim in neutral position and remove bellcrank assemblies shown on Sheet 2. Do not change push rod lengths in any manner.
2. Replace with (improved) 70270 bellcrank assemblies, using original hardware.
3. Check for proper rigging.
