Rockwell service letter No. SL-AG-75

Service Letter No. SL-AG-75
October 1, 1975

CARBURETOR AIR BOX CONTROL CABLE CLAMP REPLACEMENT

MODELS AFFECTED: MODEL S-2R, S/N 5000R thru 5082R.

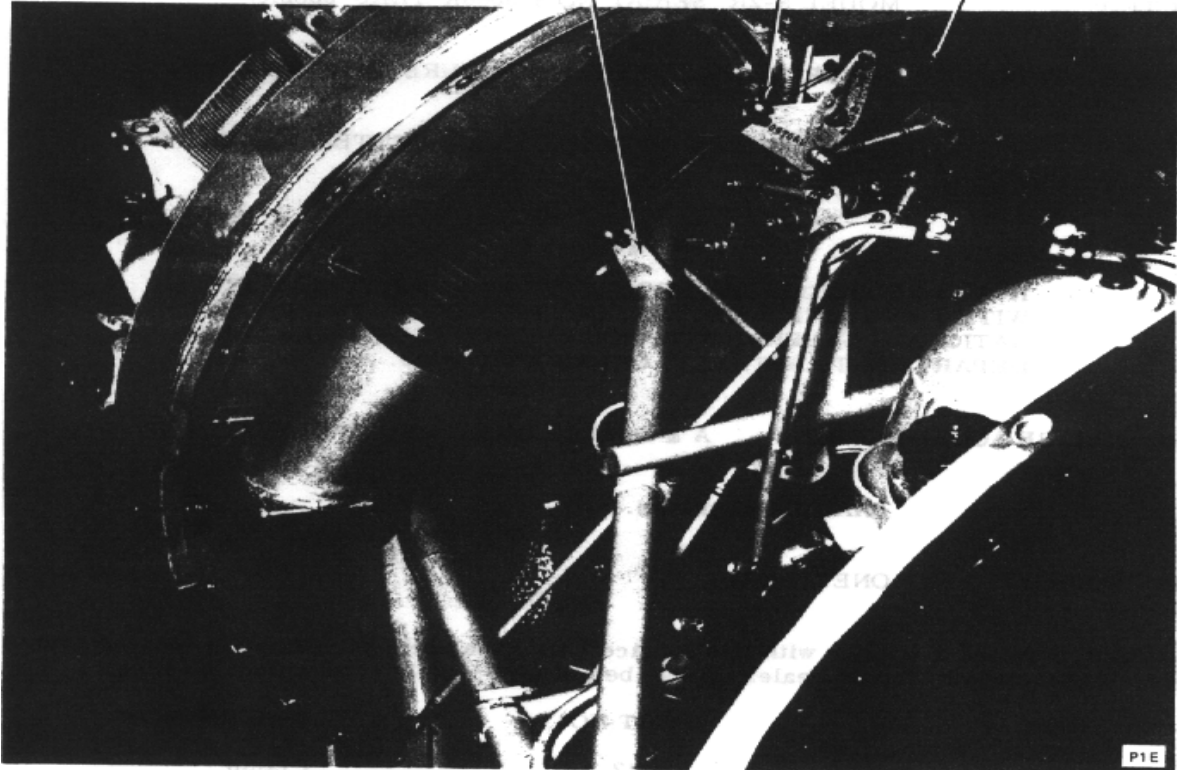
Figure 1.

REASON FOR PUBLICATION: Prevent movement of carburetor air valve.

1. Remove upper engine cowling.
2. Remove and discard existing lower clamp and bracket from carburetor air box control cable (see Figure 1.).
3. Remove and discard existing upper clamp from carburetor air box control cable and install AN742-4F clamp using existing hardware (see Figure 1.).
4. Reinstall upper engine cowling.

REMOVE AND DISCARD
EXISTING CLAMP AND BRACKET

REMOVE EXISTING CLAMP
AND INSTALL AN742-4F CLAMP
USING EXISTING HARDWARE
