Rockwell service letter No. SL-AG-77

Service Letter No. SL-AG-77
30 January, 1976

CARBURETOR AIR INLET SCOOP ASSEMBLY REPLACEMENT

MODELS AFFECTED: MODEL S-2R, S/N 5000 thru 5082.

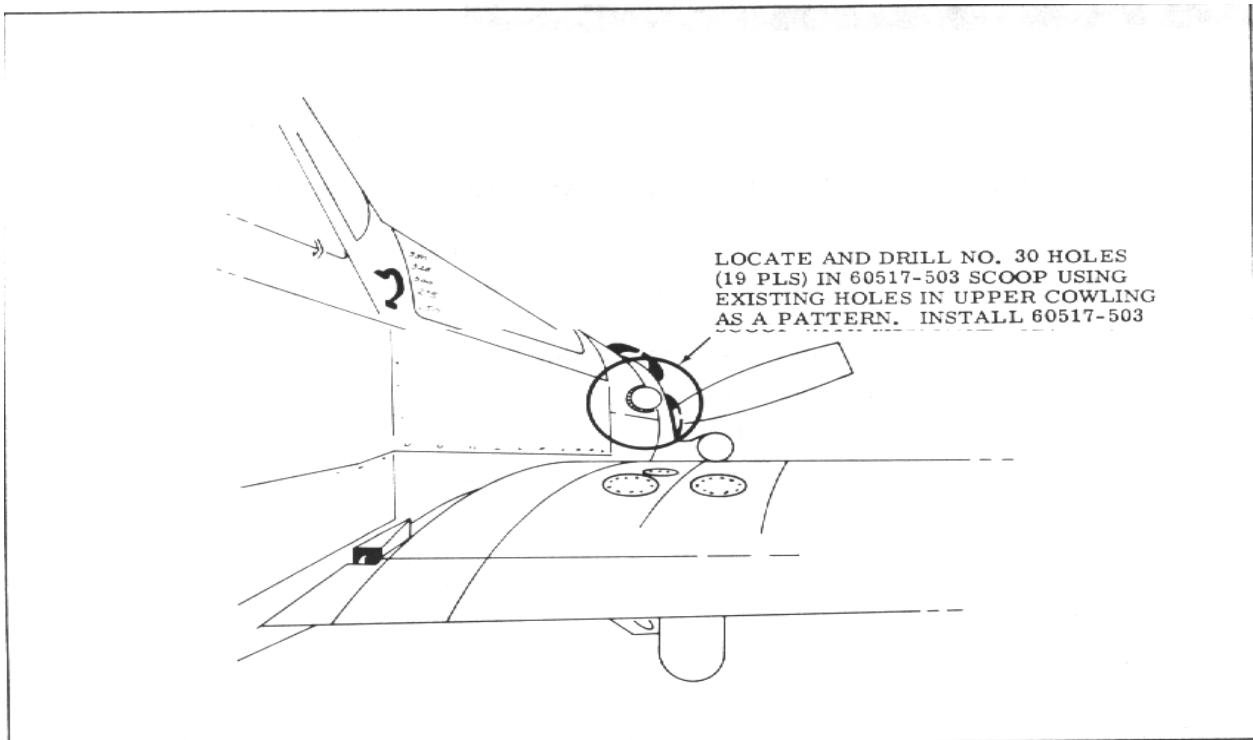
REASON FOR PUBLICATION: Provide an improved carburetor air inlet scoop.

1. Inspect existing carburetor air inlet scoop, located on right side of upper engine cowling, to assure scoop installed is manufactured from aluminum material.
2. If scoop is manufactured from aluminum material, proceed to RECORD COMPLIANCE.

3. If scoop is manufactured from fiberglass material, proceed to step 4.
4. Remove upper engine cowling.
5. Remove and discard existing carburetor air inlet scoop from upper engine cowling.
6. Locate, drill and install 60517-503 scoop picking up existing holes in upper engine cowling (see Figure 1.).
7. Reinstall upper engine cowling.
8. Fill out and mail Compliance Card.
