Rockwell service letter No. SL-AG-90

Service Letter No. SL-AG-90
8 February, 1977

ELEVATOR TRIM TAB PUSH-ROD REPLACEMENT

MODELS AFFECTED: S-2R, S/N 1416 thru 2240 AND 5000 thru 5082.

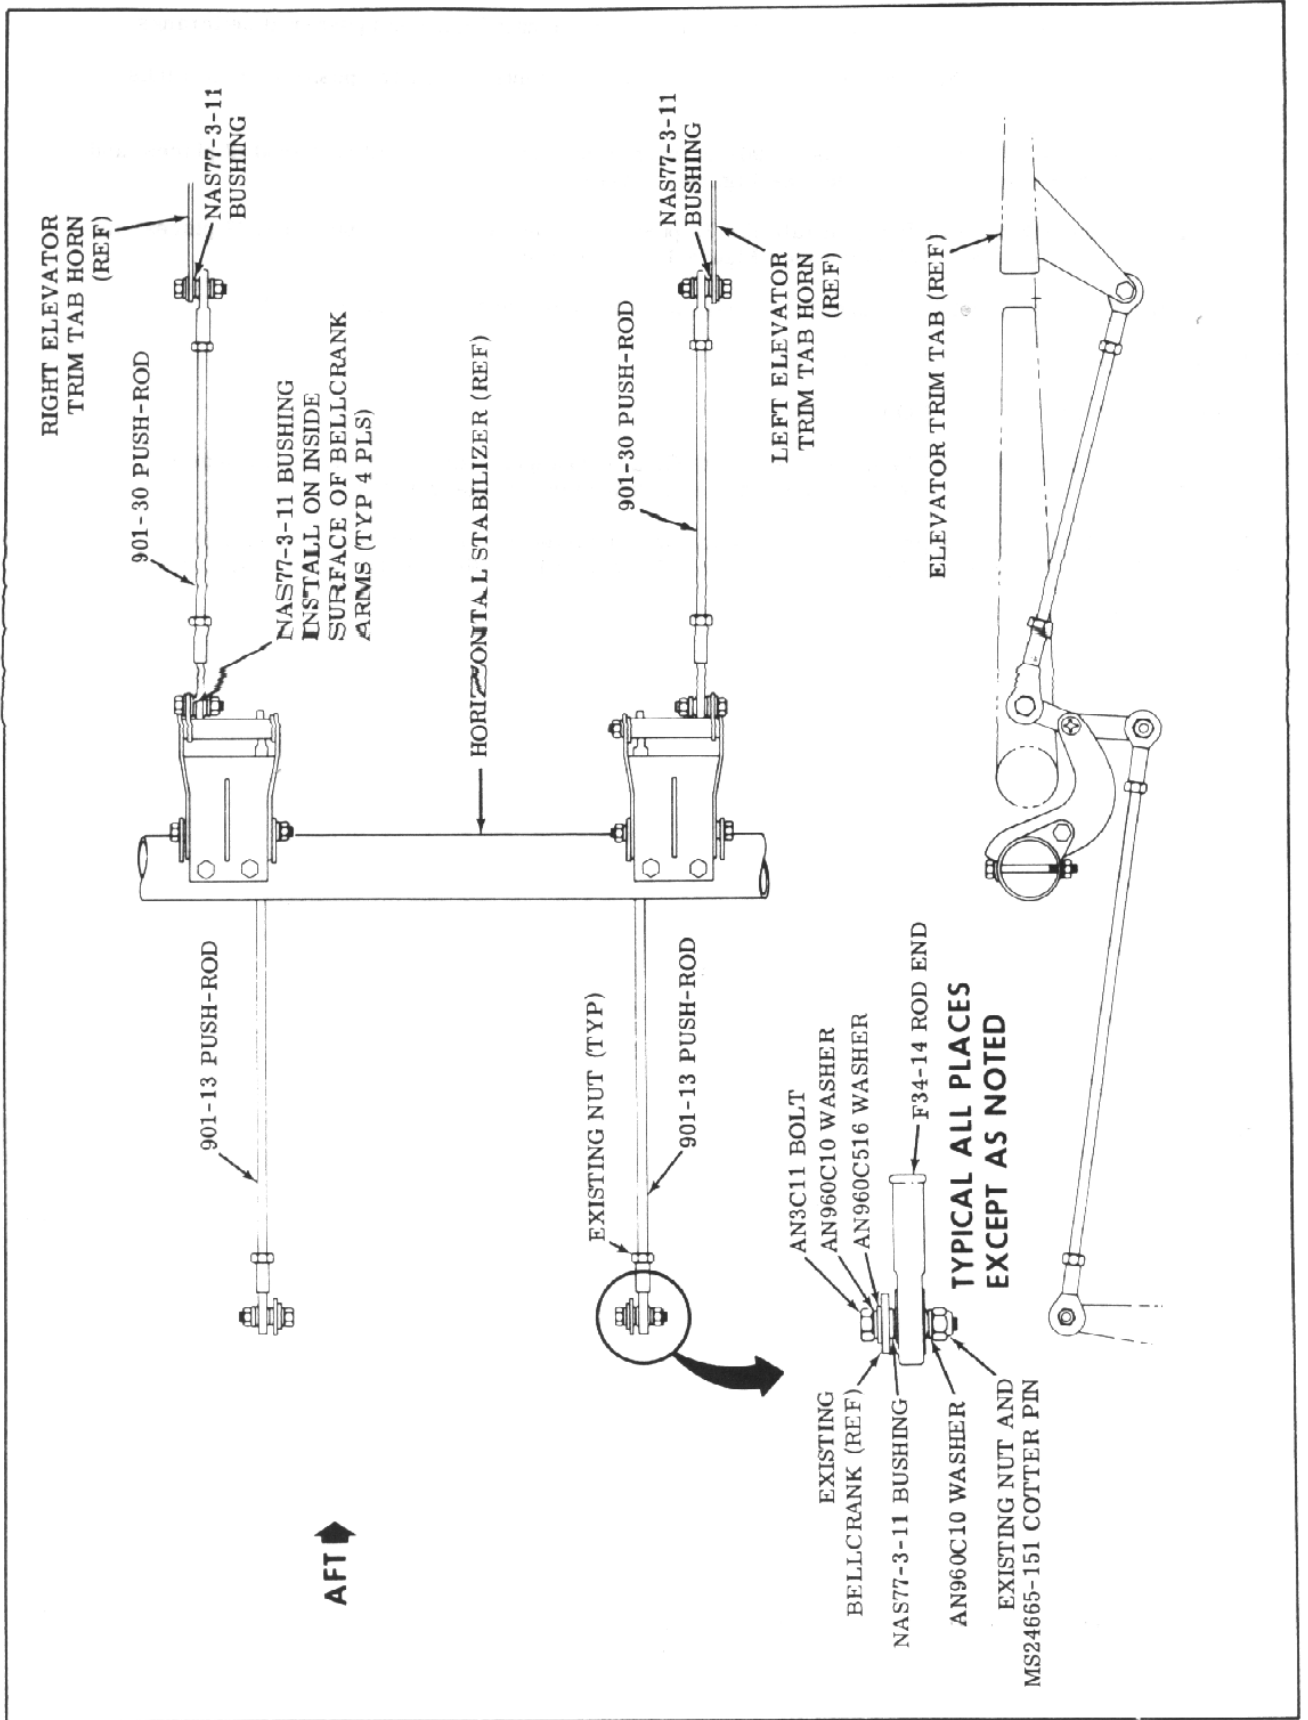
REASON FOR PUBLICATION: Attach hole in elevator tab horn may elongate in service. This service letter is being issued to alleviate this situation.

- 1 Remove and discard existing trim tab push-rods (4 places), existing push-rod clevises (8 places) and existing attaching bolts and cotter pins.

- 2 Remove and discard existing bushing from elevator trim tab control horn and push-rod bellcranks.
- 3 Press fit NAS77-3-11 bushing (8 places) on elevator trim tab control horn and push-rod bellcranks (See Figure 1.).
- 4 On Serial numbers 1416 thru 2240, install 901-31 push-rod (2 places), 901-32 push-rod (2 places) and F34-14 rod end (8 places) on airplane (see Figure 1., Sheet 1 of 2).
- 5 On Serial numbers 5000 thru 5082, install 901-13 push-rod (2 places), 901-30 push-rod (2 places) and F34-14 rod end (8 places) on airplane (see Figure 1., Sheet 2 of 2).
6. Rerig elevator trim travel as outlined in the Airplane Maintenance Manual, Section VII.
