# SERVICE LETTER

## SL-AG-133

## ALL S2R MODELS

## Aileron Bell Crank Support Tubes Inspection

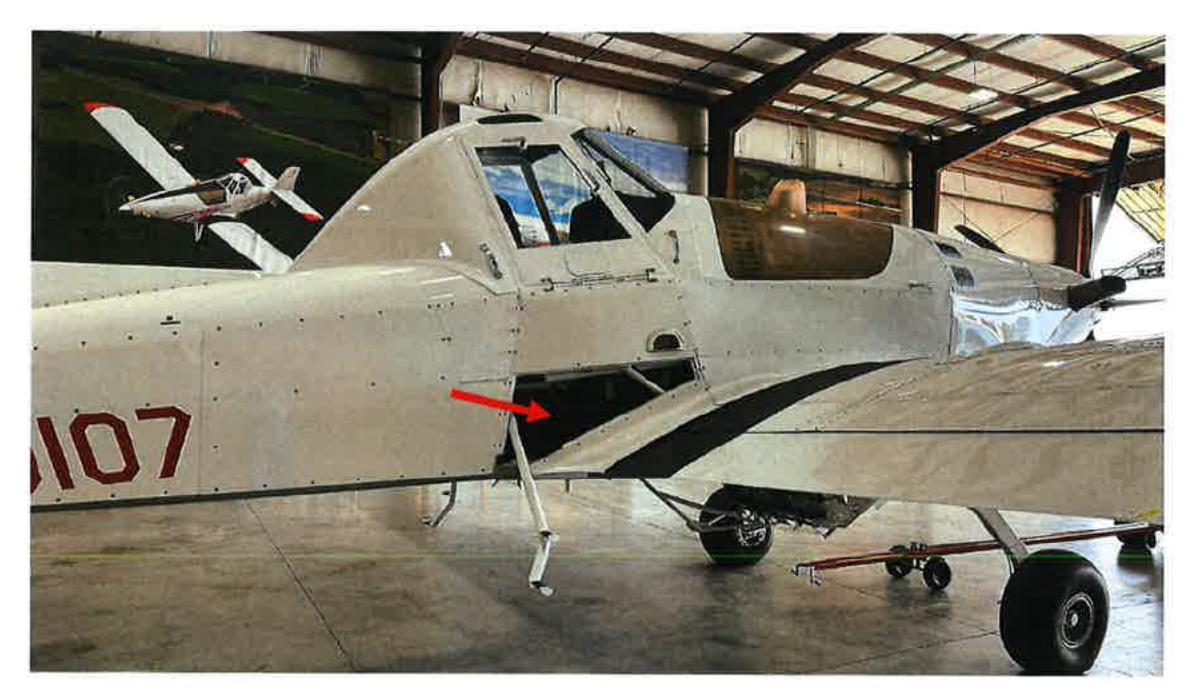
Figure 3.1.1

Remove panel from right-hand (RH) side of aircraft, located below cockpit and above aft wing fairing.

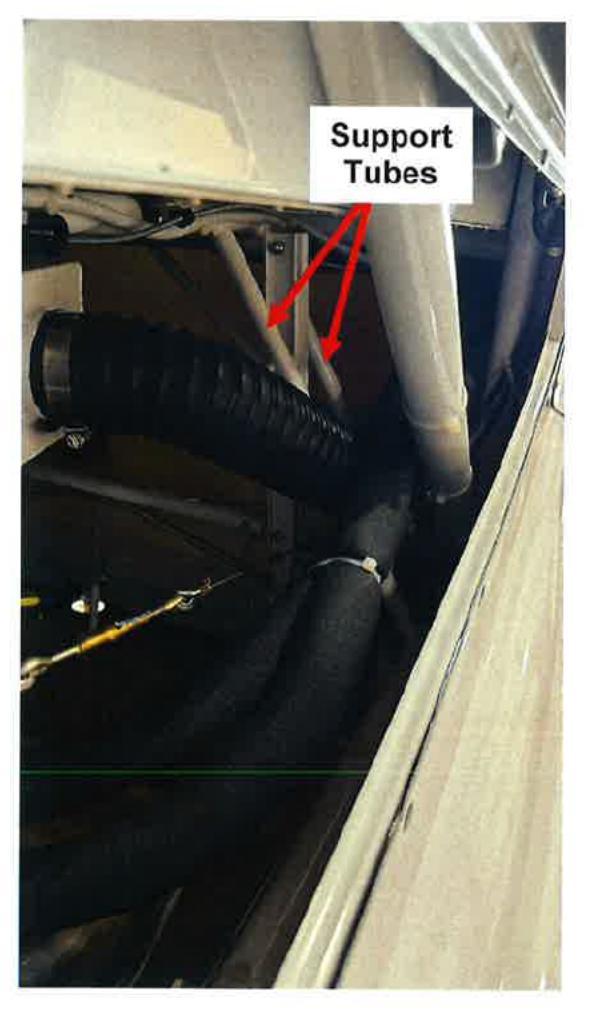
Figure 3.1.3

Thrush has been notified by one or more operator(s) of a crack that has developed on the aileron bell crank support tubes after hours of flight.

• Visually inspect both aileron bell crank support tubes entirely, especially each weld joint.

If cracks or any other damage is found, please send an email to <u>support@thrushaircraft.com</u>. Also, please fill out and return the Compliance Report, located on the next page.
