CUSTOM KIT

CK-AG-49

Step Upgrade

S2R-T34

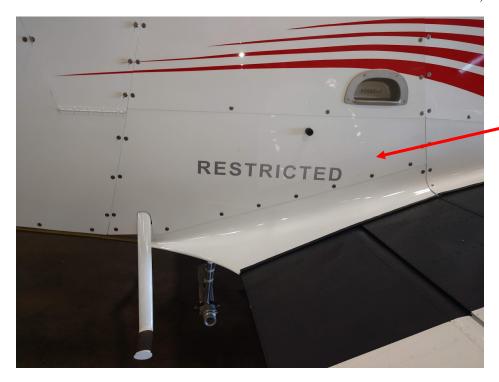
Figure 1: Lower Side Skin Removal (R/H Shown)

- 1. Make sure Aircraft is in a Secure and Stable position with wheels chocked.
- 2. Remove Lower Side Skin (R/H Shown in Figure 1) 11003T001.

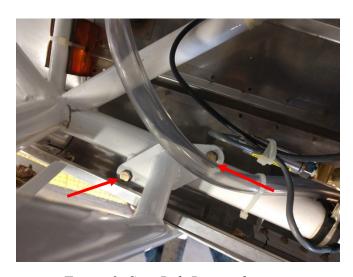
Figure 2: Step Bolt Removal

3. Using 7/16" wrenches, remove the steel step bolts from 3 places (Figures 2 and 3). Access to the head of the upper bolt is inside the cockpit.

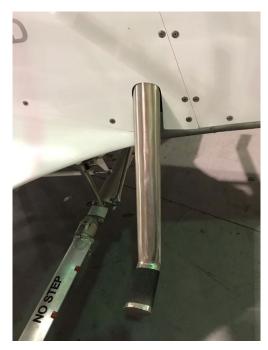
Figure 6: Step Assembly installed on Aurcraft

- 7. IF CONFIDENT in hole location, drill the upper flange to .25" and deburr.
- 8. Install new step to fuselage (3 places). Torque bolts to 50-70 In/Lbs.
- 9. Install skin and mark area around step to be trimmed. If you find the gap to be excessive, scrap and replace the skin.
- 10. Trim the area around the step to prevent chaffing and corrosion. Leave approximately 1/8" ½" of space. Refer to Figure 6. If needed, deburr, prime and paint trimmed edges with Polyurethane.
