# SERVICE BULLETIN

## SB-AG-93

### VERTICAL STABILIZER FWD ATTACH FITTING INSPECTION & FASTENER REPLACEMENT

| Affected Aircraft Models | Serial Number Range |
|---|---|
| S2R-T660 | -197 & PRIOR |

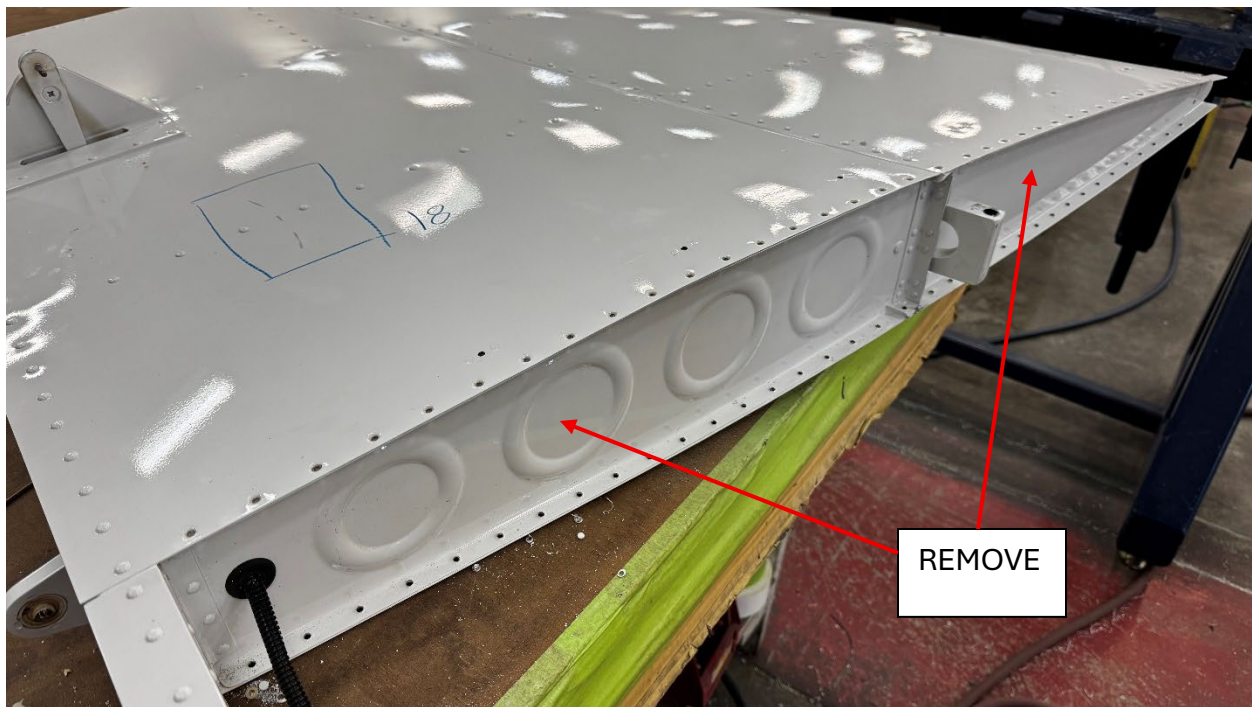
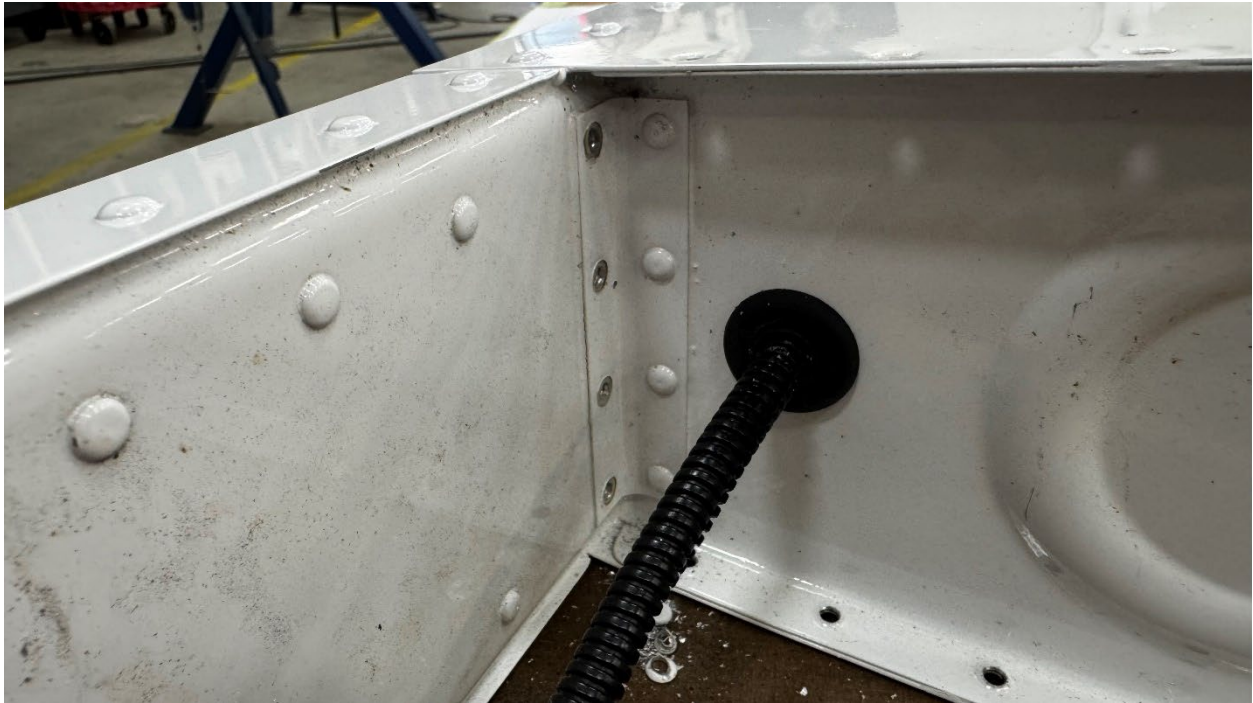
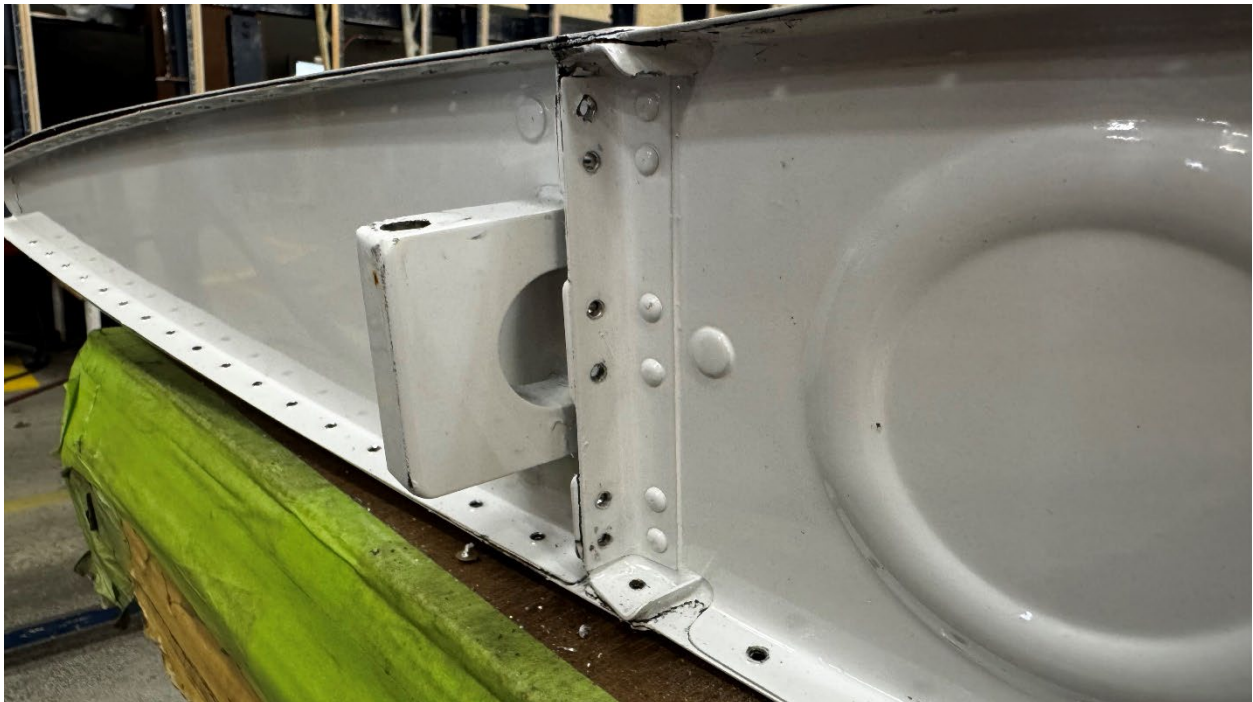
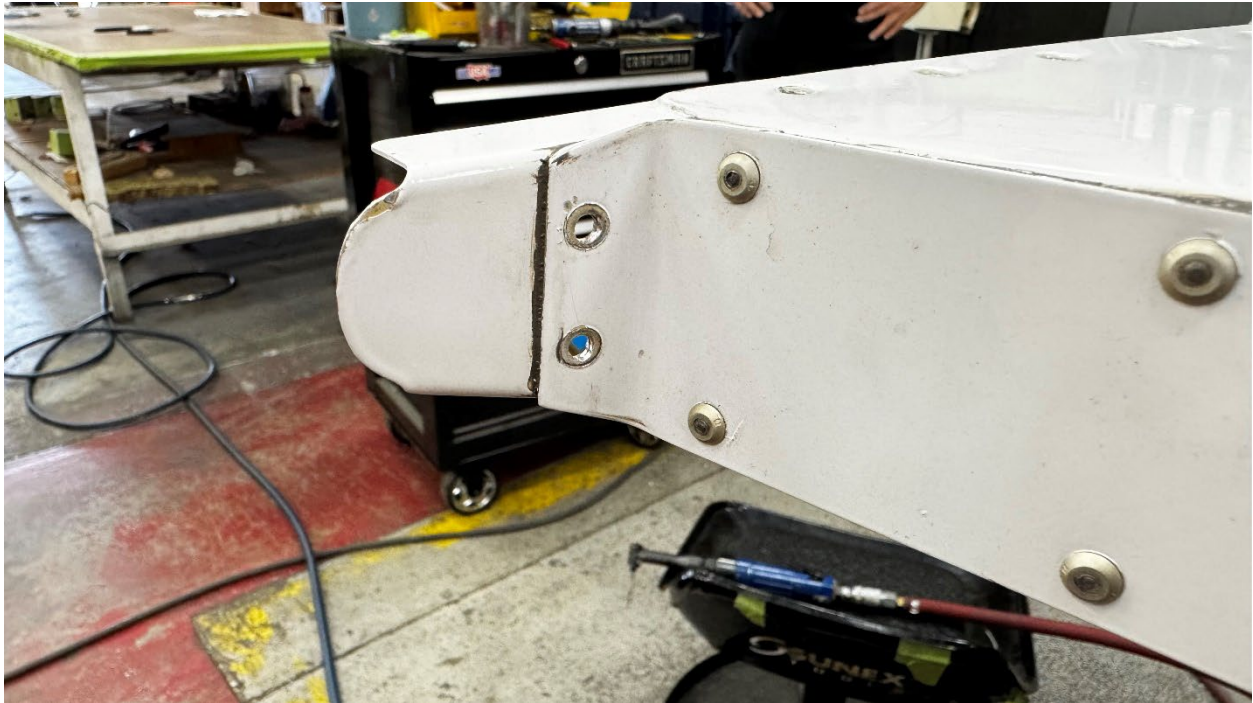
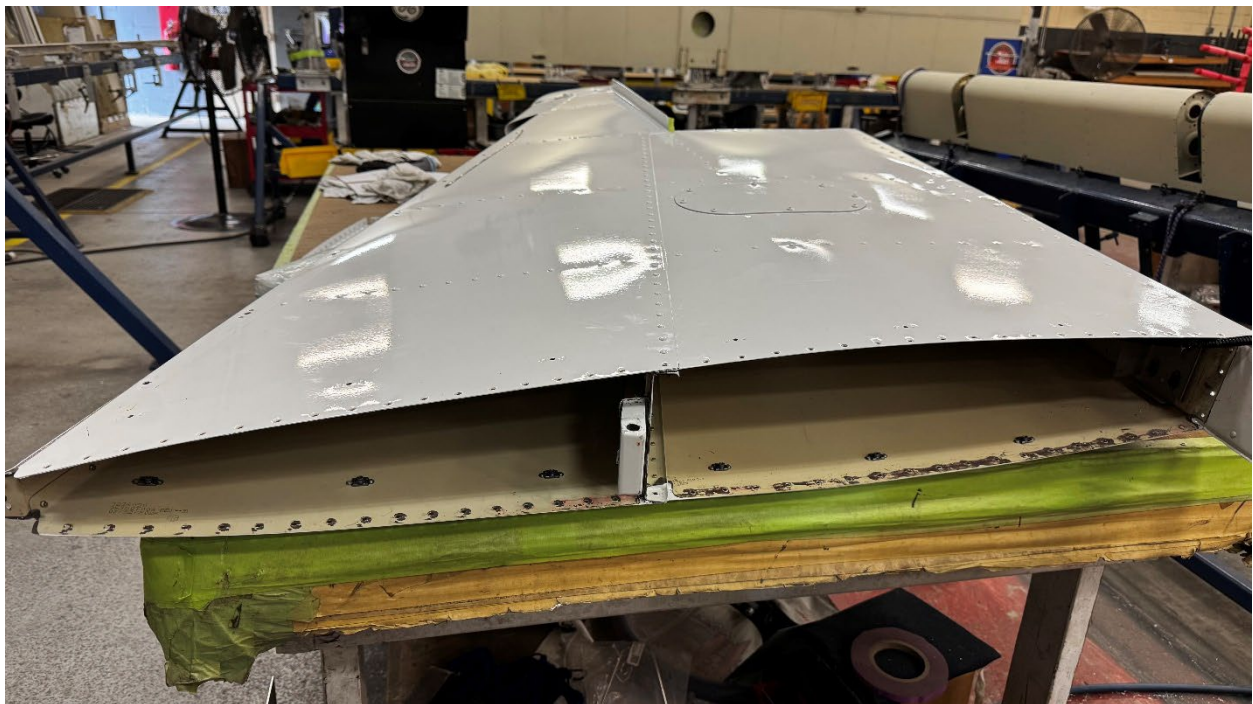
10. Remove lower forward and aft vertical stabilizer ribs (P/Ns 95254-1, 40281-1) by removing rivets (MS20426AD4 & MS20470AD4) to gain access to lower vertical stabilizer attach fitting. (Reference Figures 1 thru 5)

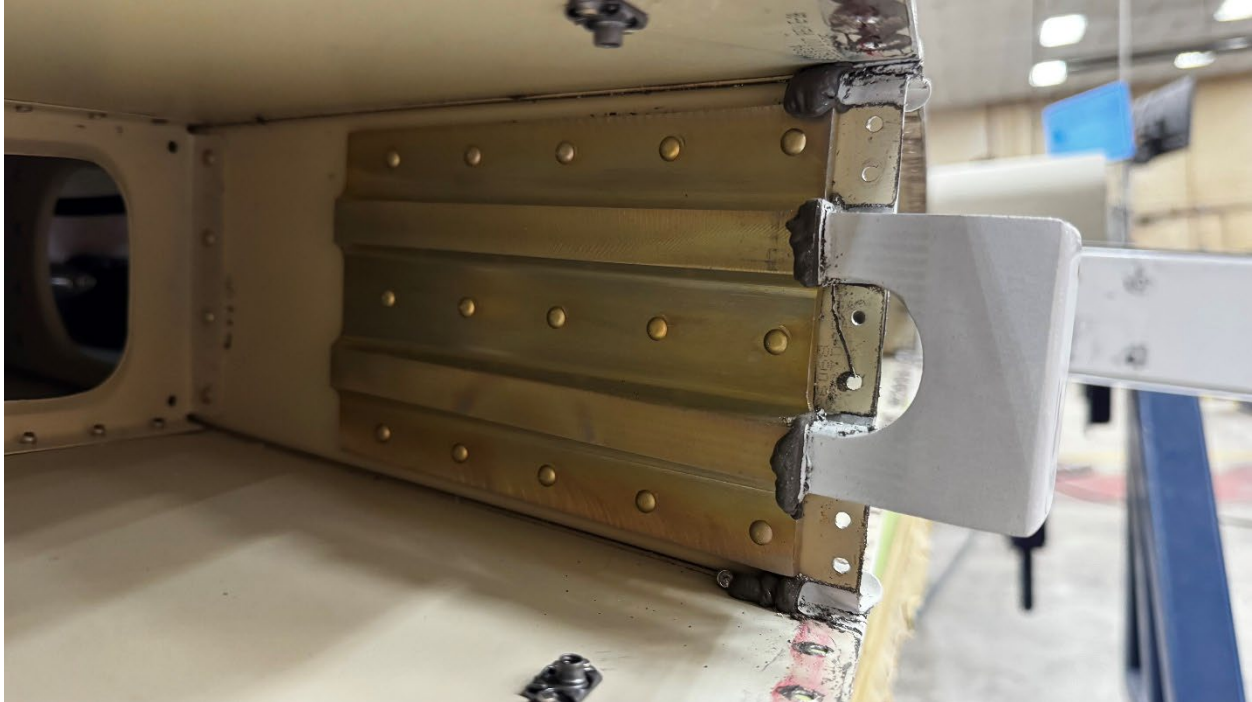
**Figure 6**

11. Carefully drill out 15ea MS20470AD4 rivets connecting lower vertical stabilizer attach fitting to vertical stabilizer forward spar. (Reference Figure 6)

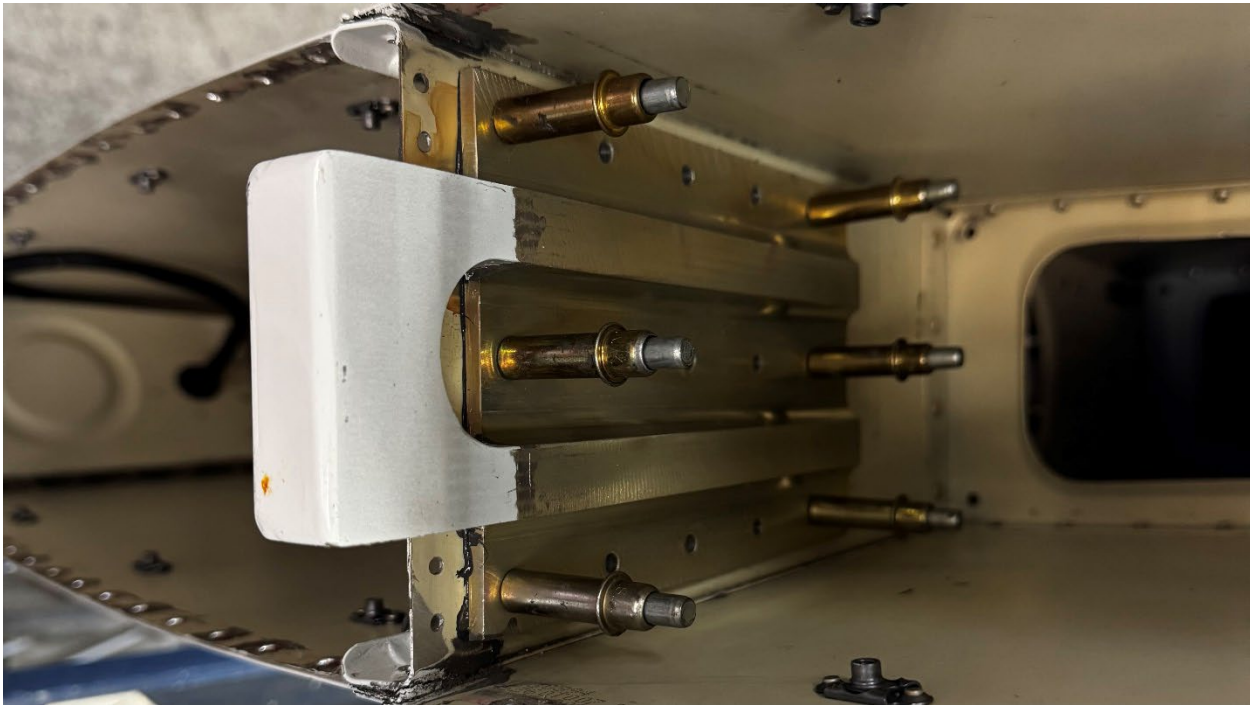
*Figure 7*

15. Match drill/ream 15ea rivet holes to  $\Phi.1850 \pm .001$  thru attach fitting and vertical stabilizer forward spar web. Maintain alignment of all holes during drill/ream operation. Deburr holes after reaming. (Reference Figure 7)

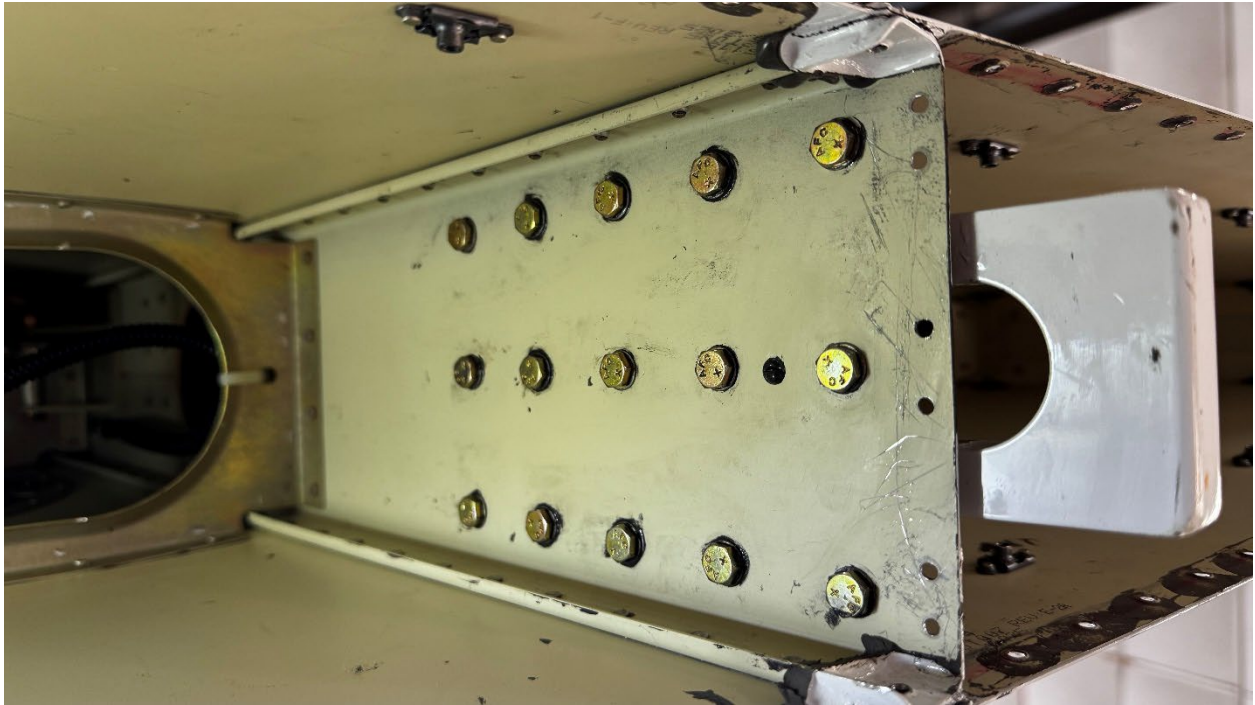
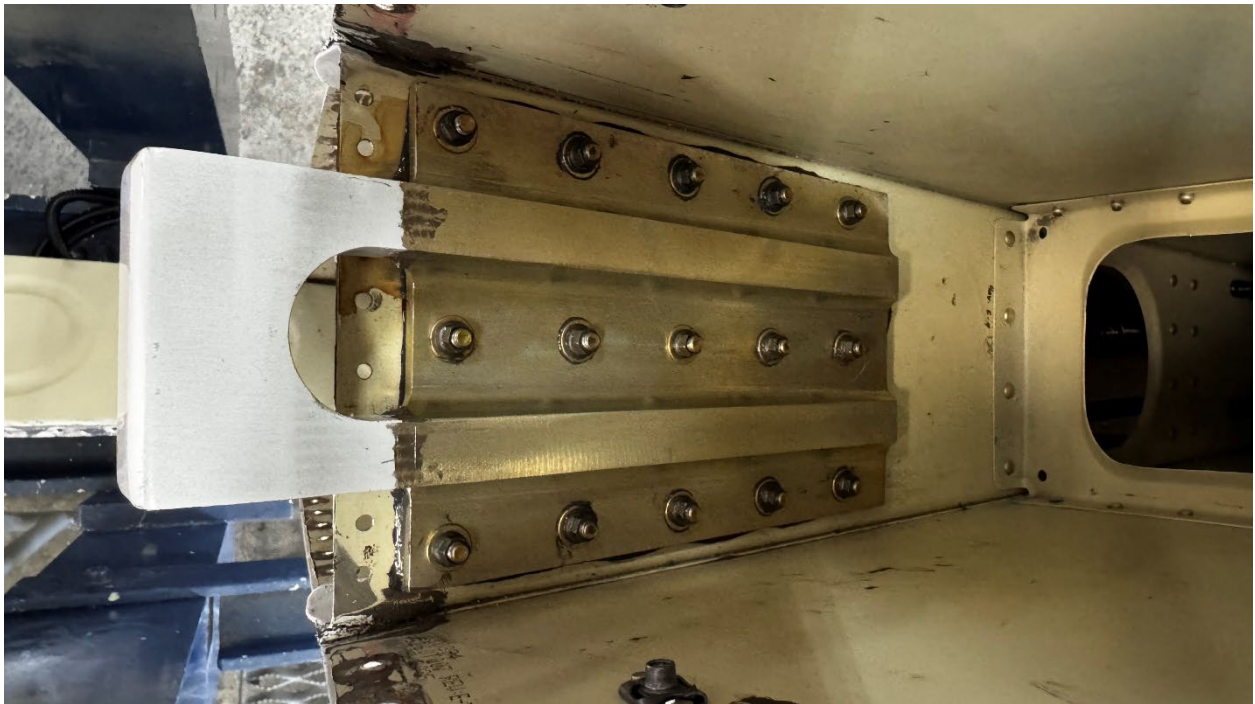
16. Install forward attach fitting wet with AMS-S-8802-B2 sealant and 15ea AN3-4A bolts, 30ea NAS1149F0363P washer or NAS1149F0332P washer (one under bolt head, one under nut, max 2 washers any combination under bolt head or nut, adjust quantity and thickness as required for 1-3 thread penetration in nut, adjust bolt length  $\pm 1$  length as required for 1-3 thread penetration in nut), 15ea MS21042L3 nuts. Install bolt head against aft spar face, nut against fitting face. Torque nuts to 20-25 in-lbs. plus running torque. (Reference Figures 8 & 9)
