SERVICE LETTER

SL-AG-135

Baggage Compartment Door Inspection

Affected Aircraft Models	Serial Number Range
S2R-H80 S2R-510	ALL

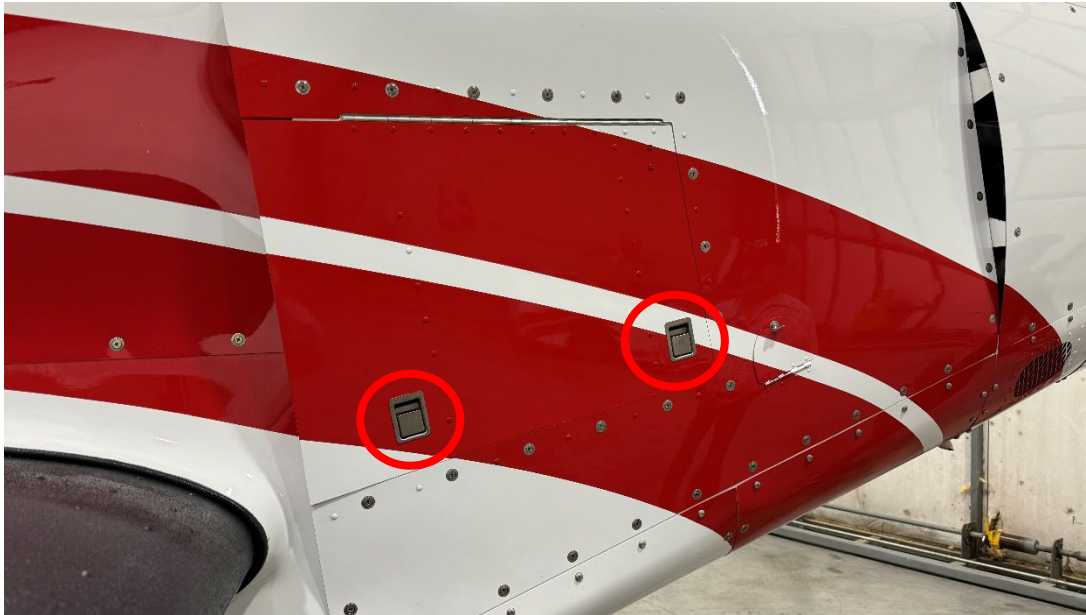
Figure 5.1

1. It is best practice to close the baggage compartment door using both hands to apply pressure at each latch simultaneously.

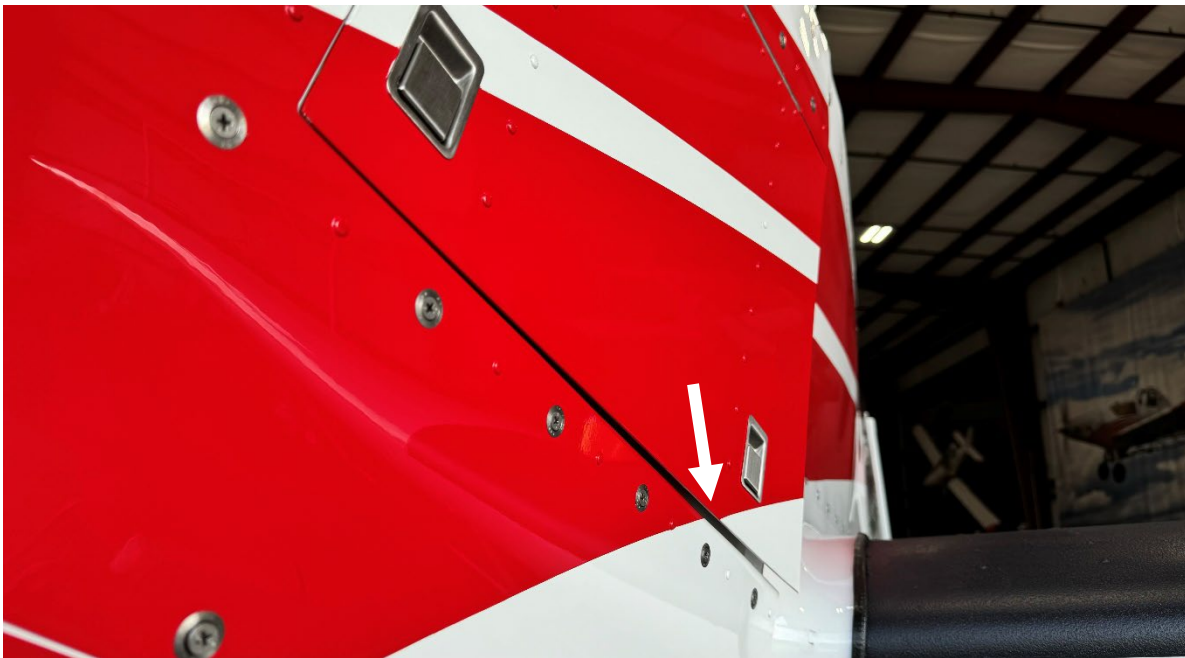
2. Reference Figures 5.2 & 5.3 for examples of baggage compartment doors that aren't properly closed, and the latches not properly secured.

Figure 5.3 – Latch Flush - Door Not Fully Closed

3. To ensure that the baggage compartment doors are properly closed, and the latches secured, carefully bump any unsecured latch with the side of the fist as needed. Examples of a seated and secured door below. (Reference Figures 5.4 & 5.5)

4. If the baggage compartment door does not properly close and the latch will not properly secure, the latch may need to be modified per following instructions.

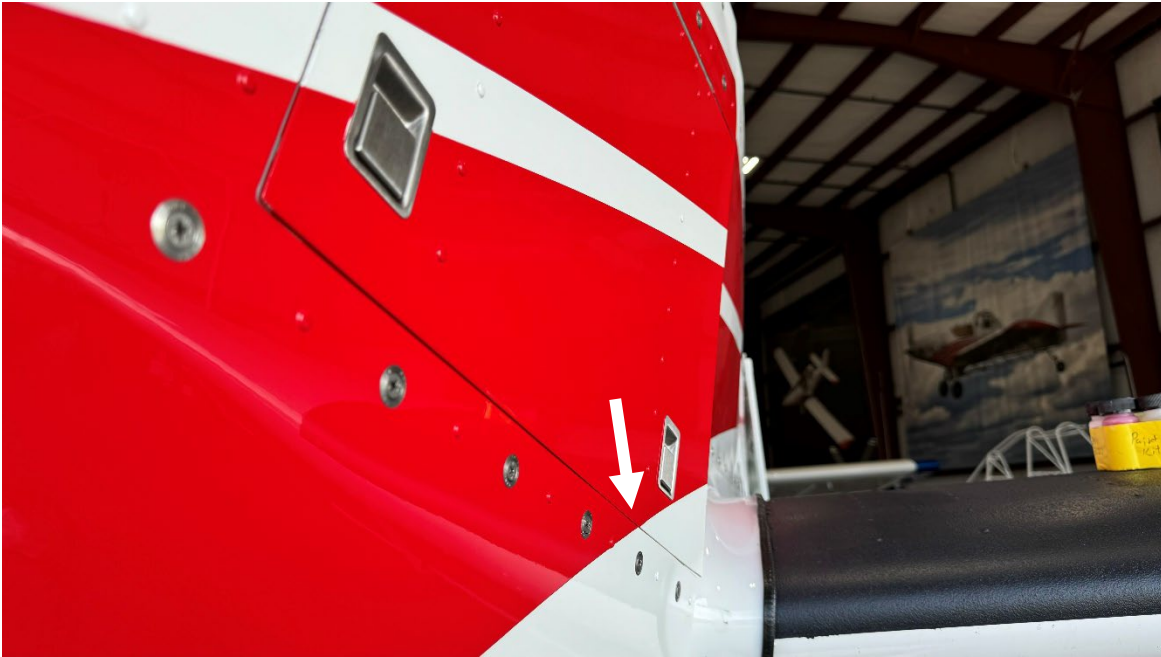
Figure 5.5 – Latch Seated Flush - Door Fully Closed
